Stabilization of endangered part of structures by building dry brunt brick buttressing, critical case study of plane wall in DKG-North Area, Mohenjo daro

J.M. Shaikh,^{a,*}, JaeSeung Park^b

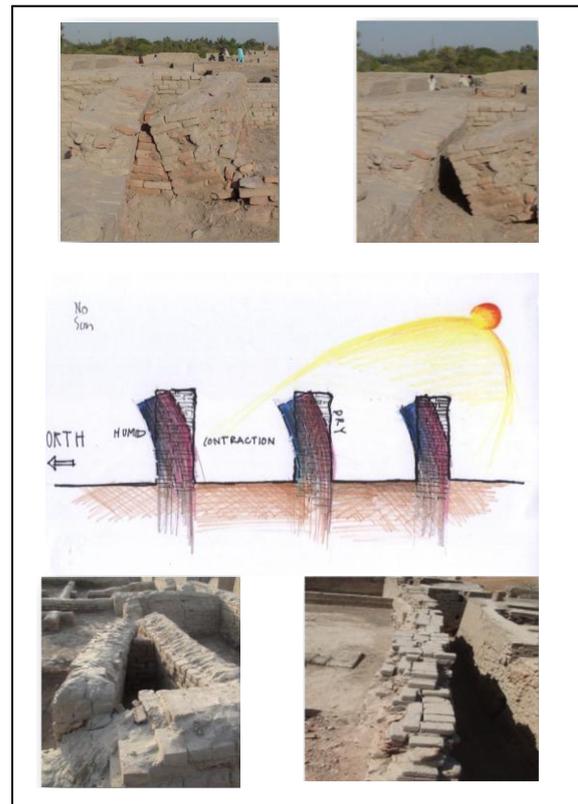
The timber and iron buttresses installed at the chief house, (Fig. 1) prevents the buckling at one side only. Though this intervention compromised the structural scheme of the building

as shown in Fig. 1, causing an excessive increase of the thrusts on the lateral wall from the external side, which were previously balanced by a system of columns and roof buttresses (original 5000 years ago). In addition the primary design was constantly transmitting loads and balancing it, hence the weight of the upper structure is usually transmitted through the lateral wall upon the pier with an offset. Today this isolated wall is not behaving similarly, but the entire load is being transmitted to the lower end of this wall, which has to fit in the narrow area of the street. The combination of these forces with the thrust of the continuity resulted in the progressive instability of the lateral wall and the formation of minor and major cracks, at the relatively weak area of the wall.

Figure 1. The thermal stress recorded and filling of gaps, voids in mud capping with pure clay in DK area

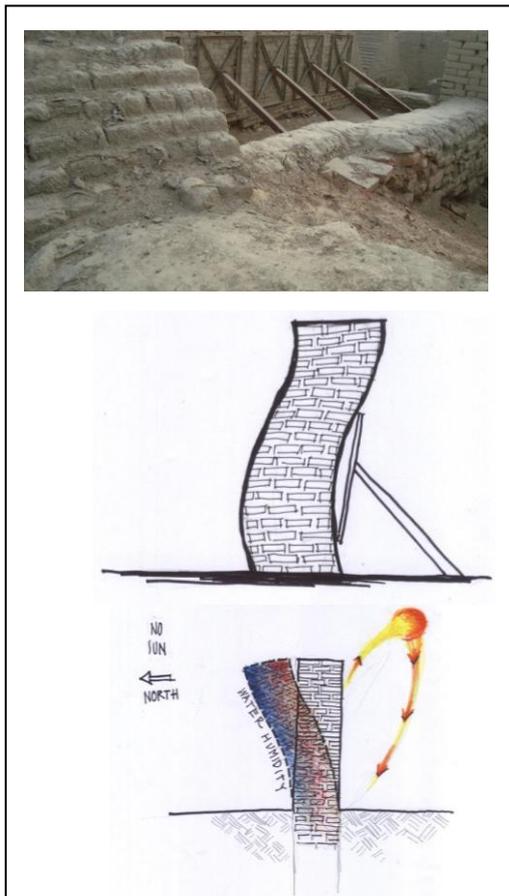
As a consequence, failure resulted from excessive horizontal displacements, and the critical crack pattern generally follows the scheme in Fig. 2 the longitudinal cracks develop at the extrados parallel to the edges. This pattern has been mainly established through inspections of damaged structures, but no information is available on crack propagation or the distribution of the loads during failure.

Figure 2a : the exo- skeletal support (30 March, 2012) This is a critical case out of plane wall in DKG-North area.

Figure 2b: Exaggerated deformation pattern in the sectional view, along with the support

Immediate buttress is needed, which could be easily installed, to stop the inclination several of the supports made up of wood or bamboo could be installed easily by local people using local

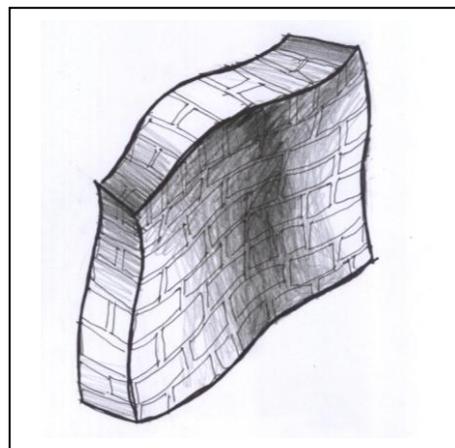
Depending on the types and signs of the ground surface movement it makes different impact on buildings being determined (Fig. 3). At horizontal tensile deformations inclined cracks in external walls are generated which are symmetrical relative to the centre of the wall. Vertical bending and vertical shear cracks are typical of curvature of convexity, the bending cracks being typical of flexible walls where the lengths exceed their heights by more than three times. Shear cracks are always generated, being more typical of two-storey and higher walls than bending crack. Under horizontal compressive deformations and curvature of concavity inclined and horizontal cracks are generated in the walls located symmetrically relative to the centre of the plan.

Figure 3: The deformation in a curvilinear form, since the material is tired and is bending with the load (March 2012)

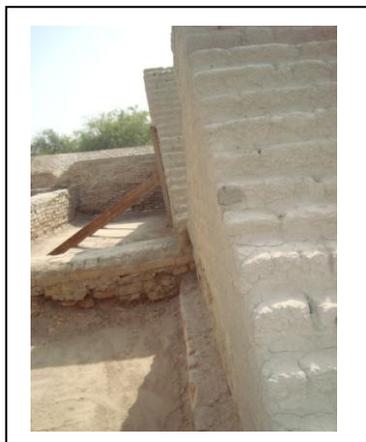
Figure 4: the view of the deformation (30th March 2012,)

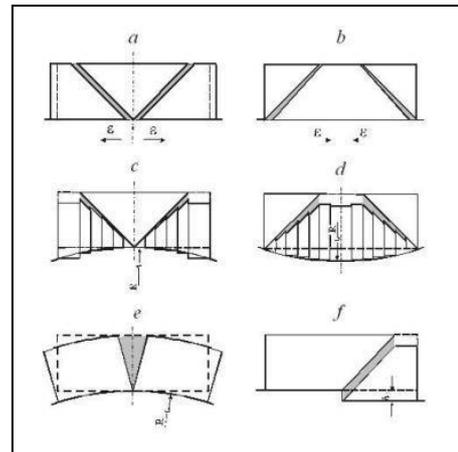
Figure 5. The generalized structural deformations of the walls induced by: a – horizontal shear due to ground surface tension; b – horizontal shear due to the ground surface compression; c – vertical shear due to the curvature of convexity; d – vertical shear due to the curvature of concavity; e – bending due to the curvature of convexity; f – vertical shear due to the bench formation

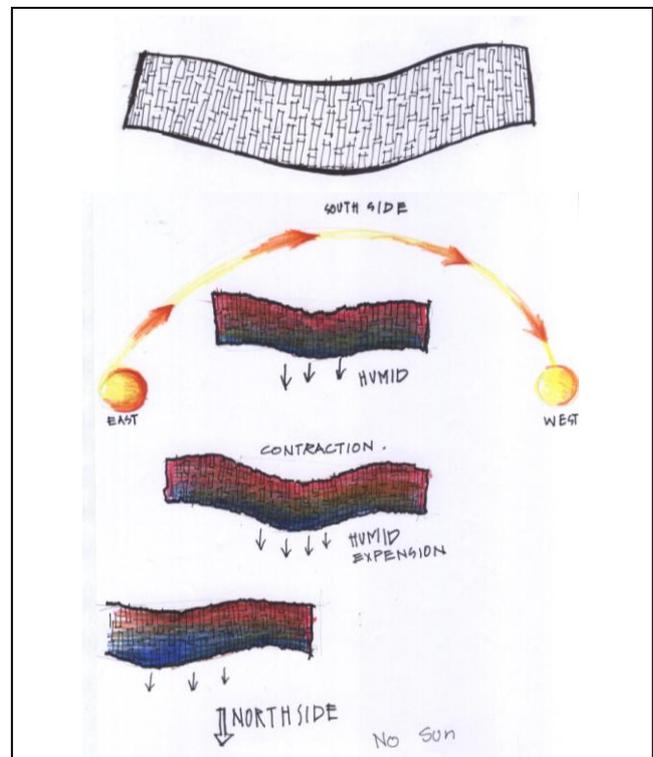
Figure 6: Exaggerated deformation pattern for understanding

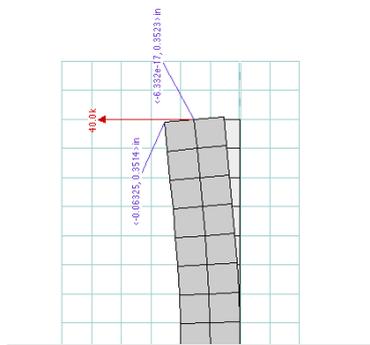
Figure 8. dead constant load of the brick, and bucking effect due to torque

In Fig 8. stresses are shown by plotting lines perpendicular to the maximum in-plane tensile stress direction, with the line lengths proportional to the maximum tensile stress magnitude. Such a depiction can help indicate where cracks might tend to form in materials sensitive to tension. Similarly, choosing the Maximum Shears option leads to the plot below in which the stress are aligned with the directions of maximum shear stress. This depiction can indicate yielding tendencies in ductile brick materials of the wall.
