INTEGRATED KNOWLEDGE ON A THREE-DIMENSIONAL BASIS: THE FOUNDATION OF THE CONSERVATION PROJECT AND POSSIBLE IMPLICATIONS IN THE BIM AREA THE CASE OF THE PORTRAIT ROOM OF PALAZZO BOREA D'OLMO IN SANREMO

2. THE CASE OF THE PORTRAIT ROOM OF PALAZZO BOREA D'OLMO IN SANREMO

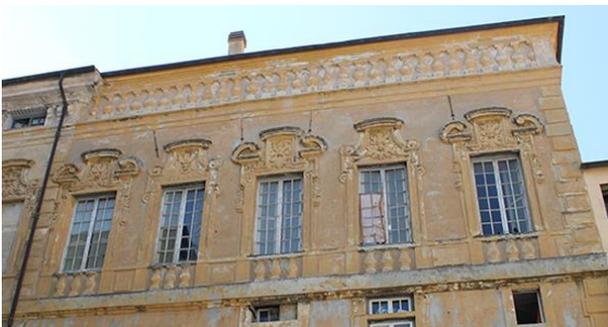
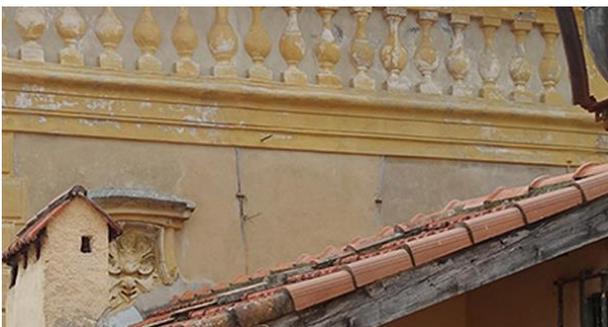
1. The persistence, on the façade, of the bolted end-plate of metal chains that have been cut and removed inside the building.
2. The reconstruction of a large portion of the vault, recognizable by the different building technique and by the loss of the fresco decorations.

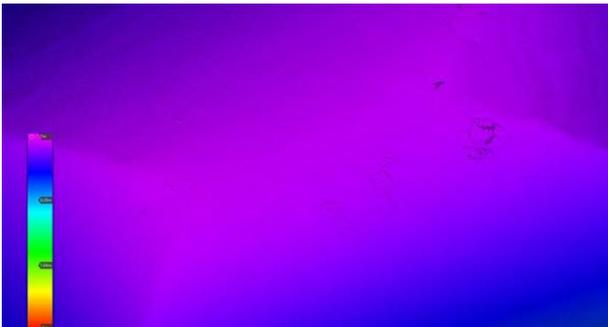
- The RGB visualization provides realistic colour photographic image (Fig. 7);
- The DEM visualization can be set with customizable colour scales in order to obtain the best graphic data reading. The DEM represents the distribution of heights in relation to the base level 0.00 (level of first scan). The DEM therefore highlights the deformations, the lesions and the discontinuities of the vault due to the different reconstructions. It emphasizes the swellings and plaster detachments attributable to degradation, infiltration, prolonged action and repeated humidity (Fig. 8);

Figure 8. DEM three-dimensional view - 3d model of the vault elaborated with laser scanning

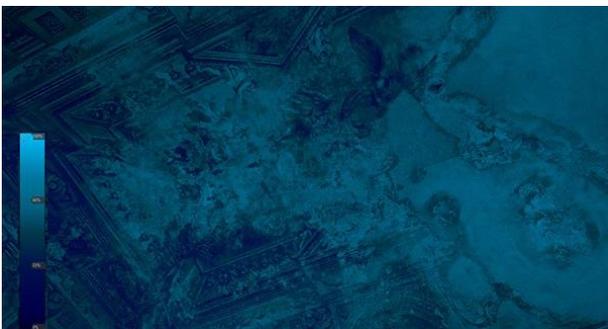
- The reflectance visualization scale (Fig. 9), customizable in order to obtain the best reading of the data, highlights the distribution materials according to their light reflection level. In this way it is possible to distinguish the materials with lower reflectance (greater absorption of the laser beam) and those with higher reflectance (low absorption of the laser beam).

Figure 9. visualization in reflectance scale (custom colours) - 3d model of the vault elaborated with laser scanning

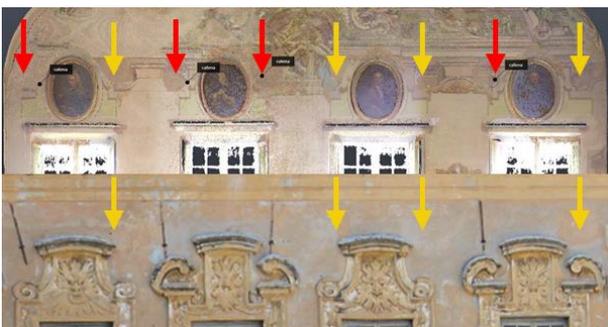
Figure 10. Interior and exterior view of the Family Portrait Room. The red arrows indicate the existing bolted end-plate; the yellow arrows indicate the plaster swellings detected where the bolted end-plate are no longer in place.

The result has been particularly effective to find out the plaster resumptptions where the metal chains were removed even if today the external metal end-plate no longer exist (Fig. 10).

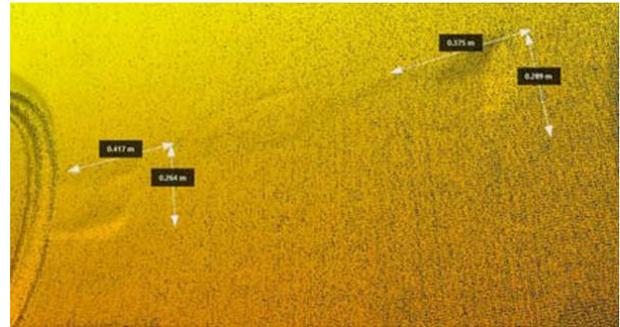
In these points, the layers of plaster and paint have marked swellings and detachments that can be seen with the DEM display of the point cloud. The comparison with its RGB version allowed us to verify the chromatic difference of the plaster. (rif. Fig. 10, 11, 12).

Figure 11. DEM three-dimensional view of the dense cloud: detail of the points where the metal chains have been removed.

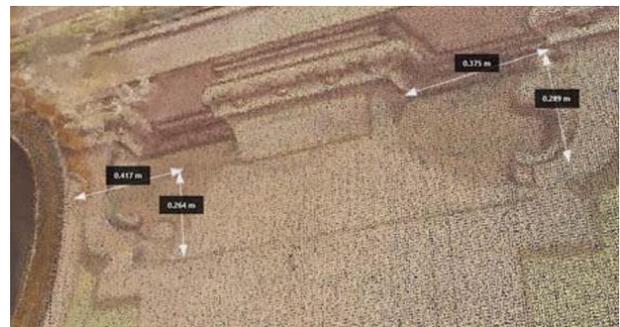
Figure 12. RGB three-dimensional view of the dense cloud: detail of the chromatic differences of the plaster in the points where the chains have been removed.

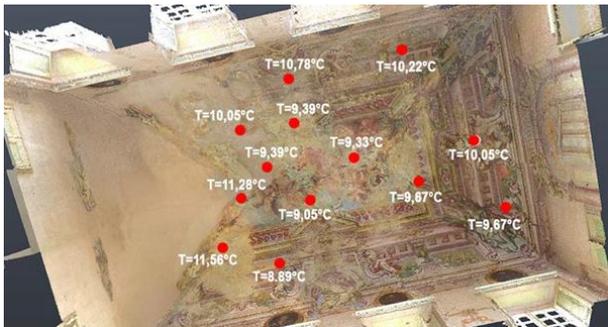
As can be seen in the image below (fig. 13), the temperatures detected at the lower level of the frescoed vault were very close to the external temperatures.

The causes are attributable to:

- Long-time lack of environmental air conditioning system at the time of the survey;
- degradation of walls, window parapets and sills;
- presence of lesions on the vault and on the perimeter walls;
- degradation of the windows wooden frames, lack and breakage of some panes,
- general humidity in all rooms of the second noble floor;
- presence of several infiltrations (and therefore of persistent humidity) in the other rooms.

Figura 13. Temperature distribution to the intrados of the vault detected with a thermal imaging camera.
