## INTEGRATED STUDY OF THE BEATA VERGINE ASSUNTA DOME WITH STRUCTURE FROM MOTION AND DIAGNOSTIC APPROACHES

S.M. Grillo<sup>1</sup>, E. Pilia<sup>2</sup>, G. Vacca<sup>2\*</sup>

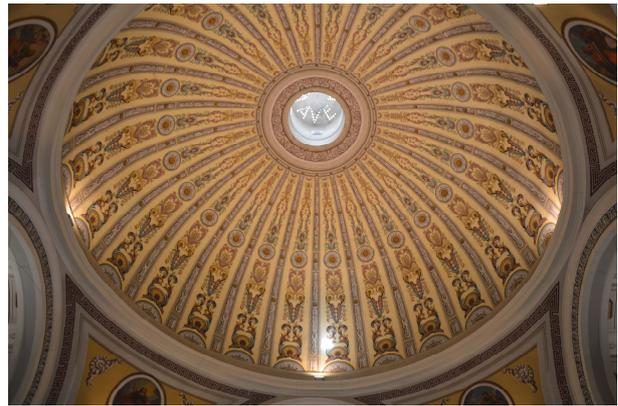
Figure 2. The internal view of the dome (Pilia E.).

In 70s a sudden worsening required an intervention on the dome, in these years seriously in danger for the high load of the waters and the consequent detachment of the painted plasters (figure 2). After the closing of the church, in 1978 the ing. Rollo proposed a series of intervention for the waterproofing of the roofs and the conservative restoration of the paintings. These interventions can be considered the most important for understanding the current configuration of the dome, widely consolidated and re-plastered with concrete mortars and repainted in acrylic temper. In the same years the roofs were completed demolished, refurbished with integration of bricks and concrete mortars, metallic grids and a new system of drainpipe for guarantee the efficiency of water disposal.

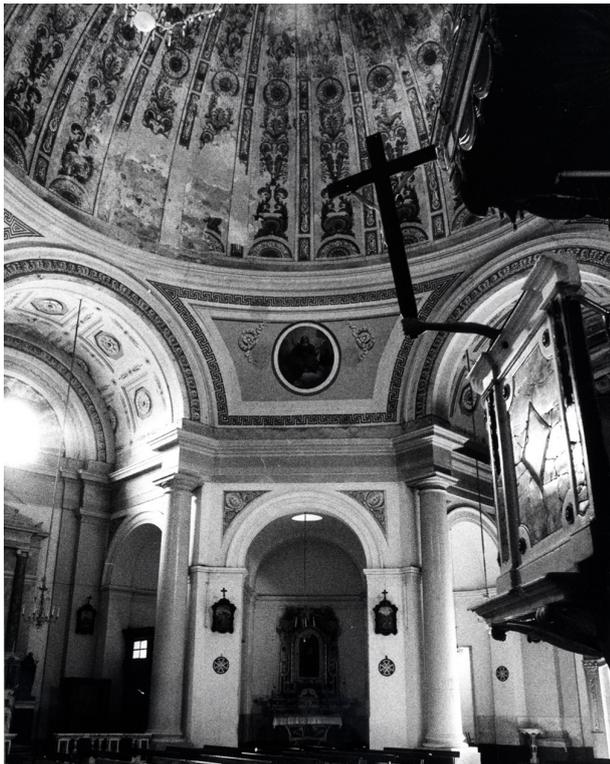
Figure 3. The internal view before the restoration in 1978 (Superintendence of BAPSAE - Provinces of Cagliari and Oristano).

From the macroscopic analysis of the material samples results clear that all the bearing structures have been realized in local sandstone as also confirmed by the indications furnished by the geotechnical surveys. As concerns the plasters (figure 3) instead, it can be confirmed the presence of three layers, with high probability linked to the restoration works. While C\_02 is clearly a concrete mortar from the 80s intervention of replastering and repainting with a thin layer of acrylic temper, the sample C\_04 shows the same concrete layer and further historical lime mortar that shows a thinner aggregate and a lower aggregate/binder relationship. Finally, C\_05 has the same composition of the deeper layer of C\_04 so, it could be part of original lime mortars designed by the Cima.

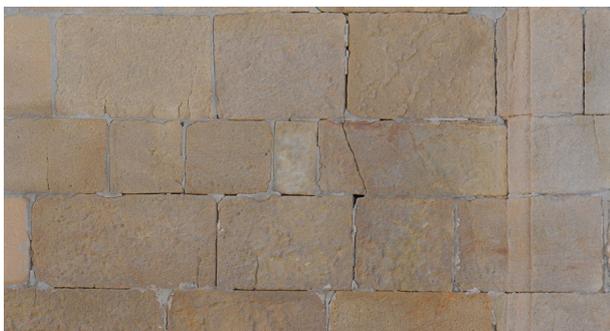
Figure 4. Sandstone masonry of the tower bell, built with the same local material (Pilia E.)

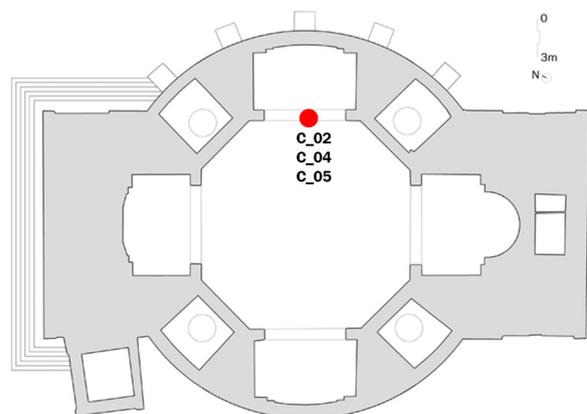
Furthermore, the material investigation has been conducted in order to understand the stratigraphy of the dome surface. Specifically, significant samples (figure 5) were analysed according to the following protocol: selection of the reasoned sample; their study by means of transmitted and reflected light microscopy; study of the aggregate and of the binder separately by means of x-ray diffractometer. All these surveys have been carried out in the laboratories DICAAR and LabMAST | Mediterranean Laboratory for Historical materials and architectures. with optical microscope in transmitted light Zeiss Atioplan and diffractometer Rigaku Ultima IV, in parallel optic, radiation CuK $\alpha$  a 30mA; pattern 5°-65°.

Figure 5. Map of the samples (Pilia E.)

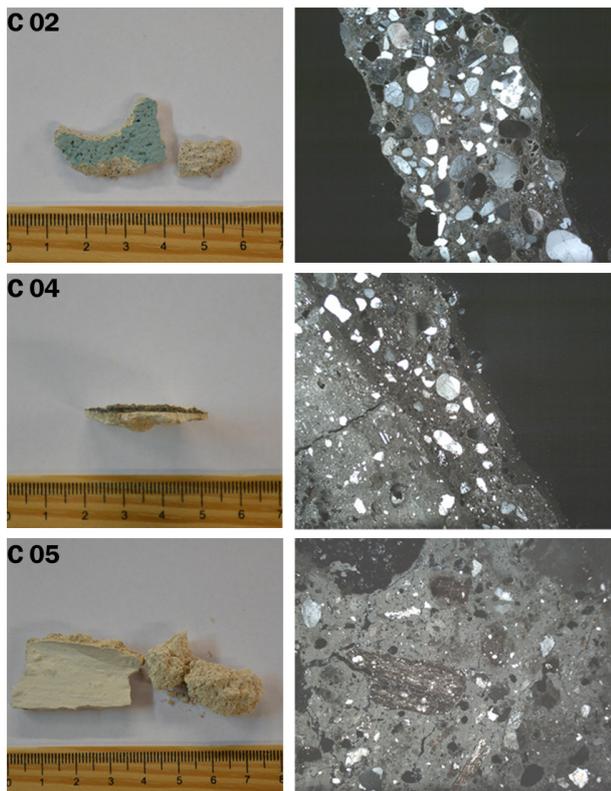
Figure 6. Minero-petrographic analysis. From the left: macro photo; thin sections under the optical microscope in Transmitted Light (Laboratory analysis: Grillo S.M., LabMaST. Graphic elab: Pilia E.).
