THE *TEMPIO DELLA CONSOLAZIONE* IN TODI: INTEGRATED GEOMATIC TECHNIQUES FOR A MONUMENT DESCRIPTION INCLUDING STRUCTURAL DAMAGE EVOLUTION IN TIME

F. Radicioni^{a,*}, P. Matracchi^b, R. Brigante^a, A. Brozzi^a, M. Cecconi^a, A. Stoppini^a, G. Tosi^a

^a Dept. of Engineering (DI), University of Perugia, 06125 Perugia, Italy - fabio.radicioni@unipg.it

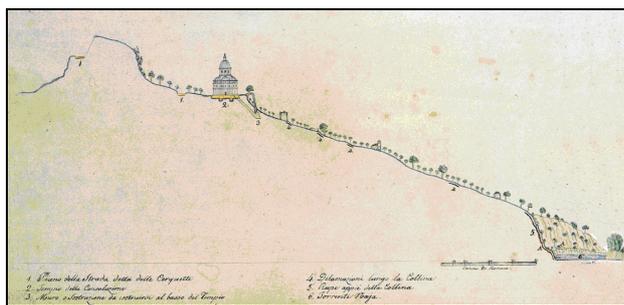
Figure 1

In the drawing of Figure 1, it is shown the profile of the slope along the direction N-S down to the Naja river. The original drawing indicates some areas of local shallow instabilities (properly *dilatazioni* in ordinary Italian – Comez, 1991), as well as the area at the foot of the slope, involving the cliff above the river. A proposal for intervention is also represented

in the drawing, which shows the section of a massive wall to be built on the south side of the church.

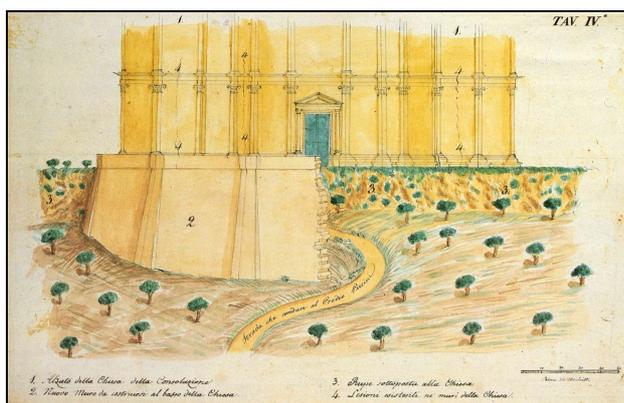
Figure 2 (*Tav. IV* in the original drawing) shows a view of the church along the west-east direction and the land around. The main vertical cracks observed on the structural walls are also shown. A half of the new massive wall is represented on the left side while the right side shows the existing situation with a view of the scarp.

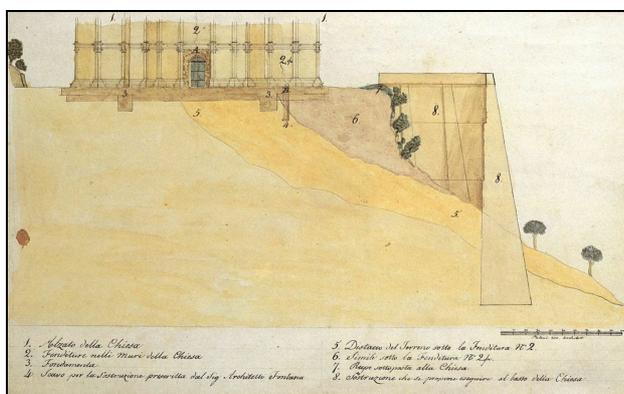
Similarly, in Figure 3, the west façade of the church is represented showing the existing vertical cracks in the *tribuna*. The drawing clearly depicts a subsoil region probably involved in a sliding mechanism, described as a *distacco del terreno sotto la fenditura n.2*. The section of the massive wall architect

Fontana proposed to build in order to retain the soil is represented in Figure 3 with number 8 (number 2 in Figure 2). Also, the drawing shows a vertical wall to be built underneath the south *tribuna*, next to the existing foundations (number 4). The proposal of countermeasures consisting of underpinning beneath the southern apse and of a large polygonal retaining wall appeared to be a valid solution to be pursued. In 1839 Luigi Poletti led to the completion of the construction of a semi-circular gravity retaining wall with niches (Vaccari, 1991, pp. 152-155).

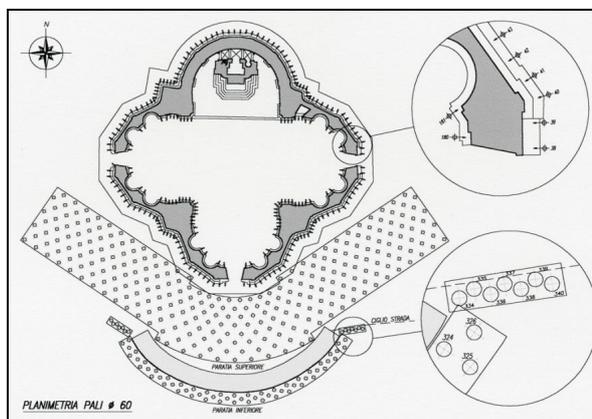
Figure 4. Recent interventions (Mariani, 2006 and 2008)

Finally, structural and geotechnical countermeasures have been undertaken more recently (1990s), consisting in underpinning (micropiles all around the existing foundations), diaphragm walls made of large piles and structural reinforcement (Mariani, 2006, 2008. Fig. 4).

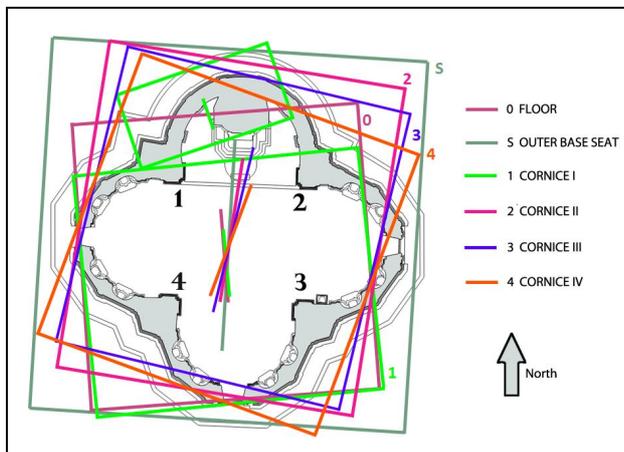
Figure 6 shows the maximum slope directions obtained for the various architectural elements, overlapping in a single plan: it can be seen, the higher the element altitude, the line tends to rotate slightly clockwise, thus putting into evidence a torsional deformation of the church.

Figure 6. Superimposition of the maximum slope directions for architectural elements at different levels (ref. Fig. 5)

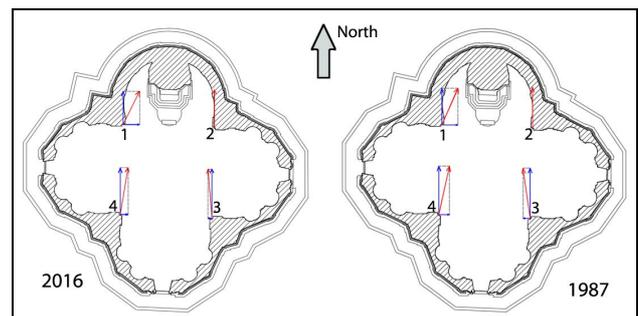
Table 2 shows the values of the off plumb (north and east components) from top to base for each pillar. In Fig. 7 the total off plumb of the four pillars was plotted in planimetry. It is clear as the vertical elements are inclined toward the north (altar area); such results are concordant with the slopes measured for the horizontal architectural elements.

Figure 7 also shows a comparison between the present pillar inclination with the values found in 1987 (Mariani, 2008): we can see that the situation has remained largely unchanged over the last 28 years.

Figure 7. 1987-2016 comparison of the pillars off plumb

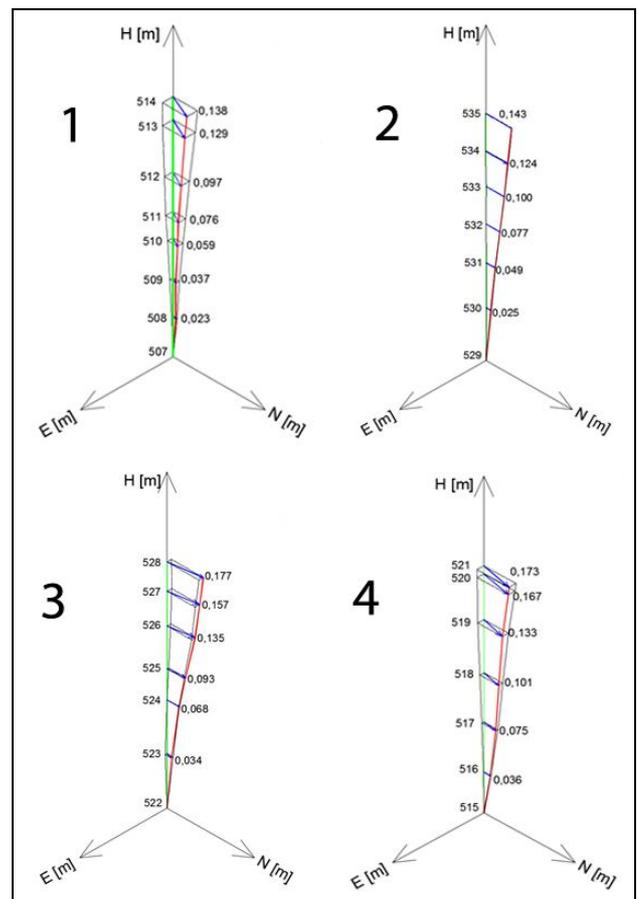
Figure 8. Axonometric representation of the pillars off plumb (amplified by a factor of 10)

Figure 8 contains an axonometric representation of the off plumb measured along the four pillars, amplified by a factor of 10. For each one, the red line corresponds the actual edge, while the green one is the vertical. These results were confirmed by analyzing the same elements from the cloud of laser points (see Par. 2.4).

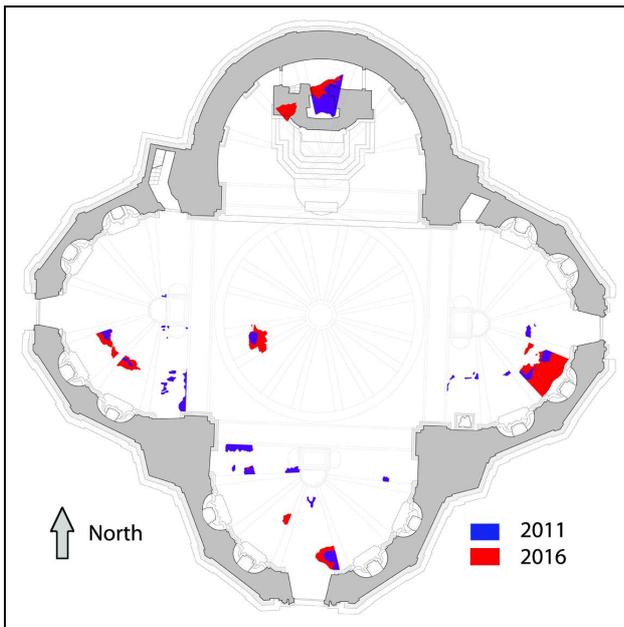
Thanks to post processing application of colour to the point cloud, it was finally possible to determine the status of the moisture spots at the intrados of the central dome and the apses semi-domes, and compare the 2016 and 2011 patterns. From the comparison (Fig.11), it is evident how the spots are considerably enlarged, especially the patches that affect the central dome, the north and east apses, and also some of new formation (north and west apses).

Figure 11. Moisture patches on the dome intrados

It has to be noted that the lead covering of the apses half-domes has been restored in 2016, so any rain infiltration should now be eliminated.

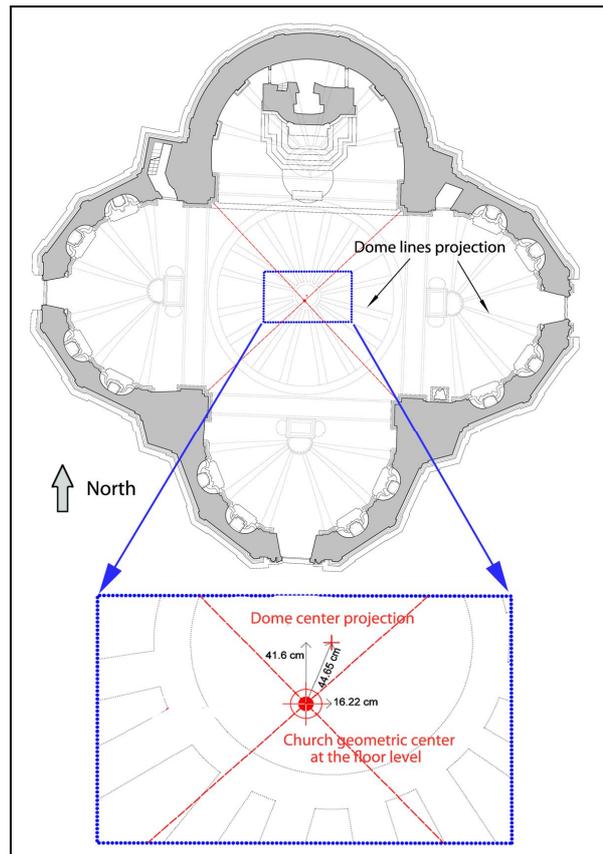
A starting point has been the determination of the offset between the dome center (lantern) vertical projection and the geometrical center of the floor. The resulting offset is 41.6 cm (north) and 16.2 cm (east) with a resultant of 44.7 cm (Fig.12). Confirming the results obtained from total station and leveling (Par. 2.1, Tab. 1), the angle of inclination of the church determined from the model section is about 0.45° toward north (Fig.13).

Figure 12. Vertical projection of the dome center on the floor

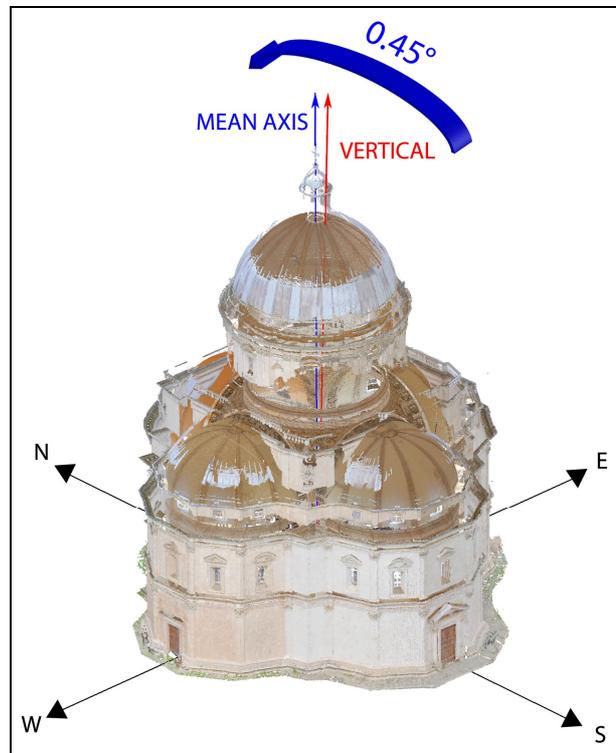
All the architectural elements of the church show a similar northward rotation: for the horizontal elements (cornices, floor, base seat) the angle of inclination is between 0.5° and 0.9° while for vertical elements (walls and pillars) the angle of rotation is between 0.6° and 1°. Summarizing, all measures and the 3D reconstruction show that the church has undergone an overall rotation leaning towards the north.

Figure 13. Overall rotation of the monument
