EXPERIMENTAL CONSOLIDATION WORKS IN RAMMED EARTH WALLS: THE CASE OF THE BAÑUELO IN GRANADA (SPAIN)

J.M. López-Osorio ^{1,*}, P. Bel-Anzué ²

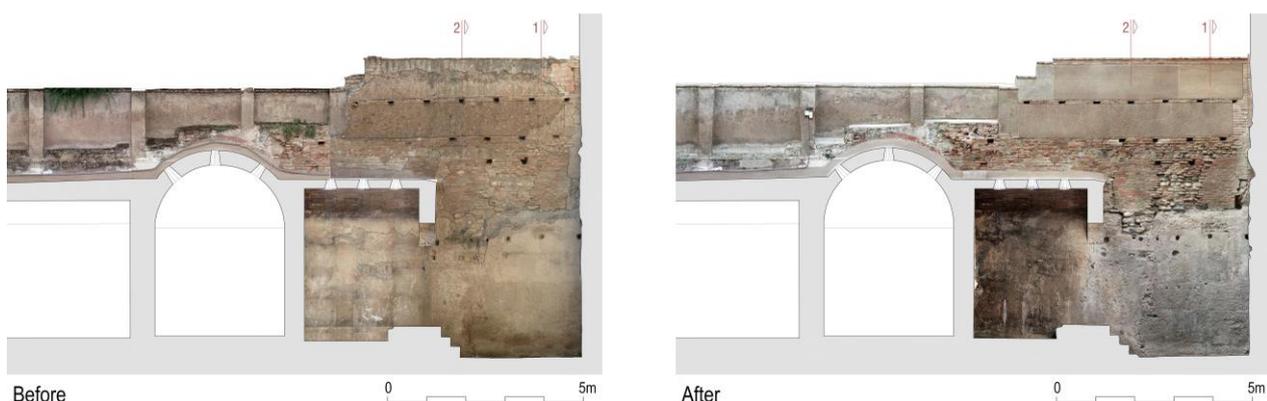
Before the last restoration works (2015-18), the 50-55 cm thickness rammed earth wall presented two sections of 85 cm high each one, separated by two courses of solid bricks, below which a series of putlog holes appeared every 90 cm; its function was to host the wooden stays in which the formwork is supported. The lower section presented also a course of bricks with putlog holes on its base, that was the finishing of a masonry and brick fabric probably built on Modern Age, although it features too the repairs done during the restorations of the 20th century. This masonry structure rests on the medieval lime concrete fabric, which corresponds to the original bath construction. The rammed earth wall is finished off on its northern side by a brick buttress that runs attached to the wall of the building located on this side (Figure 2).

Figure 2. Elevation of the west dividing wall of the Bañuelo. State before and after the consolidation works (section pl. 1-2 marked).

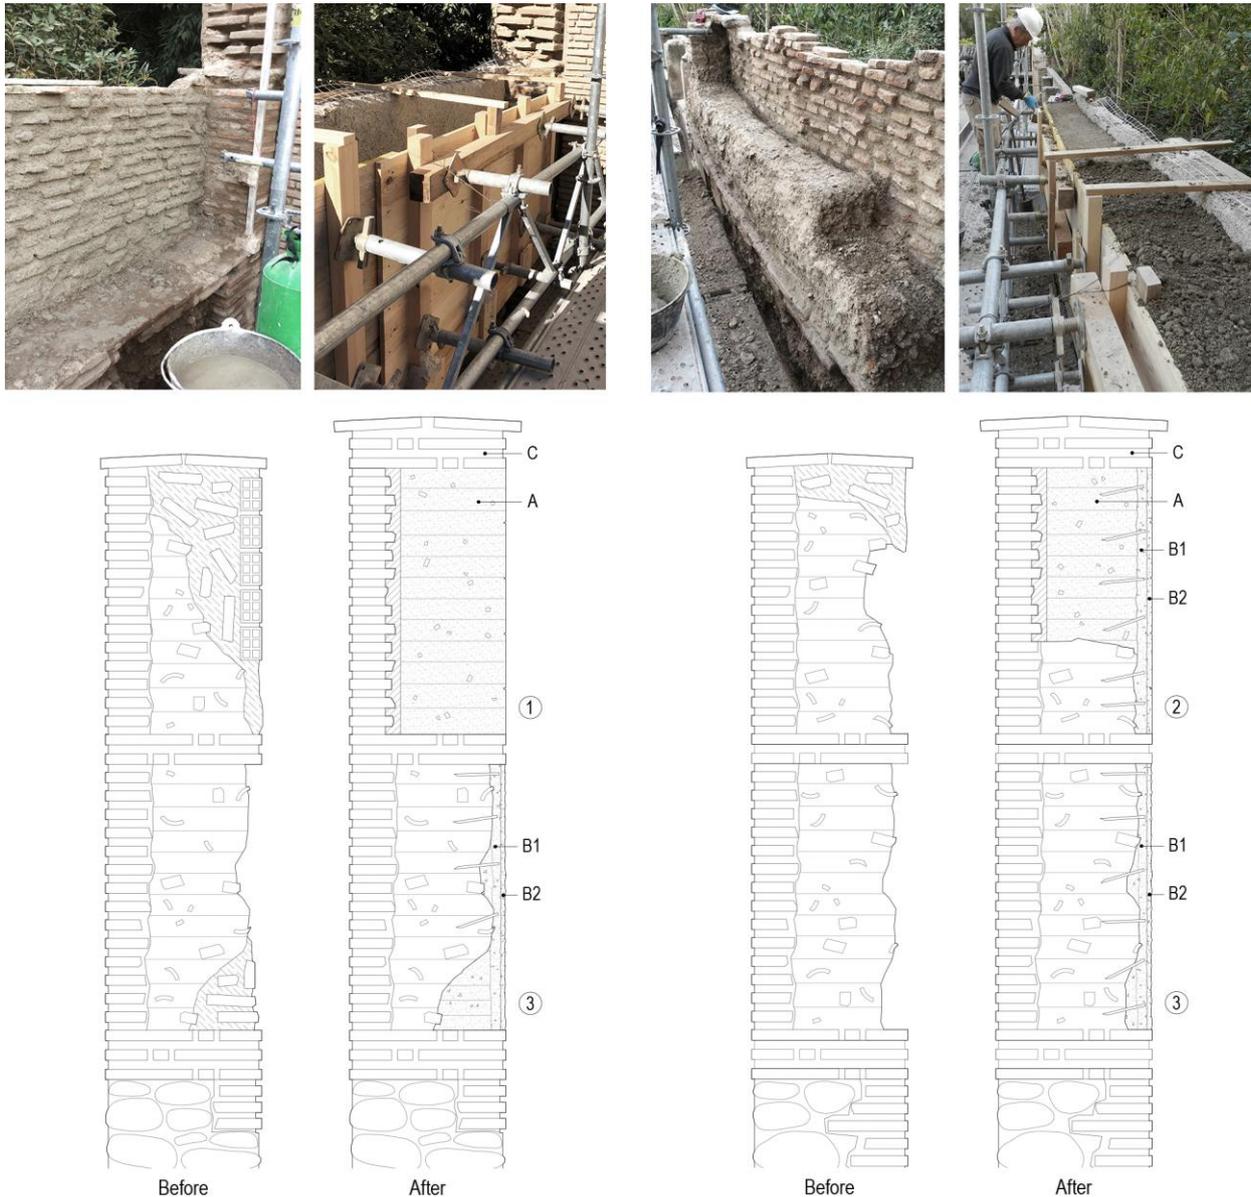
Figure 6. Left: Section pl. 1 / Right: Section pl. 2

Up: State of the wall after dismantling works and installing the wood formworks. Photograph: Bados Navarro S.L.
Down: Types of mass: A-B1-B2-C (Table 1) and types of surface finish: 1-2-3 (Table 2).

In the formwork or upper level of the wall, the rammed-earth technique was used to carry out the reintegration of the volume. had previously been repaired with half-foot thick solid brick masonry, which was in good condition of conservation and that served to fulfil the function of the formwork (Figure 6). To reinforce the brick wall, a 1:3 lime mortar reinforced with 5 x 5 cm fiberglass mesh was applied on the inside, also installing wooden slats on the outside that allowed assembling the formworks. Before installing the formwork, at the north end of the wall the entire original earthen wall was removed as it was in very poor condition and made it difficult to carry out the conservation work.

No needles stays were placed to support the walls, inserting a threaded steel rod into the putlog hole to close the frame. The boards were supported on the scaffolding through a wooden slat and were bent against it using metal bushings and spindles (Figure 6). Once the two types of formwork were installed, the earth was poured, which was carried out in 10 cm thick layers, performing the ramming manually with wooden rammers (Figure 10). The soil used was of coarse grain size (Mass A), to which a small amount of water was added to achieve a dry consistency. The degree of compression reached was 70%, which means that 1.43 m³ of dry volume was required to obtain 1 m³ of rammed earth wall.

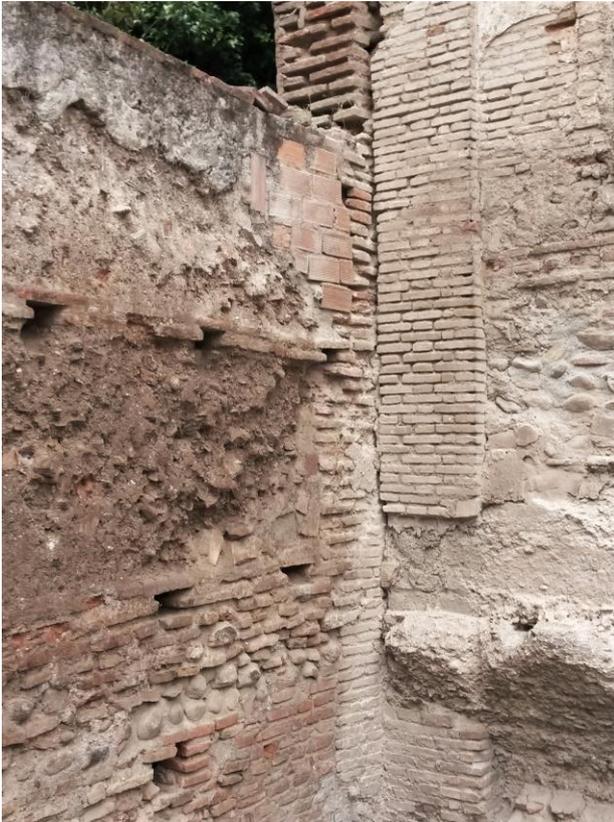
As the rammed earth fabric of the west wall presented different levels of degradation (Figures 7 and 9), the consolidation works demanded two clearly differentiated techniques. The fabric presented in some parts a significant loss in mass, normally at the upper level and the top of the wall; in this case, it was necessary to reintegrate the missing volume. It was carried out by the formwork and rammed techniques. In other parts of the wall, a partial loss of material due to surface erosion or holes at middle or lower levels was observed.

Figure 7. State of preservation of the rammed earth wall before the consolidation works.

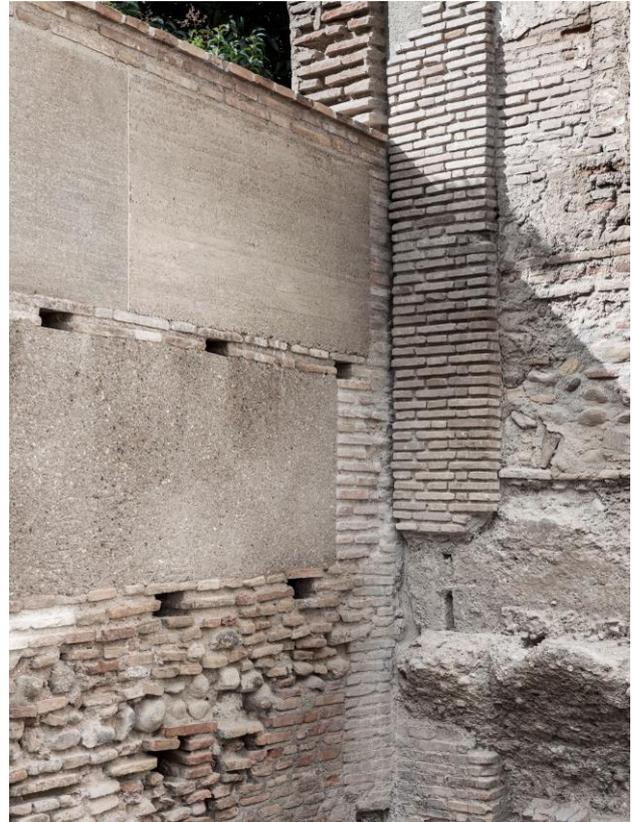
Figure 8. Final state of the rammed earth wall after the consolidation works. Photograph: Cristina García-Zarza.

For the execution of the new rammed earth wall, two types of formwork were installed. The main one was arranged flush with the brick courses that define the surface plane, and it was built with 24 mm thick five wooden boards. The secondary formwork was aligned with the remains of the original fabric that remained 27 mm behind the face plane, which coincided with the thickness of the three-layer wooden board used. Once the works were finished, it was marked the interface between the two formworks on the surface of the new rammed earth fabric, in order to show the different reintegration techniques used. The distinction was signalled by introducing a thin wooden profile on the mass (Figures 8 and 12).

The surface of the rammed earth wall had two types of finishing depending on the formwork system (Figures 8 and 12). In the case of the main formwork, once the board was removed, no surface treatment was carried out, since it had a relatively smooth texture where the imprints of the wooden boards were manifested (Surface finish 1, Table 2). In the case of the secondary formwork, since it had been submerged with respect to the facing, it was necessary to apply an additional layer. To simulate a similar finishing as described above, light scraping was performed with a round tip palette. Furthermore, horizontal scratches with the help of a metal ruler were made to simulate the imprint of the wooden boards (Surface finish 2, Table 2).

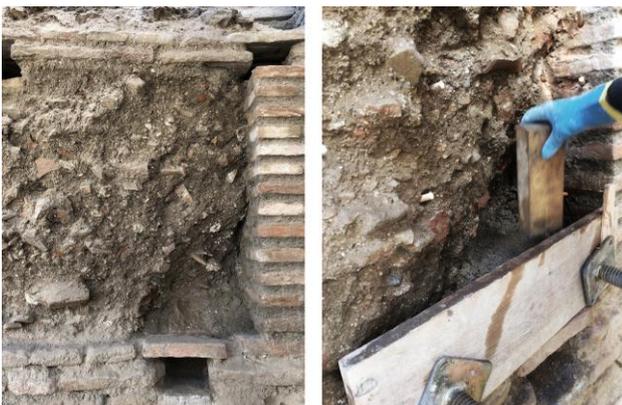
Figure 9. Detail of the previous state of the rammed earth wall with the presence of a void. Punctual formwork and ramming

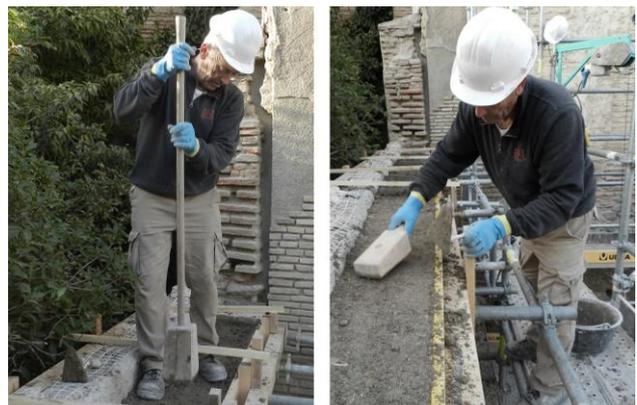
Figure 10. Manual ramming of the mass with the use of a rammer, and taping of the top surface with a hand-rammer.

A. Coarse soil (1:8) used for volume reintegrations carried out using the rammed earth wall technique with pouring and ramming of the mass (Figure 10).

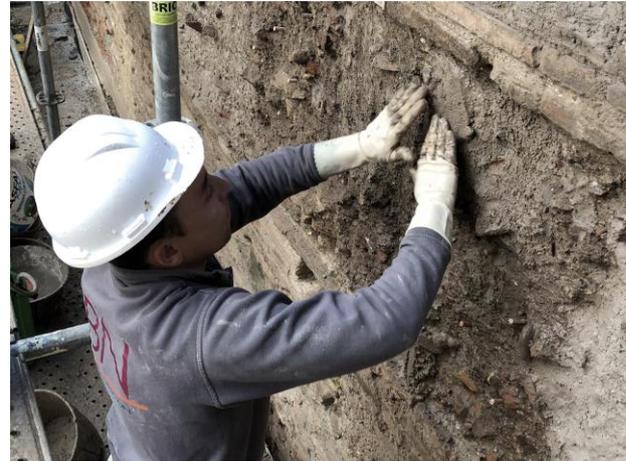
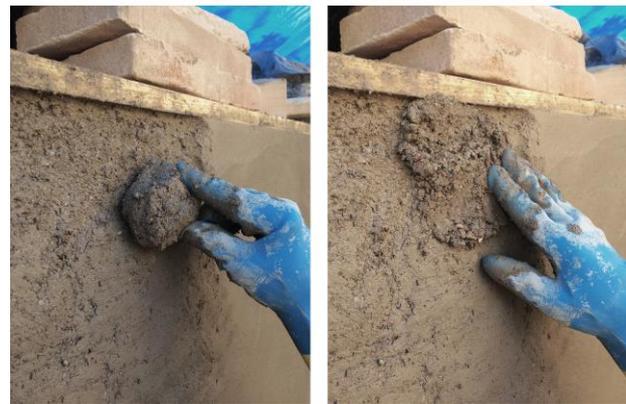
Figure 11. Surface reintegration with clay lumps, applied in the base and the final layer, by manual shaping and mashing.

B. Medium and fine soil (1:8) used for the filling of void and superficial reintegrations carried out by vertical ramming, clay lumps, screeding, laying, pressing and mashing (Figure 11).

Superficial erosions of variable depths (i.e., 2-10 cm) appeared in the lower part of the rammed earth wall, which, in some sectors, showed greater material loss and reached 15-20 cm. The filling of these voids was carried out with soil of medium granulometry (Mass B1), which was rammed vertically with the help of a small wooden formwork adapted to the shape of the void (Figure 9). Minor erosions were filled with clay lumps, using the same type of material rammed horizontally, regularizing the surfaces until they were at a distance of 4-5 cm from the final finishing face (Figure 11).

The surface reintegration work was carried out in two layers: a 3-4 cm thick base layer, made with medium grain soil (Mass B1), and a 1.5 cm thick final layer with a finer soil (Mass B2). The first operation consisted of scraping the surface of the rammed earth wall to create a rough plane that would facilitate the adherence of the applied layer, also installing beech wood pegs 8 mm in diameter and 150 mm in length, arranged in staggered, which is nailed to the wall with the aim of improving the anchorage. During the previous tests carried out, a hemp rope was also knotted to improve the assembly, a solution that was ruled out in the final intervention. The application of the soil begins with the execution of vertical guides of the same material that are arranged according to the flatness of the existing wall (screed), accepting deformations and lead losses. The base layer (Mass B1) was applied with a plastic consistency and manually, pressing the clay lumps against the surface and mashing them with the help of wooden dowels. Once the mass had reached the proper consistency and after scraping the surface again, the final layer (Mass B2) was applied also by clay lumps, but with reduced thickness (Figure 11). This surface was finished by deep scraping with a round-tipped trowel to remove the heads from the aggregates and achieve a rough texture (Surface finish 3, Table 2) (Figura 12). This slightly irregular face allows the integration of the new fabric with the structures on which it rests, which featured an important diversity of materials (Figure 8).

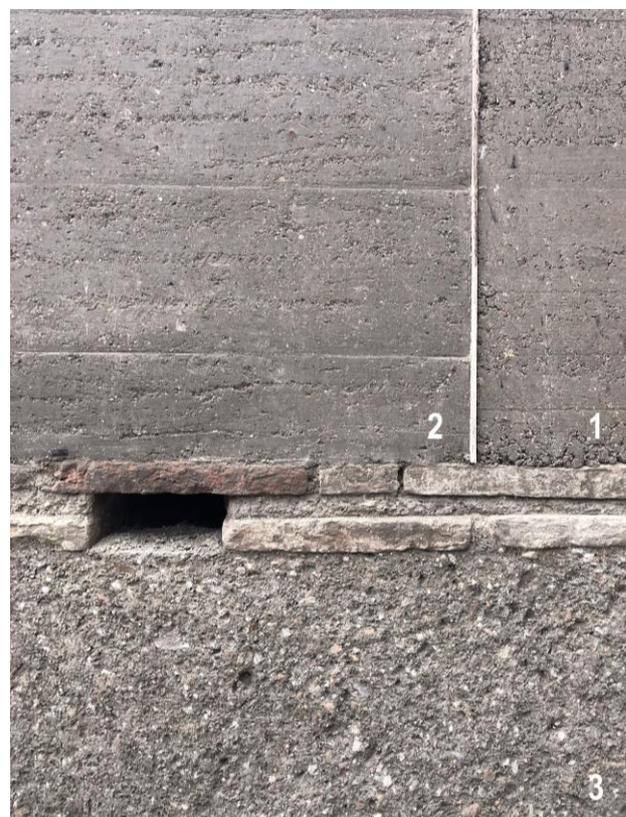
Figure 12. Different types of surface finish: 1-2-3 (Table 2).

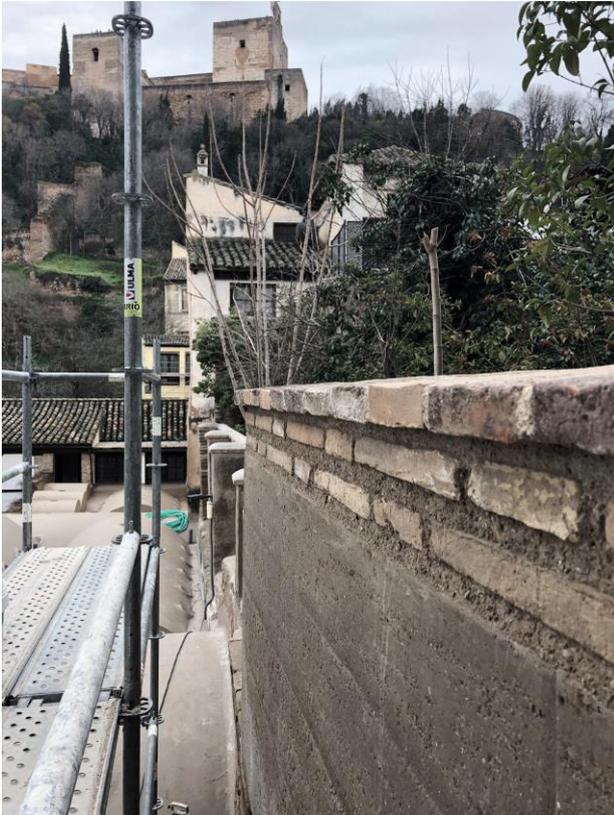
Figure 13. Courses and brick coping as upper auction of the rammed earth wall. At the bottom: the Alhambra of Granada.

C. Fine earth mass (1:4) used for receiving and subsequent soiling of brick in courses and coping (Figure 13).
