A LOOK AT THE ERRONEOUS RESTORATION OF THE HISTORICAL KASBAH OF AGADIR, MOROCCO

M. Nassir^{1,*}

KEY WORDS: Diagnosis, Evaluation, Erroneous Restoration, Degradation of architectural features, Preservation, Earthen Building

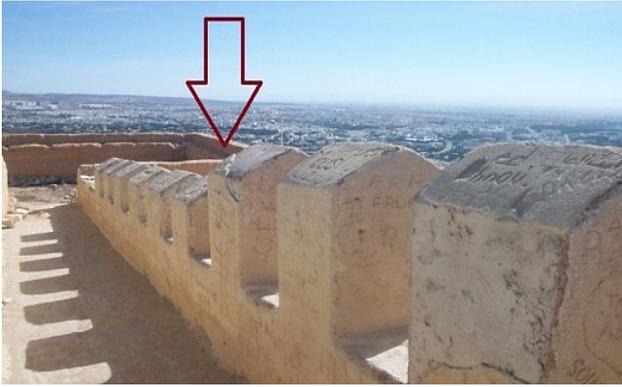
4.2.2 Crenels: Crenels topped the outer wall of the kasbah and have a pyramidal shape. There are about three hundred and thirty-five crenels. Their number varies following the sections and towers. They are sixty-five to seventy centimeters high and forty-seven to fifty-three centimeters wide while the interval between them is approximately fifty-four centimeters. We note a large variation in the height and width of the crenels, which distorts the view of the kasbah.

Figure 1. Difference between the height of the crenels of the Kasbah wall.

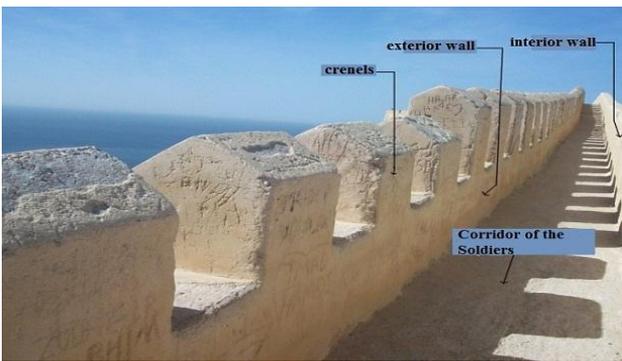
4.2.3 The inner wall: It is about one thousand and thirty meters long, fifty to sixty-five centimeters wide and one to five meters high. One of the serious mistakes made here, we find that the height of inner wall exceeds the crenels of the outer wall of the kasbah in some parts while in others the inner wall is equal to the walkway of soldiers, which results in the deterioration of the inner wall because of footsteps.

Figure 2. The inner wall above the crenels.

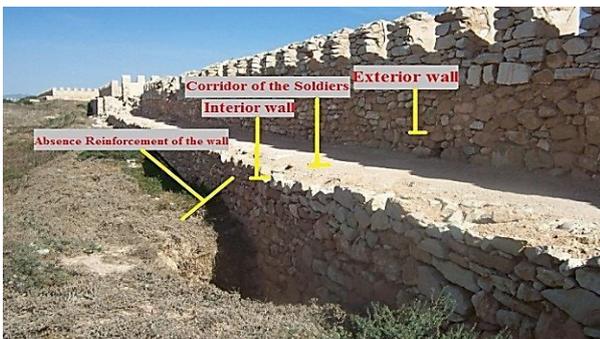
4.2.4 The walkway: It is between the inner and the outer walls. It is about three hundred and forty-four meters long and fifty to ninety centimeters wide. The path was built by compacting soil so that resists the movement of soldiers between different parts of the kasbah. The restorers made several mistakes when restoring the walkway. For example, they did not pave the alleys with flat stones or tiles. Therefore, water infiltrated into the foundation and walls, in addition to the narrow walkway, which threatens the safety of the site visitors.

Figure 3. Degradation of the architectural elements of the kasbah due to the mismatch between building materials.

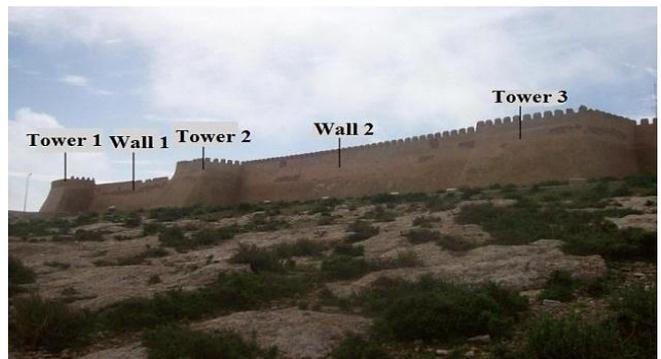
4.2.5 Towers: The Kasbah of Agadir Ouffela has three towers whose height ranges from seven to ten meters. They are decorated with crenels that vary in number from tower to tower. The first tower has four crenels and the others crumbled. The second tower has nineteen crenels two of which are crumbling and a third was completely destroyed. The third tower has nineteen crenels, including two in a deteriorating condition. The three towers are on the eastern side of the kasbah and, with field observation, it is apparent that they vary in height, between seven and nine meters. Some of them are equal to the ramparts of the kasbah to the point that it is difficult to distinguish between the tower and the kasbah wall. This is the most serious mistakes made in the restoration. In the ABC of military architecture, we know that towers rise above the walls to facilitate observation.

Figure 4. The height of the wall equal to the kasbahtowers.

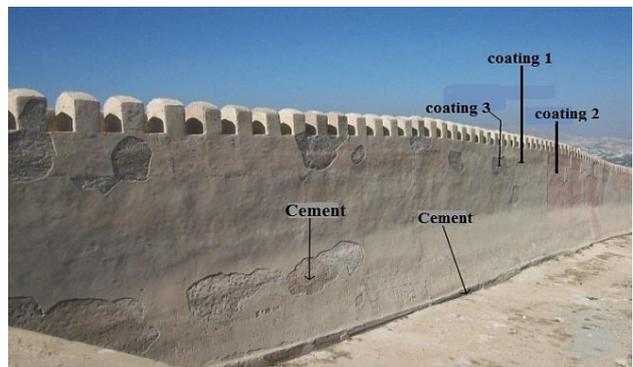
4.2.6 Coating: The use of materials with a destructive effect and the presence of thick layers of coating and their inconsistency led to the partial fall of the kasbah's coating (Nassir et al., 2017). The coating consists of the following materials: one hundred and sixty liters of volcanic material called "Tufs", twenty liters of lime, thirty liters of cement "CPJ 30", sixty liters of crushed sand and natural coating (Zniber et al., 2002) Furthermore, modern surface protections that are too visible nowadays, such as sand-cement, glue or resin, proved to provide only a temporary protection for the earthen structures while potentially causing great damage and high expenses in the long run. Their physical and chemical properties prevent them from properly and durably adhering to raw earthen surfaces. Moreover, their use worsens the pathologies linked to moisture for lack of porosity. Their use should have been avoided whether in coating vertical or horizontal surfaces. (Boussalh et al., 2005) Laboratory analyses showed that mortar used to paint the original façade contains 62% of lime. This type of mortar is known or excellent resistance to erosion (Nassir, Ouamou, 2010).

Figure 5. The wall coating damaged due to the mismatch of the components of the layers.

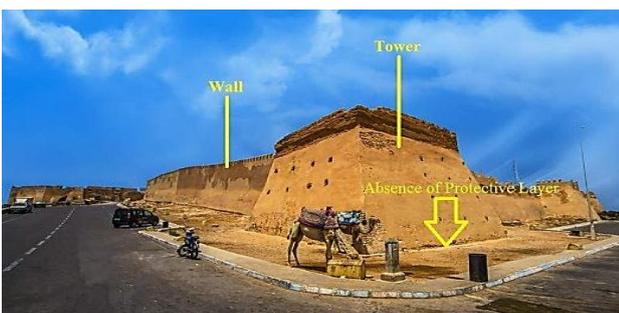
4.2.8 Reinforcement of the wall foundations: It is noticeable that the protective layer is absent in the wall foundations. Coping is a covering of stone or terracotta or any appropriate material on the exposed top of a wall to prevent seepage of water. It plays an important role in protecting walls and foundations from erosion due to water pouring from roof scuppers and water streaming along the walls (Boussalh et al., 2005). Indeed, the absence drainpipes damaged the lower part of the walls of the kasbah.

Figure 8. Absence of the Protective layer in the kasbah walls and towers.
