ANALYSIS AND CHARACTERISATION OF ADOBE BLOCKS IN JOJUTLA DE JUÁREZ, MÉXICO. SEISMIC VULNERABILITY AND LOSS OF THE EARTHEN ARCHITECTURE AFTER THE 2017 PUEBLA EARTHQUAKE

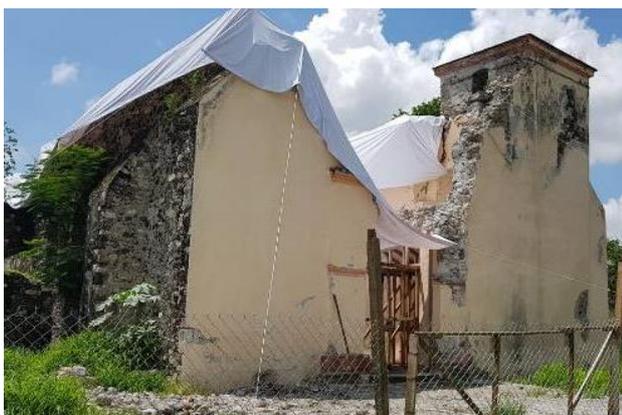
Figure 3. Colonial church damaged by the 2017 Puebla earthquake in Jojutla de Juárez, Morelos. Photo: Adrià Sánchez Calvillo (2018).

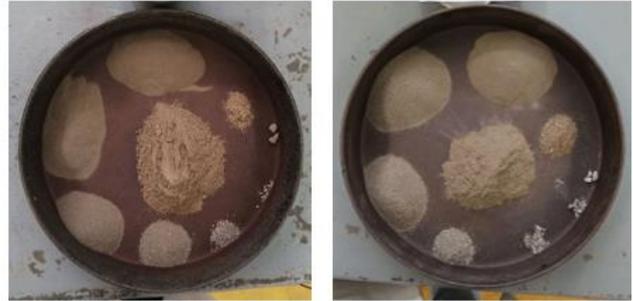
Figure 8. Breakdown and grain size of the adobe samples. Photo: David Preciado Villicaña (2019). © SPOT Image Copyright 2020.

The USCS classification of the material shows relevant information. Samples M1 and M13 correspond to the natural clays from the quarries near Jojutla and are clays of high plasticity. The other samples, corresponding to the adobe blocks of the downtown are either clays of low plasticity or silts (Table 1); also the plasticity graphic shows how the healthy clays of the soil samples are in very different zone of the graphic than the adobe samples. (Figure 9) This demonstrates that the adobes contained other materials probably due to the attempt to stabilise them.

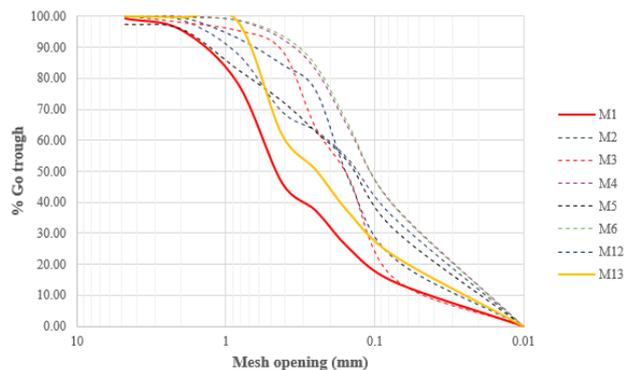
Figure 9. Granulometric curves of the adobes and soils. Continuous line: Natural soils, Discontinuous line: Adobes.

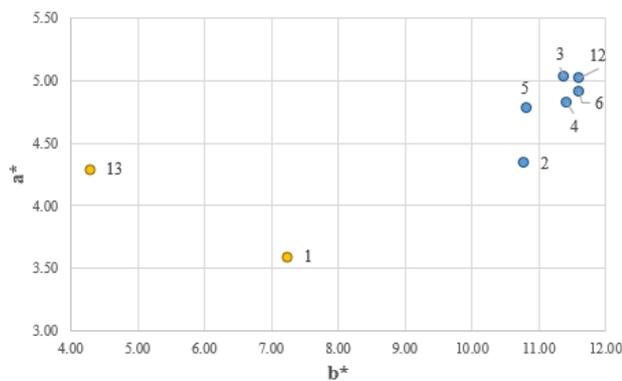
Figure 11. Colorimetric values of the samples. Yellow: Natural clays, Blue: Modified adobes.

The results of the colorimetry show a separation between the healthy clays from the quarries and the samples of adobes from the downtown. This change of the colour is produced by the addition of other elements to the mixture, excluding the natural fibres, like straw, which not contribute to the variation. There were found remainders of lime with the microscopy tests; lime is one of the main stabilisers in earthen architecture and has been combined with clay for centuries (Villaseñor Alonso, Barba Pingarrón, 2012; Navarro et al., 2019). The presence of stabiliser elements also explains the transformations of the soils, clays of high plasticity, to the low plasticity materials of the adobes (Table 1).

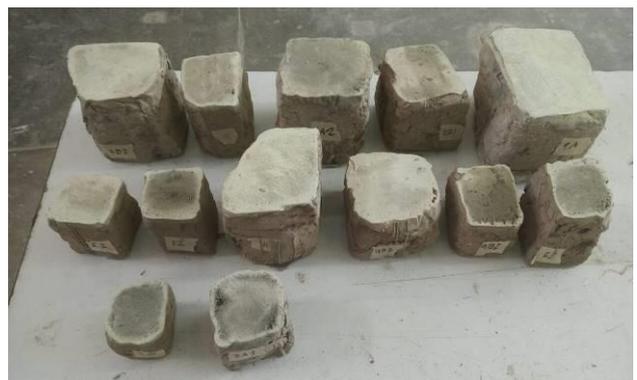
The results of the Compression strength test were not encouraging, with resistance values between 5-13 Kgf/cm², being the average of 7.26 Kgf/cm², really low compared to other studies of the adobes of Morelos, which can achieve 16 Kgf/cm². (Guerrero Baca, 2019) Other Mexican studies also characterised the compressive resistance of this material, obtaining major values in all the cases (Arroyo Matus et al., 2013; Cruz Farrera, 2018; Ordaz Zapata, 2019).

Figure 12. Adobe samples prepared for the compression test. Photo: Adrià Sánchez Calvillo (2019). © SPOT Image Copyright 2020.
