## RECOVERING VALPARAÍSO'S URBAN ELEVATORS: THE RESTORATION OF THE CORDILLERA FUNICULAR

C. Giribas<sup>1</sup>, G. Paredes<sup>2</sup>, A. Riquelme<sup>3,\*</sup>

The restoration of the Cordillera elevator was carried out by the Chilean Ministry of Public Works between 2016 and 2018. Its original construction effectively represents the infrastructure that illustrates Valparaíso's historical, urban and social configuration from the 19th Century until today.

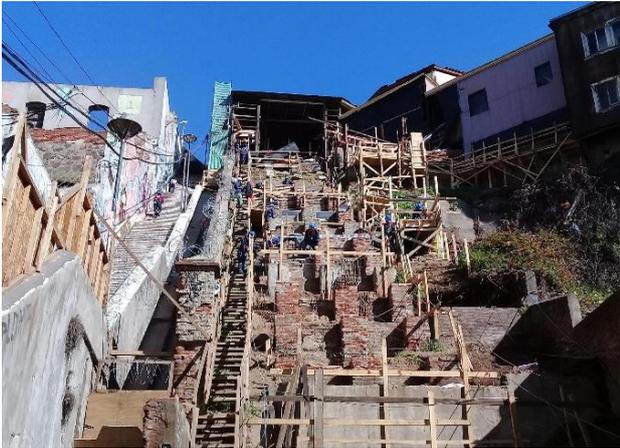
The restoration project included structural consolidation of both the simple masonry elements present in the elevator and the foundations of the entire upper station, as well as the structure of the railway where the rails and ties were built.

Figure 5. View of the railway at the Cordillera elevator.

On the railway, the original masonry was restored and a new structure of reinforced concrete was integrated on its back. This solution complies with Chilean regulations, since the construction of simple masonry is currently prohibited due to seismic requirements within the country.

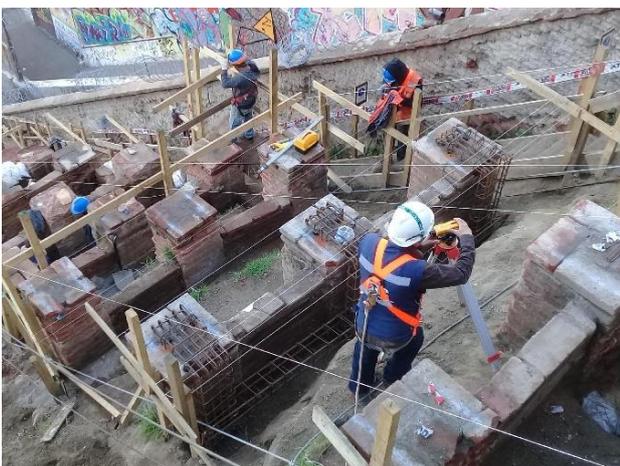
Figure 6. View of the masonry and its reinforcements.

The restoration of original masonry elements involved the removal of old stucco, reintegration of missing pieces and the introduction of new lime and sand mortars in empty or eroded areas. Finally, a water-proof finish was applied to protect the burnt bricks.

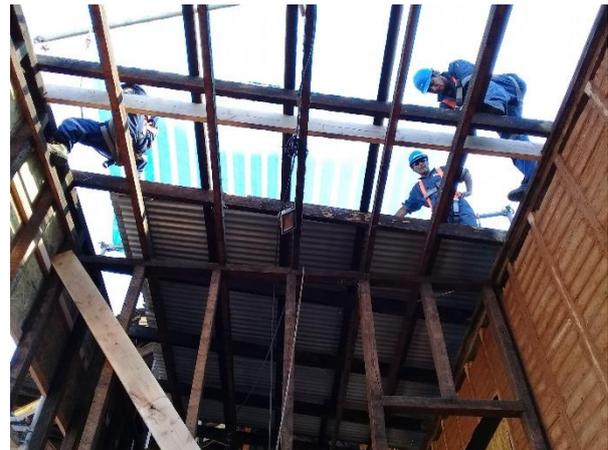
Figure 7. Structural consolidation of wooden beams.

**5.2.2 Structural consolidation.** Consolidation of the structure has the aim of stabilizing the different components and elements within it. To accomplish this, all loose or missing sections that compromise an element's capacity to support itself, including cracks and other degradations with a mechanical origin, have to be intervened. Consolidation of the Cordillera elevator was carried out by re-gluing all openings with PVA adhesive and applying pressure until each one closed. In some cases, some parts had to be rebuilt in order to complete the structure.

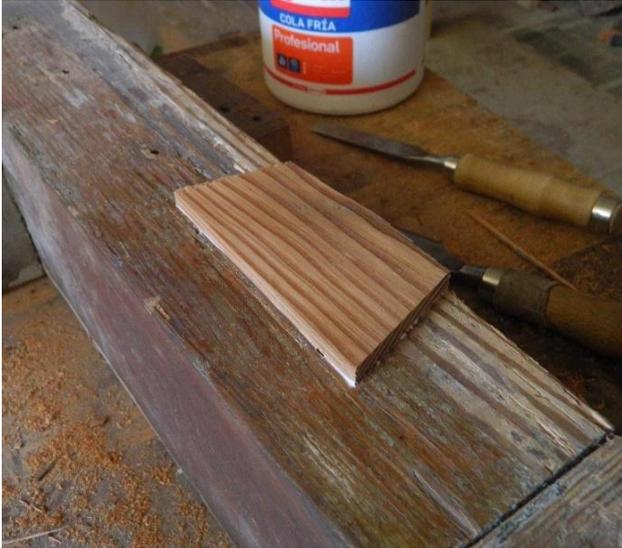
Figure 8. Integration in American Oregon pine.

**5.2.5 Wood integrations and reintegrations:** Non-structural elements were integrated and reintegrated. First, wood sections were reintegrated into elements that showed functional wear, which in the case of door stringers was due to hinges and locks. In lower combs, functional wear was associated with moisture, among other mechanical degradations and photo degradation in elements exposed to the sun. In cases where there was considerable material loss, pieces of wood were integrated according to the species and shape of each wooden element.

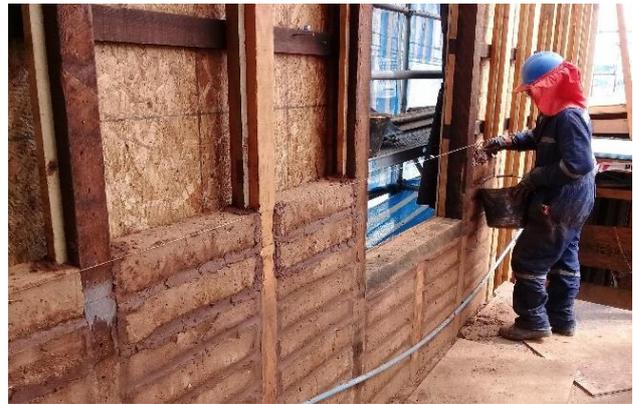
Figure 10. Installation of *adobillo* bricks.

**5.3.3 Slat replacement:** The integration of a 1x1 slat of impregnated pine wood was implemented to ensure fixing of earthen blocks. This element replaced old poplar ribbons which showed significant degradation both due to general rot and, in some specific sectors, the activity of xylophagous insects. Poplar wood has low levels of extractives, making it highly vulnerable to the appearance of xylophagous damage.

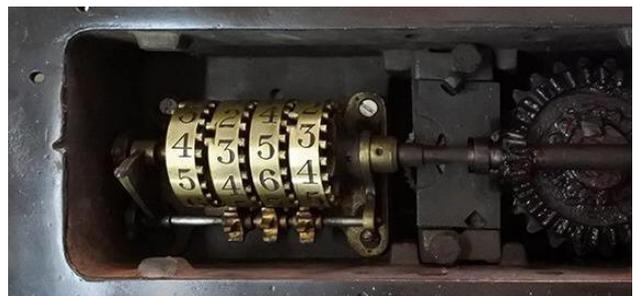
In order to carry out the restoration of this element, a diagnosis of its conservation status was made, in which existing lesions and pathologies were defined. The tourniquet itself, which was in a medium state of preservation, had oxidized sections and an impact fracture in one of its pieces; which also showed an eccentric displacement in its operation, due to one of its broken blades.

Figure 11. Cordillera elevator turnstile counter.

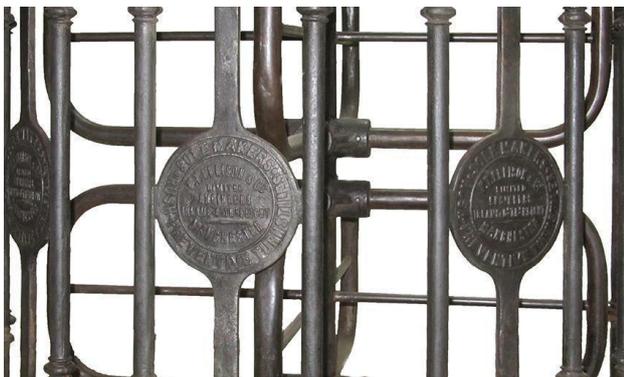
Damage was mainly divided into two types: structural, related to fracture of materials and operation of blades, and aesthetic. The latter, consisting of the loss of paint layers and interventions associated with inappropriate maintenance and manipulation, made the adequate interpretation of the element difficult. First, the metal parts were cleaned, focusing on releasing damaging elements left behind from discordant interventions and existing chromatic films. A “dry” mechanical cleaning, and later, a chemical cleaning, were carried out in order to remove the aforementioned elements. After this, the broken piece was consolidated, welded and chromatically reintegrated to resemble the colour of the rest of the finishings. Oxidized parts were stabilised by the use of acids. Because of this, it was necessary to clean the piece again, this time with 2% active tensile, and then with the application and subsequent removal of 5% oxalic acid. Finally, two coats of 5% tannic acid were applied, the second of which generated a natural patina which was then coated with microcrystalline wax.

Figure 12. Turnstile blades of the Cordillera elevator.  
Source: Xiloscopio
