CONSOLIDATION AND RESTORATION OF HISTORICAL HERITAGE: THE FLAVIAN AMPHITHEATER IN ROME.

S. Podestà ¹, F. Romis ^{2,*}, L. Scandolo ¹

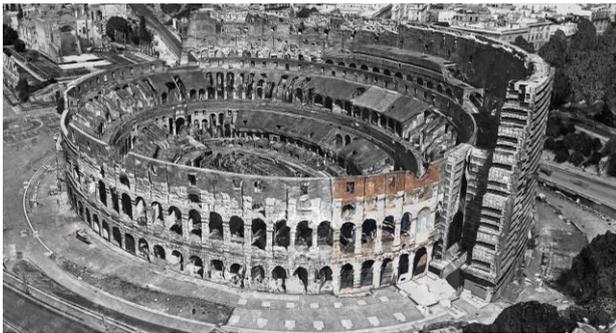
Figure 1. Photo of the eastern entrance of the Flavian Amphitheatre, in which the portion analysed is highlighted.

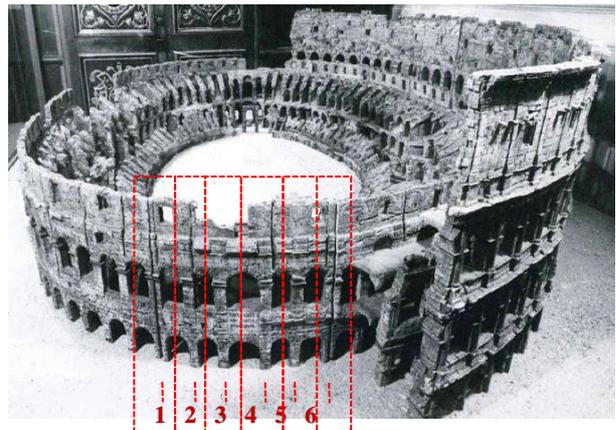
Figure 2. 3D model made of cork by Carlo Lucangeli. In red the six columns, arranged in two storeys, under study are highlighted (Image taken from (Coarelli, 1999) p. 217).

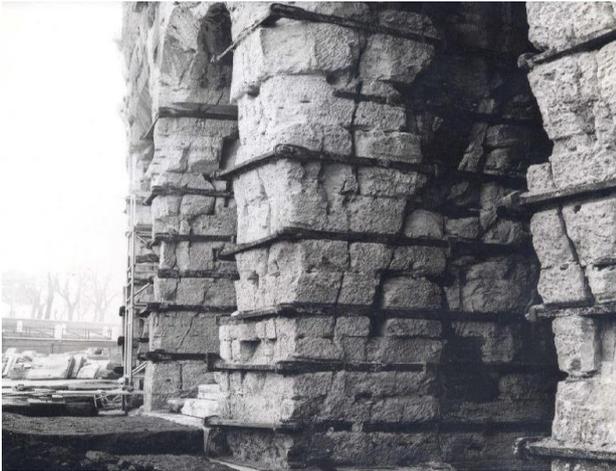
Figure 4. Image related to the retrofit interventions carried out in the 1970, that shows the state of the columns.

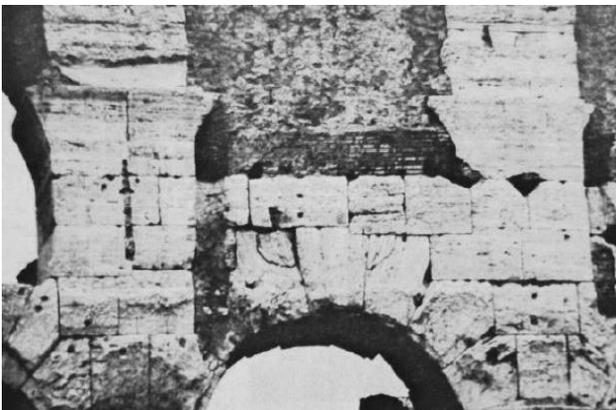
Figure 5. Detail of an arch of the second floor, where the sliding down of the key blocks was observed, as well as different cracks on the travertine blocks.

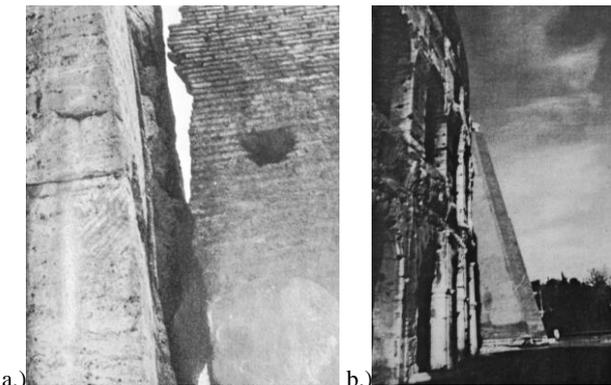
Figure 6. a.) Detachment of the travertine columns from the radial walls. b.) Out-of-plane behaviour of the façade from the North-west view of the analysed area.

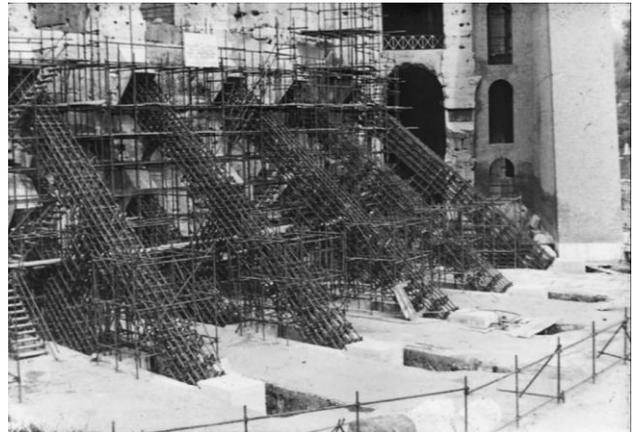
Figure 7. Construction of steel buttresses to prop up the columns of the first and second floors.

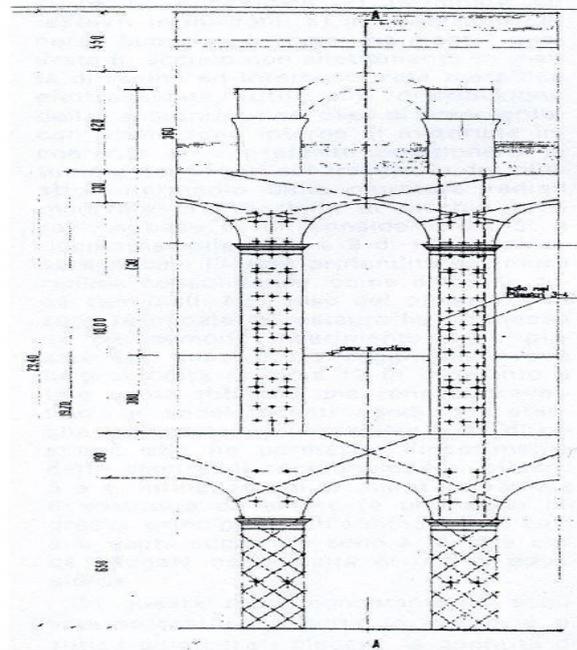
Figure 10. Drawings of the retrofit intervention project, with post – tension cables designed at the second level of the right column.

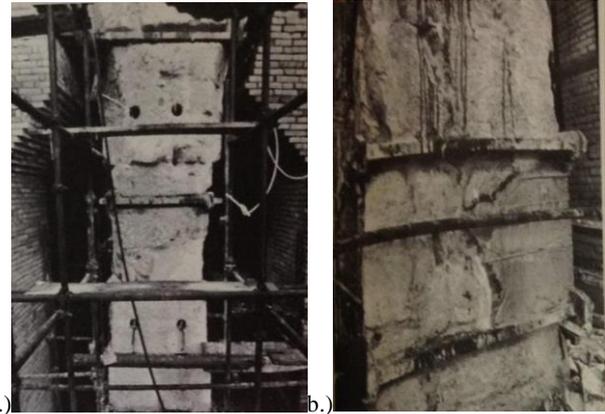
Figure 11. a.) Image of the harmonic steel cables in the travertine columns during the phase of work. b.) Reconstruction of the pillar section with epoxy resin and travertine pieces.

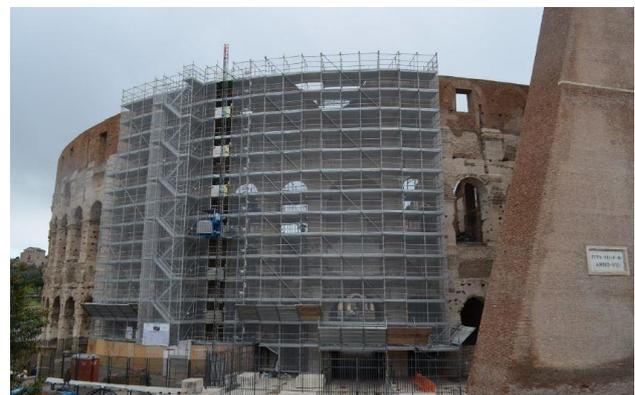
Figure 12. Construction site for the study of the columns affected by the current damage.

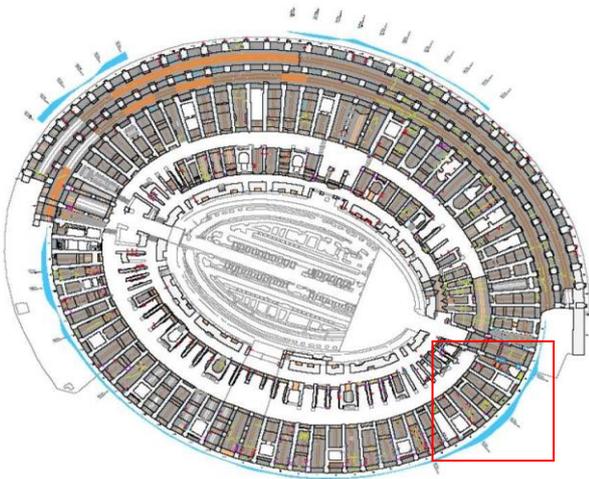
Figure 13. In red the area analysed is highlighted, while the out of plane intensity of the façade is shown in light blue colour. (Image taken from the analyses performed for the construction of the new C line of the underground under construction (AA.VV., 2009).

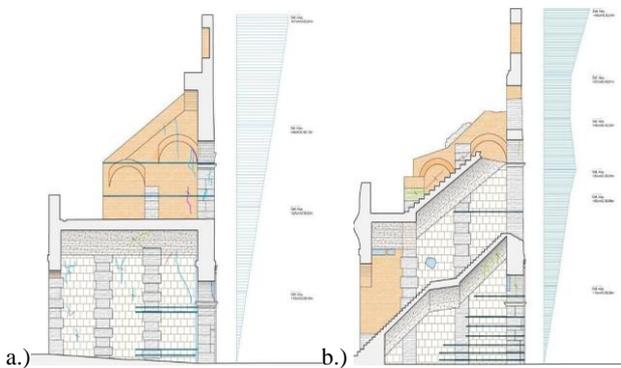
Figure 14. a.) Out of plane measured along the height of column 1; b.) Out of plane measured along the height of column 2. (Images taken from the analyses performed for the construction of the new C line of the underground under construction (AA.VV., 2009)).

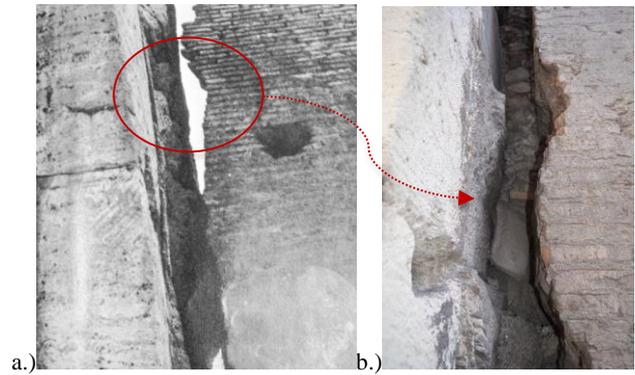
Figure 15. a.) Image taken during the retrofit interventions of 1978 and 1979; b.) Photo taken during the 2015-2016 surveys from the same point of view.

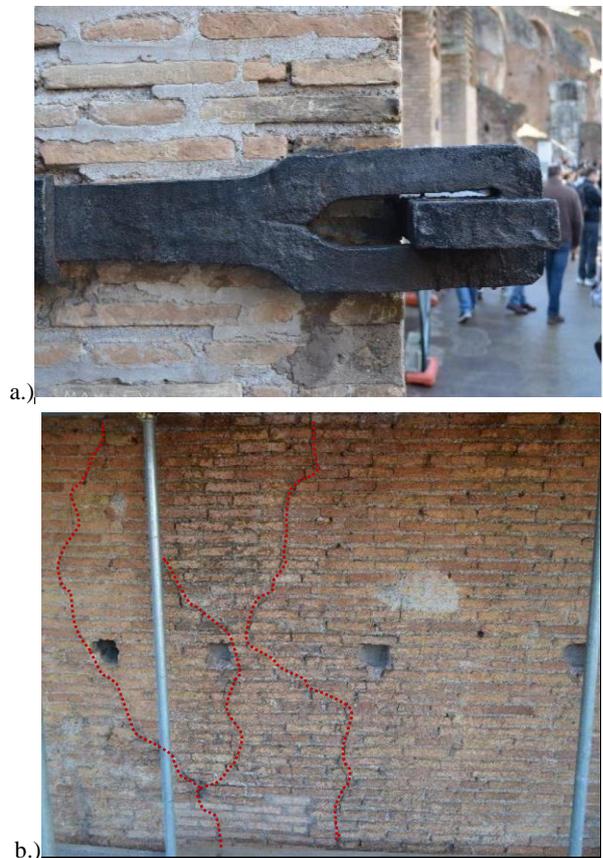
Figure 16. a.) Metal ties on the second floor, that connect column 1 with the masonry orthogonal wall; b.) Crack pattern, highlighted in red, of the same masonry wall at the first floor.

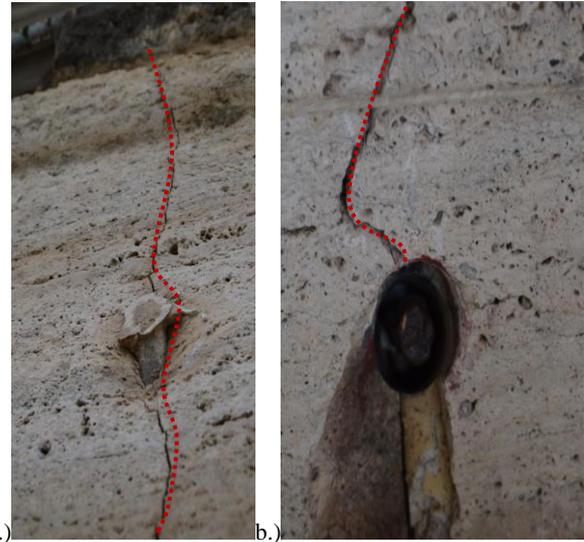
Figure 18. a.) Rebar coming out from the original position, inside of the travertine column and crossed by a sub – vertical crack; b.) Image of the metal bar inside the pillar after removing the cap made by epoxy resin and travertine pieces.

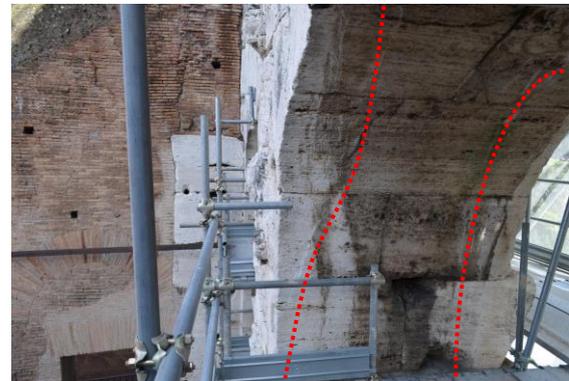
Figure 19. Vertical cracks, highlighted in red, in the internal part of the arch between column 4 and 3.

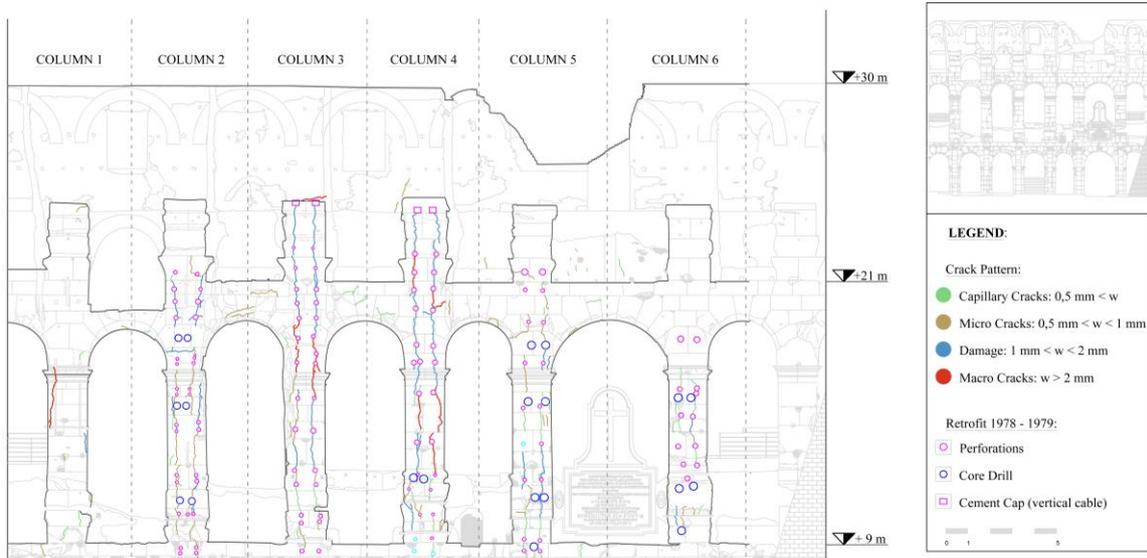
Figure 17. Crack pattern of the travertine columns at the second floor from the external point of view.

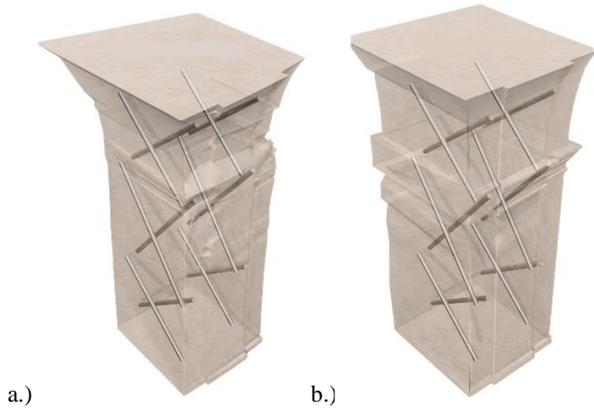
Figure 20. a.) 3D Model of column 2 with rebar disposition; b.) 3D Model of column 3 with rebar disposition.

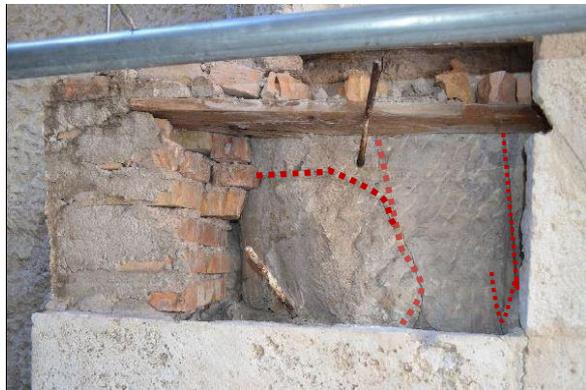
Figure 21. Cracks detected and highlighted in red on the columns of the first floors after removing the travertine slabs in pillar 5.

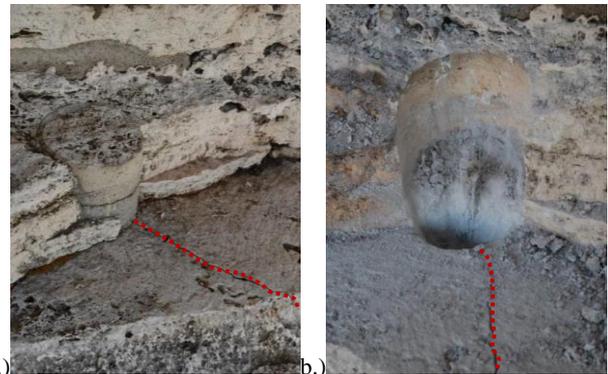
The horizontal post tensioned cables inserted in the first floor (Figure 9) were not monitored since the exposed columns and the walls behind them showed no visible damage. A test was performed in the third column at the second level, where a vertical post tensioned cable was inserted (Figure 23). Here the cracks detected had the highest dimension (Table 2). After removing the concrete cap of the upper part, in order to check the internal conditions, it was noted that the cable inside was less corroded and the cable sheath didn't show clear signs of wear or degradation. It was not possible to investigate further parts inside the column, to check the corrosion of the post-tensioned cable.
