## MANAGEMENT OF ENVIRONMENTAL RISKS IN COASTAL AREAS

**KEY WORDS:** Environment, Risk Management, GIS, UAV, Photogrammetry

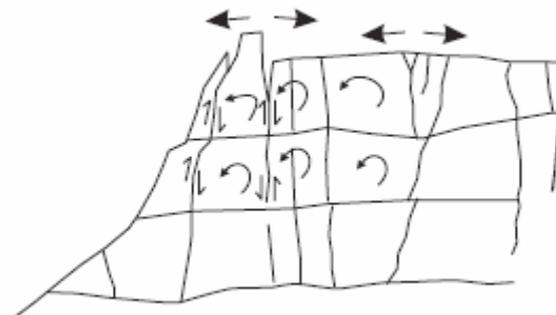
Figure 2. Toppling failure mechanism (after Hoek et al., 1977)

The main types of erosional and landslide processes observed along the coastal stretch investigated are related to slides, falls and topples. The waves attack the weak part of the rock and leave the resistant areas to form the different features. Processes of erosion are more active along joint systems. Wave energy causes gouge or hollow forming caves and arches which are continually widened by erosion and weathering. The roof becomes too heavy and collapses forming a stack. The stack is then eroded and may form a stump. Falls of blocks and big slices of rocks are triggered by undercutting at the base of the cliff. Tension cracks and fractures control their detachment. Toppling of blocks mainly occurs along failures parallel to the coastline causing cliff retreating (Fig. 2).

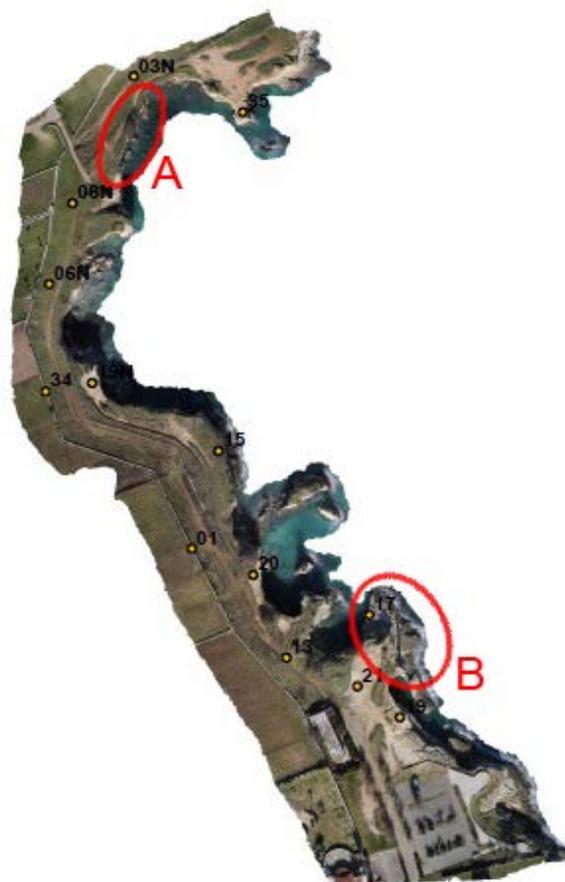
Figure 3. Orthophoto of the surveyed area with GPC location

Thanks to the GPS-Position-Hold technology a framework of 10 Ground Control Point (GCP) has been set on the study area and, for internal use and further error checking, 3 more points (check points) were collected using dual frequency Trimble GPS receivers. The location of Ground Control Point (GCP) and surrounding check points are reported in Figure 3.

In Figure 4 the orthophoto of a coastal strip of the rocky cliff is shown (zone A in Figure 3). The processed image highlights the presence of a longitudinal fracture that heavily risks the stability of the rocky blocks.

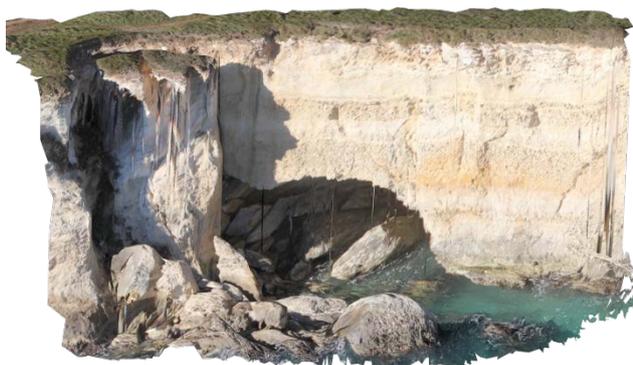
Figure 5. Orthophoto with an arched cavity

Figures 5, 6, and 7 show details of the ortho-projections of the rocky front. Note the presence of an arched cavity (Fig. 5), generated by the erosional processes that affect the entire coast, and of a crumbling block (Fig. 6).

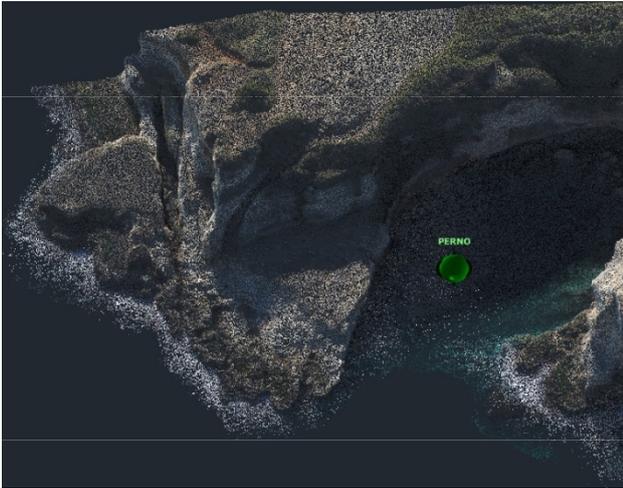
Figure 8. 3D point cloud

Figures 8 and 9 refer to another investigated area (area B in Fig. 4) that in the summer season is very popular with bathers so it represents a dangerous zone for people safety. Figure 8 is an axonometric view of the point clouds and Figure 9 shows the 3D model obtained. Note the access stairs and the little beach very popular with young people.

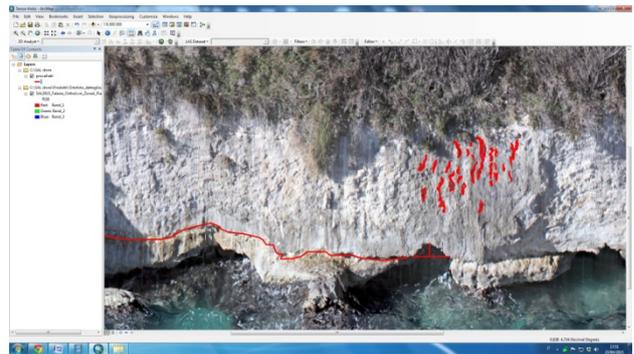
Figure 11: GIS layers with open fractures

In order to highlight the structural features responsible for the instability of rock masses different layers have been created including different metric characteristics (Figs. 11 and 12). As an example in Figure 13 three layers are marked: open fractures

Analysing these measurements from a geo-structural point of view, the evaluation of the risk of collapse of rock masses can be made and therefore it will be possible to assess the conditions of risk for the safety of people.

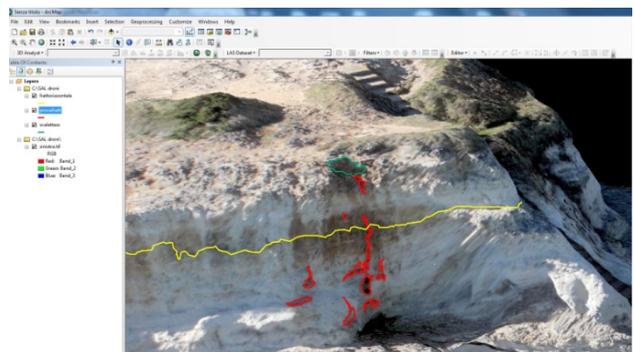
Figure 12. Unevenness line (yellow), fractures (red) and crumbling mass (green)

(red lines), surface unevenness (yellow line) and crumbling mass (green line).

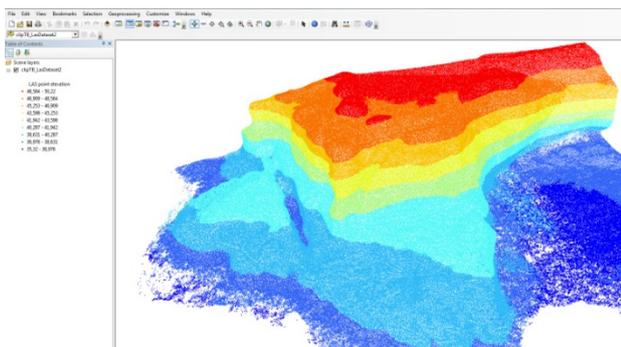
Figure 10. LAS point cloud imported in ArcGis (9 classes)

Figure 10 shows the LAS point cloud imported in ArcGis with 9 classes of elevation.

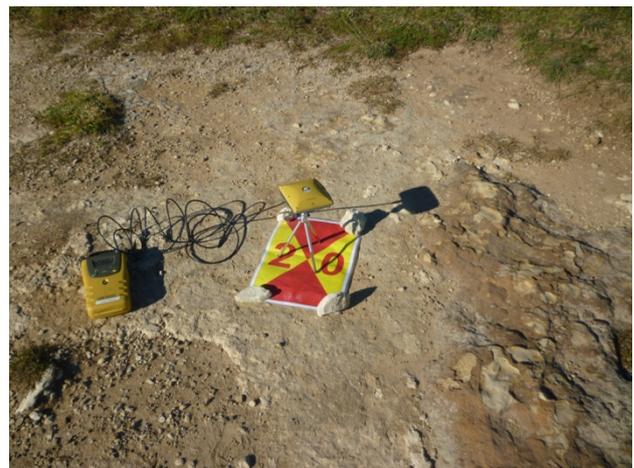
Fig 13. GPS Ground Control Point

Furthermore, establishing a reference topographic network based on Ground Control Points (Fig.13) that can be assumed stable with respect to the crumbling phenomena, the methodology presented here allows for in time monitoring the evolution of the dangerous elements and then the prediction and prevention of the natural “disasters”.

As a matter of fact, georeferencing the UAV survey, with the same or better accuracy, it is possible to measure the changes of the characteristic parameters and to identify the trend of dangerous phenomena.
