THE SURVEY OF CULTURAL HERITAGE AFTER AN EARTHQUAKE: THE CASE OF EMILIA –LOMBARDIA IN 2012

A. Adami ^a, S. Chiarini ^a, S. Cremonesi ^a, L. Fregonese ^a, L. Taffurelli ^a, M. V. Valente ^a

^a Politecnico di Milano, Dept. of architecture, built environment and construction engineering, Via G. Ponzio, 31, 20133 Milan, Italy
(andrea.adami, silvia.chiarini, stefano.cremonesi, luigi.fregonese, laura.taffurelli, marco.valente)@polimi.it

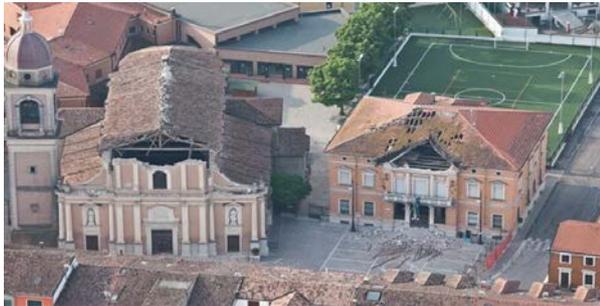
Figure 1. The church of Moglia (near Mantua) and the Municipality seriously damaged after the earthquake.

On 20 May 2012, an earthquake of magnitude 5.9 with epicenter in the town of Finale Emilia caused damage to homes and production facilities in some municipalities of Mantua. On 29 May, the Mantua area was hit again by three successive shocks with a magnitude until 5.8. The earthquakes caused heavy damage to buildings rural and industrial, works of water canals, as well as to buildings and historical monuments and buildings of civil old stone or pebbles. In particular, most of the monuments and places of artistic interest in a wide area, from Mantua to Modena to Ferrara to some municipalities in the province of Bologna, was seriously damaged or partially collapsed (Figure 1).

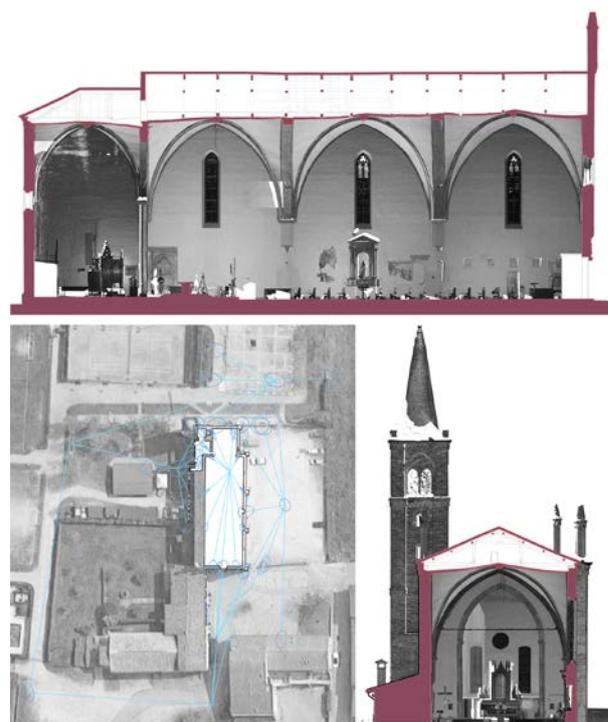
Figure 3. Example of survey of case 1 building. In particular: Chiesa degli Angeli. Above the longitudinal section with the quasi orthophoto on the background. Below, on the left the topographic network, on the right a cross section with the bell tower

The processed products were architectural plans and sections. To give more information to the designer, we enriched the classic drawings with the orthographic projection of the point clouds, as a background. These images can be considered as quasi-orthophoto as they have the same characteristic of an orthophoto even if they are not released with images. They are measurable, with a pixel coverage on real object of about 4 mm. They allow a better comprehension of the architecture and to extract the change in the cracks, the gaps, the degradations (figure 3).

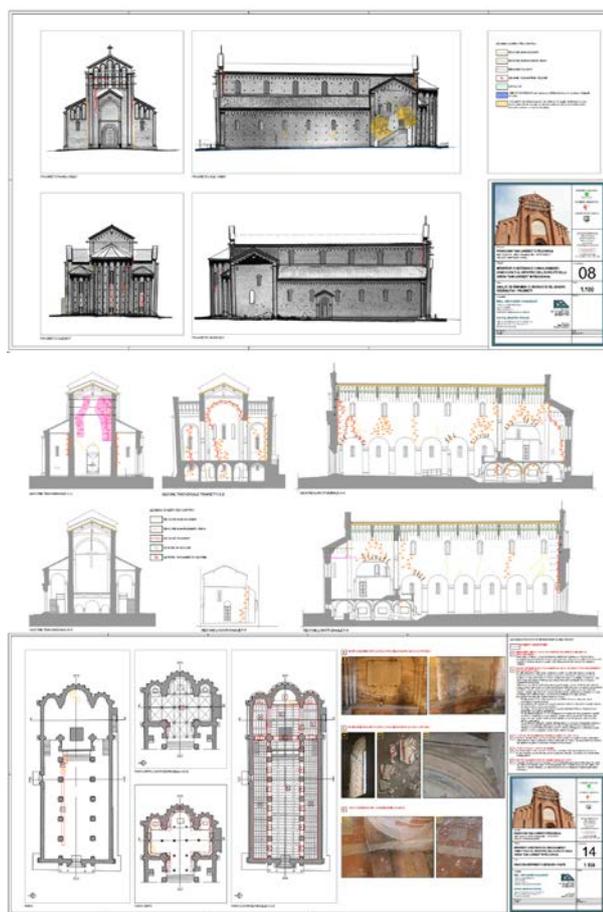
Figure 3. Example of survey of case 2 building. In particular: San Lorenzo di Pegognaga. Above the drawings from the survey, in the middle the crack analysis based on the orthophoto and below the restoration design.

Usually three or four operators made the acquisition (laser scanner and topography) in 1 or 2 days. The deadlines to complete the drawings was about days (figure 4).

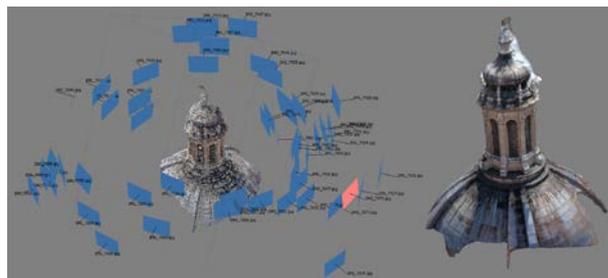
Figure 4. An example of the photogrammetric approach applied for the survey of the lantern of S. Andrea in Mantua. On the left the images oriented and the sparse point cloud, on the right the 3D model

The aerial surveys have been performed instead, for the two cases cited Lantern Andrea S (figure 4) and the bell tower of Santa Barbara, with an octocopter equipped with digital camera Canon EOS 650D from 18Mpxl, 2 gyros, GPS and barometric altimeter for the flight control.

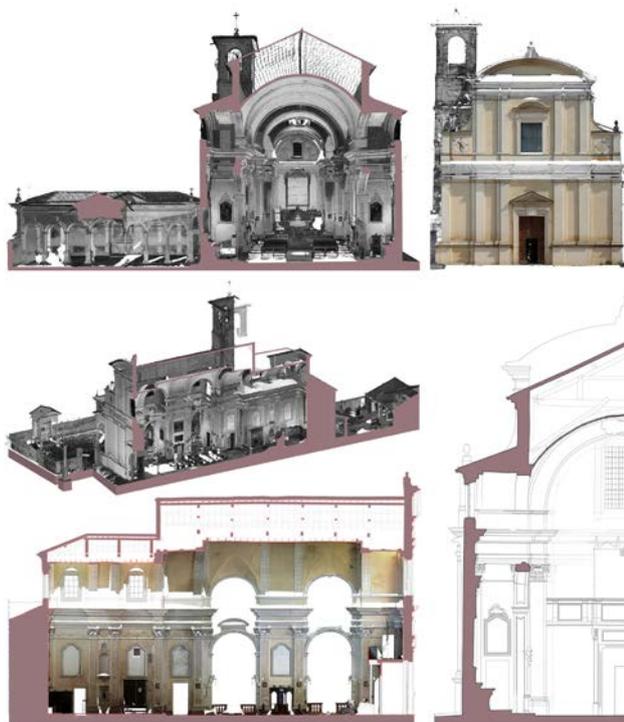
Figure 5. The complete documentation of a church of case 3:

church in Sustinente, near Mantua. Above the cross section and the orthophoto of the façade, the 3D model and the cross sections with and without orthophoto

Other churches of this group needed some specific approaches. In many cases, it was necessary to acquire the real RGB values of the surfaces for the documentation of preservation status of frescoes, decorations, furniture elements and altars in stone and marble. The problem of the absence or poor interior lighting has been overcome with the use of lighting balloon for uniform enlighten (balloon Airstar, model 575W Sirocco, hot restrike, with pole to 6 mt and internal ballast) where it was logistically possible to bring electrical connections. In the church of S. Giovanni del Dosso, for example, we used those lighting balloon to avoiding areas at risk of collapse and stopping under movable scaffolding, designed and calculated specifically for the protection of operators. In other cases, we tried to make the most of natural lighting, working in post-production on color management and display of images to their mosaicking (i.e. church of Sustinente – figure 5).

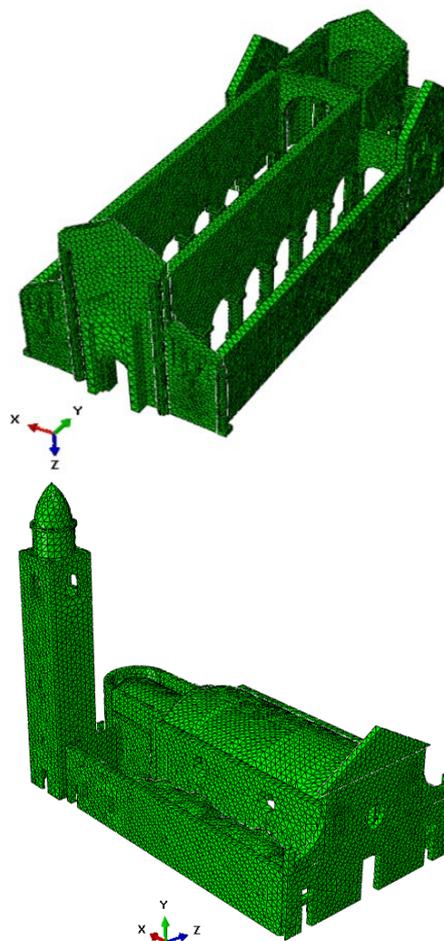
Figure 6. Finite element models of San Lorenzo Church in Pegognaga and San Giovanni Battista Church in San Giovanni del Dosso

An effective seismic vulnerability assessment of the churches can be obtained through non-linear dynamic and static analyses by means of suitable finite element models. To this aim, detailed three-dimensional finite element models of the churches are created through the computer code Abaqus (ABAQUS) taking into consideration geometrical and material nonlinearity. A damage plasticity material model, exhibiting softening in both tension and compression, is adopted for masonry. Figure 6 shows the finite element numerical models of two churches: San Lorenzo Church in Pegognaga and San Giovanni Battista Church in San Giovanni del Dosso. The choice of the element size is done in order to share the advantages of sufficiently reliable results and numerical efficiency during the non-linear dynamic analyses that usually need very long time to be performed.

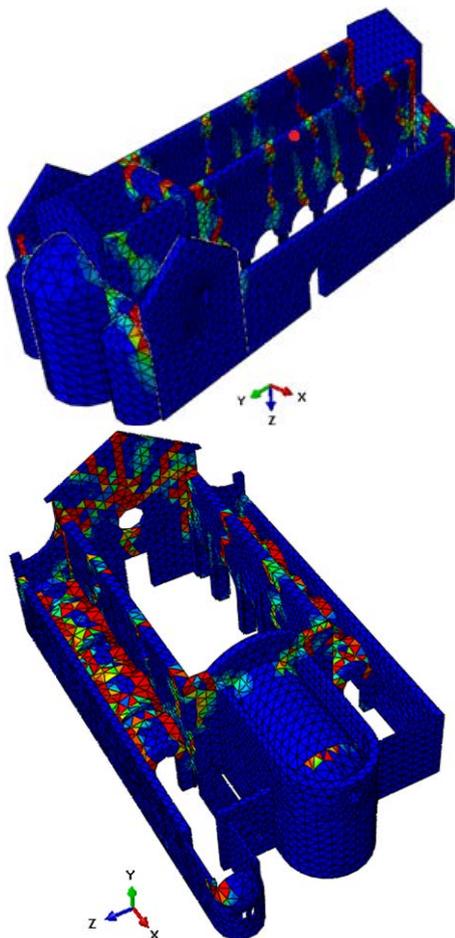
Figure 7. San Lorenzo Church in Pegognaga and San Giovanni Battista Church in San Giovanni del Dosso: false colour representation of tension damage at the end of the numerical simulations.

In order to capture all possible failure mechanisms, non-linear dynamic analyses are conducted applying simultaneously two accelerograms along two horizontal orthogonal directions. Such type of analysis is very time-consuming, but it is much more

accurate and reliable than other approaches for its capability to identify in- and out-of-plane, as well as local and global failure mechanisms. The seismic performance assessment of the churches is carried out mainly in terms of displacement time-history of some control points and tensile damage distribution. Figure 7 shows the contour plots of tension damage at the end of the non-linear dynamic analyses performed on San Lorenzo Church and San Giovanni Battista Church. The results of the non-linear dynamic simulations show the high vulnerability of the churches under horizontal loads. The role played by the complex geometry, local irregularities and the insufficient resistance of the constituent materials is investigated, also in light of the actual failure mechanisms. In all cases, the numerical analyses provide a valuable picture of all possible failure mechanisms, thus giving useful hints for appropriate and suitable interventions of consolidation to reduce the seismic vulnerability of the churches.

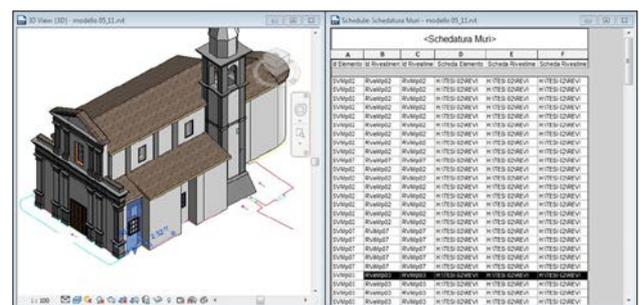
Figure 8. The BIM model of the church of Galvagnina with the linked data of the state of conservation and restoration project.

The BIM was projected in order to link to each part of the building some information about the conservation and the restoration project. The entire project, described in (Achille et al, 2015 b) focused of the possibility to use a BIM model not only in the project of new buildings, but also in the restoration stage, and in particular for the maintenance plan (figure 8).
