## CONSERVATION MONITORING OF A HERITAGE CEILING BY PHOTOMETRIC STEREO

**KEY WORDS:** Architecture, conservation, monitoring, camera, imaging, reconstruction.

Photographic survey techniques were employed to monitor the condition of the paintwork on the ceiling of the Queen's Staircase at Hampton Court Palace. Illumination was provided by a flash, mounted on an 8 metre telescopic mast, raised to approximately 60 cm below the ceiling, with images were taken from a fixed camera position on the floor of the landing at a range of 6.5m. The photometric stereo method was applied to images from ten lamp positions, to calculate surface normals and a depth map. Cross-sections at the estimated surface resolution of 7.7 pixels/mm, achieved a depth (Z axis) resolution of approximately 100 microns.

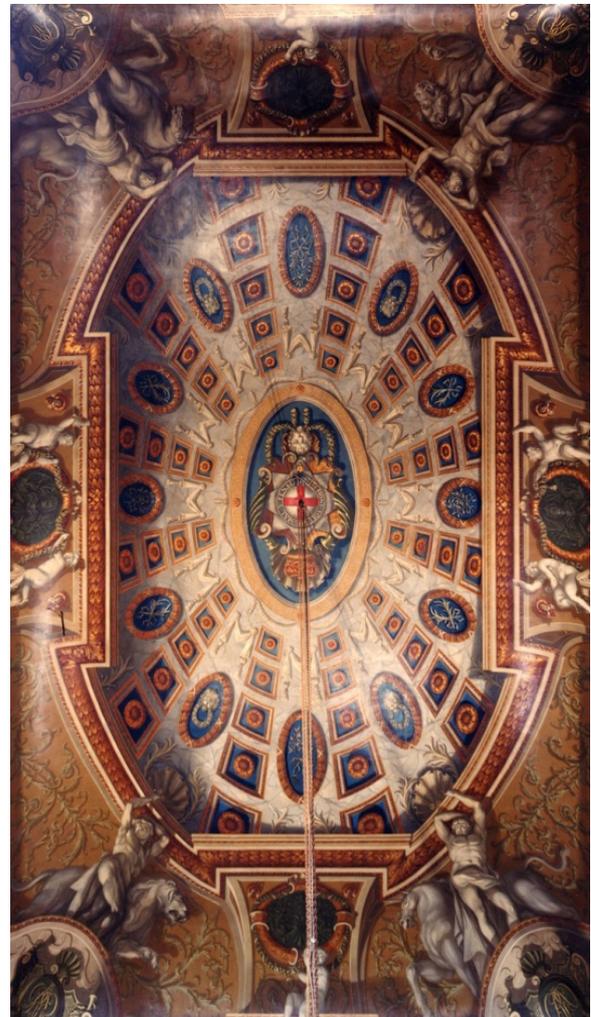
Figure 1. Rectified view of the painted ceiling over the Queen's Staircase at Hampton Court Palace.

The painted ceiling, constructed in lath and plaster, is part of the decorative scheme completed by William Kent in 1734. The painting is executed in oil bound pigment and depicts a marble dome supported by a cornice and figures, featuring a central garter star. Extensive use is made of *trompe l'oeil* techniques with coffered panels, mouldings and elevated height to enhance the grandeur. The design is centred on a Garter Star and supported by grisaille figures and elaborate ornament (Fig. 1).

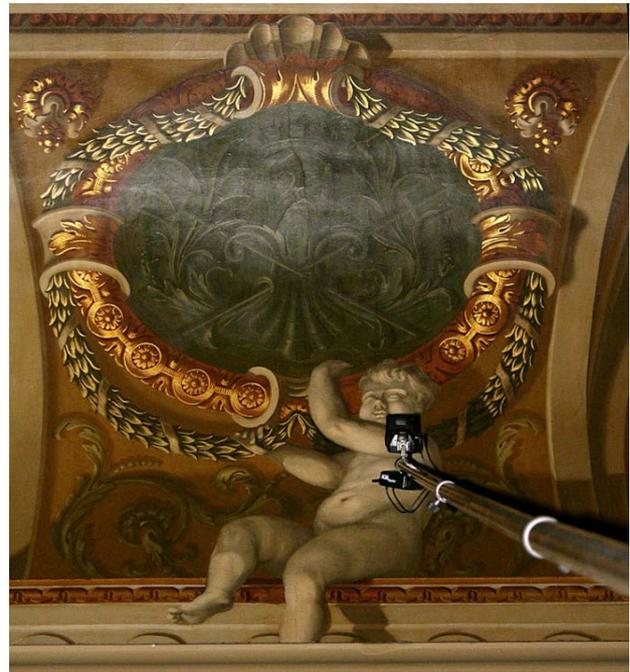
Figure 2. Upward view of flash mounted on top of 8m mast.

the landing floor. The flash light was mounted on an 8m telescopic mast, enabling it to be raised to less than 1 metre below the ceiling (Fig. 2). The mast consists of six concentric 18 gauge aluminium tubes, ranging from 2" dia (outermost) to 1" dia (innermost), each of length 1.5 metres, supported by a tripod base. When fully raised, the top of the mast is 7.75 metres above floor level. The flash unit and radio receiver were both mounted on a 1/4" dia screw, bolted onto the top section. Their combined weight, as payload, was 620 grams. The height of the mounted flash above the centre of the pole was 10 cm, hence 7.85 m (= 25'9") above the floor.

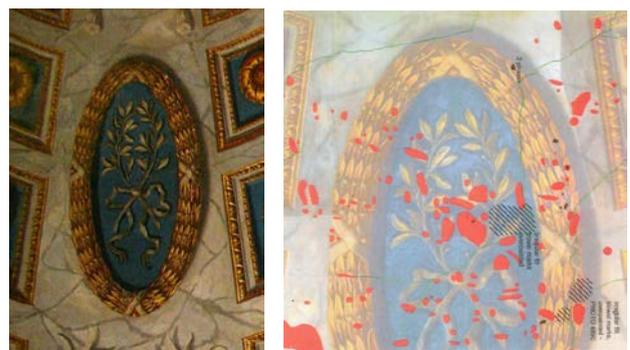
Figure 3. (left) Target area on ceiling; (right) locations of damage marked in red from previous survey in 2010.

The previous rectified photographic survey of the ceiling in 2010 identified many places subject to damage. An area in Tile 67 was chosen, depicting two branches of laurel tied by a ribbon within an oval gilded laurel garland (Fig. 3). The target area was located on the longitudinal axis of the ceiling above the centre of the landing rail. The camera was placed directly below, pointing vertically upwards. The flash light when fully raised was at approximately the same level as the top of the cornice. Images were taken from the fixed camera position with the zoom lens set at 300mm, while the flash light was moved successively to eleven locations around the floor of the landing, with five locations in each of two concentric semicircles plus one at the centre (close to the camera axis).

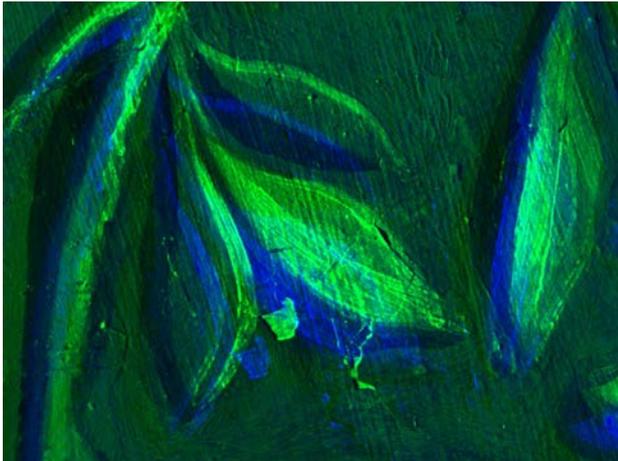
Figure 4. The effect of the misalignment of images is clear in this false-coloured composite of a detail of image 1 (green) and image 5 (blue). The offset is 45 pixels in X and 73 pixels in Y.

The sequence of 11 images of the oval panel on the ceiling took more than an hour to capture. Although the tripod holding the camera remained in the same position, it took an average of 7 minutes to set up each successive position of the telescopic mast holding the flash light. The high magnification of the image through the 300mm lens made the process very sensitive to small perturbations of the camera and its tripod, and resulted in misalignment of the images (Fig. 4).

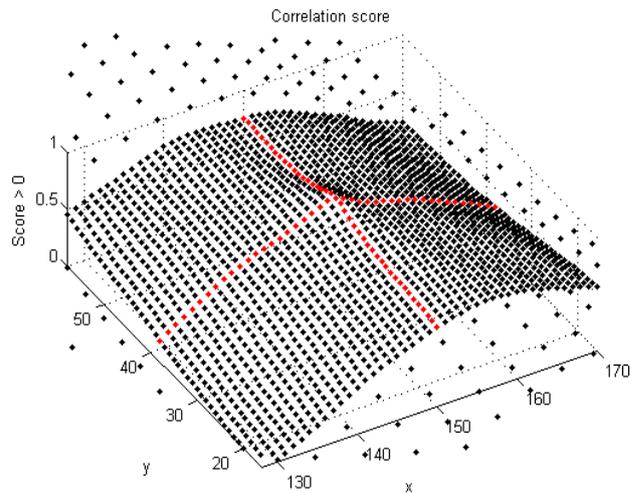
Figure 5. Surface of correlation scores for offsets of  $\pm 21$  pixels from maximum. Red lines indicate maximum row and column.

The method for registration used 2D correlation, provided by the Matlab function `corr2`, taking a small square of size 101x101 pixels of the reference image, and (in effect) sliding it around an enclosing region of 201x201 pixels from the test image to find the best fit (Fig. 5). At each successive pixel coordinate position the correlation coefficient  $r$  was calculated:

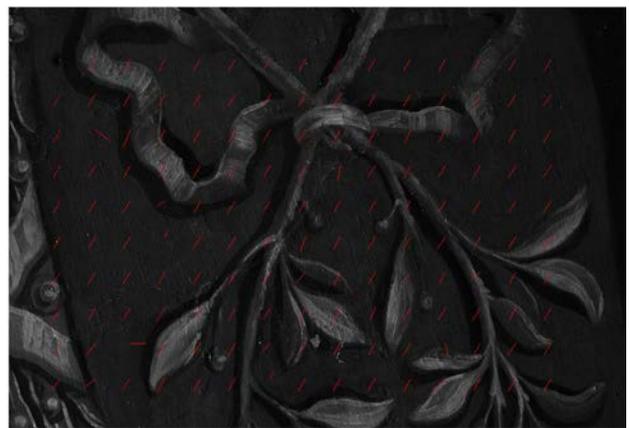
Figure 6. Monochrome of image 1 with translation vectors for image 5, calculated at 150 positions in a 15x10 grid.

To make the procedure more robust, the calculation was repeated at 150 locations across the image pair, on a 15x10 grid with centres separated by 220 pixels in each dimension. The corresponding translation vectors between images 1 and 5 are plotted in Fig. 6. It is evident that the great majority are parallel and of equal length. This indicates a simple translation – if there were any rotation the vector lengths would vary systematically across the image. Some vectors are clearly different, however, because the correlation process may go wrong if there is insufficient image detail or excessive noise (particularly in the dark regions) or if the shadow formation from the different illumination directions is too dominant.

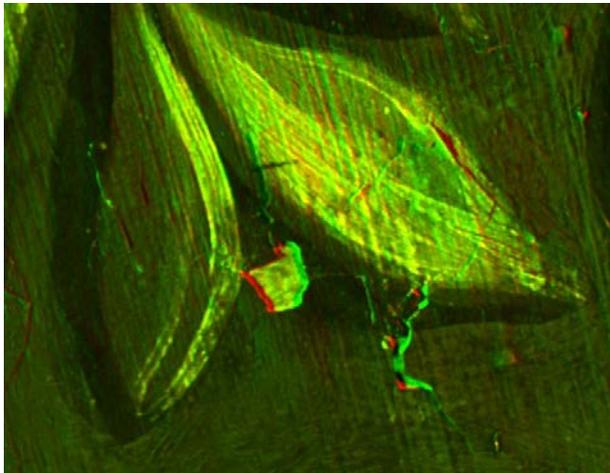
Figure 8. False-colour composite of same pair of images as in Fig. 4, after alignment. The intensity differences caused by illumination from the opposite directions are apparent.

The translation offsets were validated by processing all images and comparing them in sequence, displayed full screen with an image viewer. There was no visible displacement between successive images. The accuracy is also clear from a false-colour composite (Fig. 8).

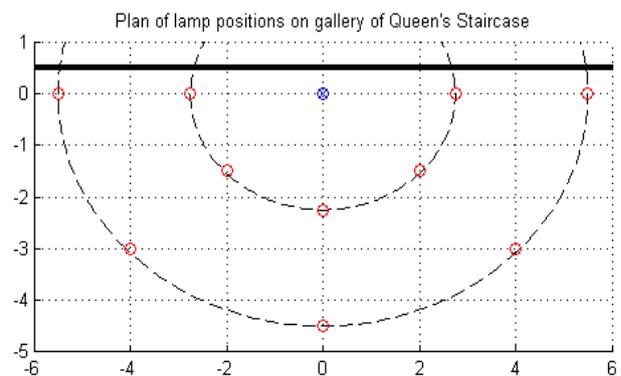
Figure 9. Ten coordinate positions of the flash lamp (red) relative to the camera (blue). All units are in metres.

The successive positions of the flash light on its mast over the floor area of the landing of the Queen's Staircase were plotted on Cartesian coordinates, with the camera position at the origin (Fig. 9). They fall approximately onto two concentric ellipses. The lamp was at a constant distance of 62 cm below the ceiling. From these dimensions the cosines with respect to the three axes were calculated (Table 2). The angle of incidence of the light onto the surface was in the range 6°–8° for lamp positions in the outer ellipse and 13°–15° in the inner.

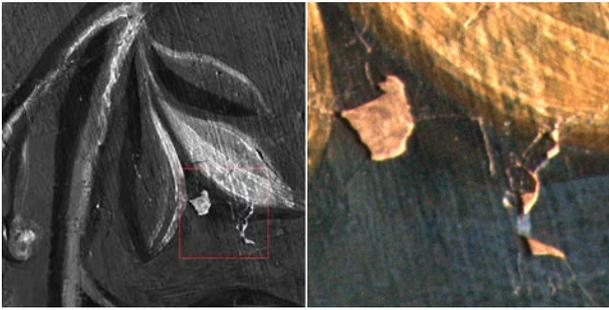
Figure 10. (left) Area from lower centre of image with red square showing the detail of 300x300 pixels (right).

A false-colour image of the normals of the detail in Fig. 10 shows that the depth information is rather subtle, but the outlines of the missing paint flake on the left and the crack on the right are clearly visible.

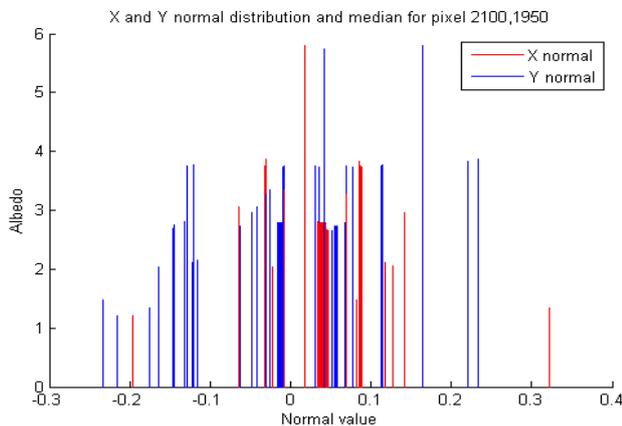
Figure 11. Distribution of values for the X normal (red) and Y normal (blue) for a single pixel in the image.

Normals for X,Y,Z were calculated using Eq. (5) for each of the 37 selected three-lamp combinations for every pixel position. This produced normal values with a considerable spread (Fig. 11), because the differentiation process is very subject to noise. The median of the distribution was taken independently for each of X,Y,Z following the method of an earlier study (MacDonald and Robson, 2010) in which it was found that the median gave a good estimate of the true value of the normal. The method has been applied successfully to analysis of ancient Egyptian clay tablets, with both positive relief (raised moulded characters) and negative relief (incised characters).

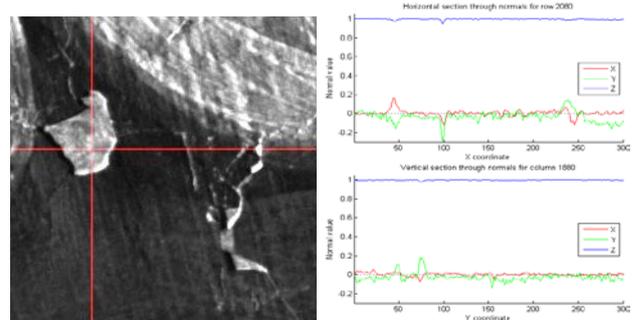
Figure 13. (left) Monochrome image of 300x300 pixel detail (same as Fig. 10), with locations of horizontal and vertical cross-sections shown by red lines; (right) normals along corresponding sections.

Plotting the normals in horizontal and vertical cross-sections shows how small is the modulation of the normal direction. It also reveals that the camera axis was not quite perpendicular to the plane of the ceiling: the X normal rises steadily across the horizontal section, while the Y normal rises down the vertical section. Zooming in on the normals within the detail of Fig. 10 shows that they do detect the edges of the features (Fig. 13), particularly the left and right edges of the paint flake (a positive normal indicates a negative slope).

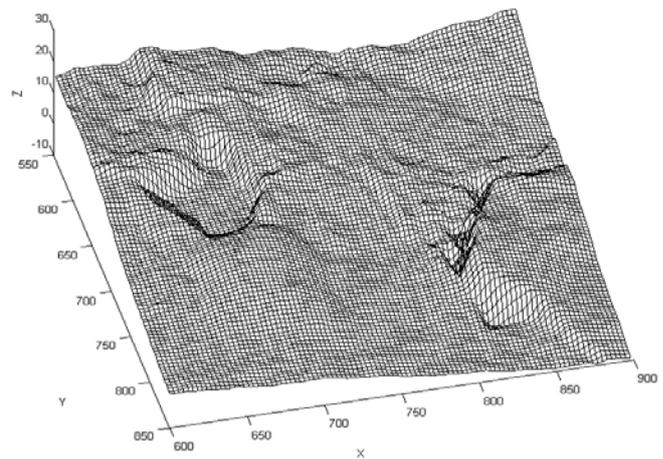
Figure 14. Reconstructed surface of 300x300 pixel area.

Figure 14 shows an oblique view of the reconstructed surface of the image area in Fig. 13, in which the region corresponding to the missing flake appears clearly as a pit and the raised flake as a ridge. Taking cross-sections of the reconstructed surface along the same lines as in Fig. 13 yields two elevations of the surface (Fig. 15). The Z axis has the same pixel dimensions as the X and Y axes. The downward overall slope of both sections is the consequence of the non-perpendicularity of the camera to the surface (assumed to be planar), resulting in an offset from zero of the mean of the normals. The rising slope of the normals, for example in the X normals across the image width, indicates a change from negative to positive slope. This could be a genuine curvature in the ceiling but is more likely to be an artefact of

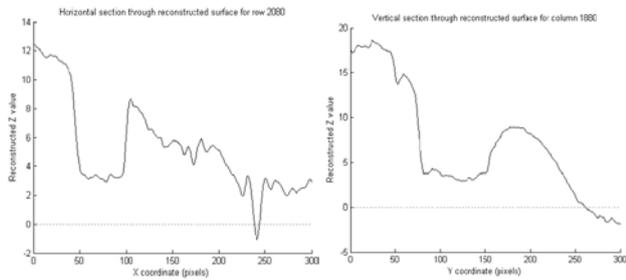
Figure 15. (left) Horizontal and (right) vertical cross-sections through the reconstructed surface.

either the image formation process (e.g. barrel distortion in the lens) or the geometry of the normal calculation (angle of incidence of light and also angle of reflected ray to camera are not parallel but change continuously across the image field).

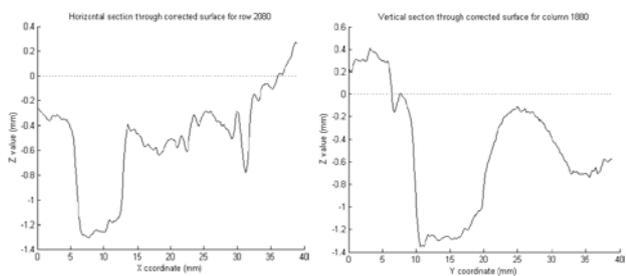
Figure 16. (left) Horizontal and (right) vertical cross-sections after correction of the normals.

After surface reconstruction of the corrected normal values, the cross-sections of Fig. 16 were obtained. The axes in these figures have been converted to physical units of mm, using the estimated surface resolution of 7.7 pixels/mm. Note that the depth (Z axis) resolution achieved by the photometric stereo technique is finer than 0.2 mm (i.e. 200 microns). With a better lens (400mm and higher MTF), combined with more careful placement of the flash light in successive positions, a depth resolution of 100 microns could readily be achieved. This is an order of magnitude better than most 3D laser scanners, and compares very favourably with the Z-axis resolution achieved by the best (and most expensive) 3D scanners, operating at a range of 6 metres (Table 3).
