LASER SCANNING FOR THE GEOMETRIC STUDY OF THE ALCÁNTARA BRIDGE AND CORIA CATHEDRAL

This communication presents the application of laser scanning in the Alcántara Bridge and Coria Cathedral, both in the province of Cáceres (Spain). It outlines the criteria used for scanning both monuments: selection of placements, recording technique, errors between placements and the elimination of residual points.

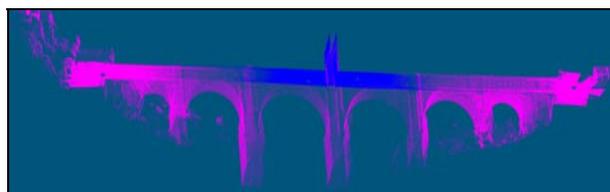
Figure 1. Final cloud of points.

Once all the scans had been put together, the 3D model of the bridge was made using Trimble Realworks v6.5 (Figure 1), and longitudinal (Figure 2), horizontal (Figure 3) and transversal sections (Figure 4) of the bridge were obtained.

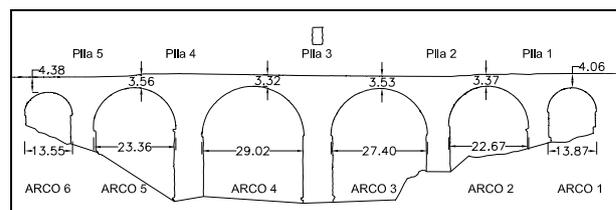
Figure 2. Longitudinal section of the bridge of Alcántara.

From the analysis of the geometry represented by laser scan, significant differences were found between the results obtained and the drawings and plans that already exist (Durán, 2004). For example, regarding the span of the arches, the differences are close to a meter in the case of arches 2 and 4 compared with the data of Taramas (s. XVII) (Blanco, 1977), and even greater than a meter in arch 4 when compared with those of F. Rodríguez (Cruz, 2001), (Liz, 1988). But even in the case of the most recent measurements, such as those made by the Revista de Obras Públicas (R.O.P.) in 1926 (Obras, 1926), they reflect spans between arches from left to right (13.20m – 22.00m – 26.23m – 28.00m – 22.69m – 12.63m) with considerable differences, with all spans less than those obtained using TLS of 80 cm.

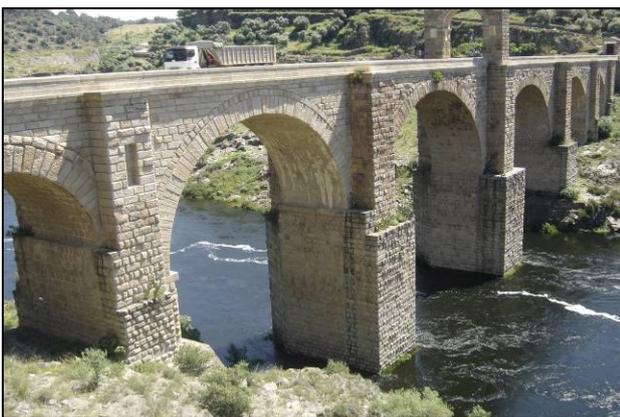
Figure 5. View of pile 4 under the triumphal arch.

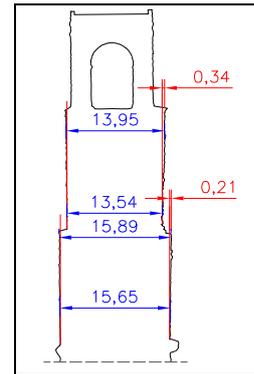
Figure 6. Transversal section of pile 4 (values in meters).

The upstream surfaces of pillars 4 and 5 present a slight collapse, which is greater in pile 4. This collapse is 21cm in the section from the cornice halfway up the pile and the beginning of the arch. In the section from the beginning of the arch to the impost (a line of ashlars), the collapse is 34cm (Figure 6). This is coupled with the fact that the length of these pillars is not uniform throughout its height, but is greater in the upper part of each section. The downstream surface is practically vertical, and does not present any significant collapses.

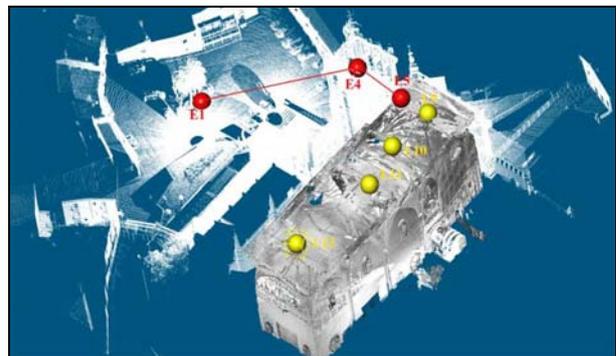
Figure 7. Scanning and station location.

The figure 7 shows the topographic stations to carry coordinates to the over-vault (E1, E4 and E5) and the scans made in the part of the over-vault (L9, L10, L11 and L12).

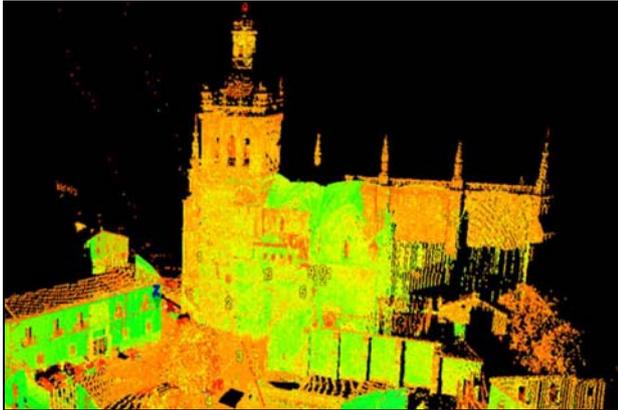
Once the corresponding scans had been taken, the cloud of points was made with the help of the software Faro Scout LT, and then the 3D model was constructed. Similarly, the same process was followed as with the scans made using the Leica Scanstation C10, with the difference that the Cyclone Navigator was used (Figure 8), in which the data obtained with the laser scanner were used.

Figure 8. Cloud of points recorded with the Cyclone Navigator.

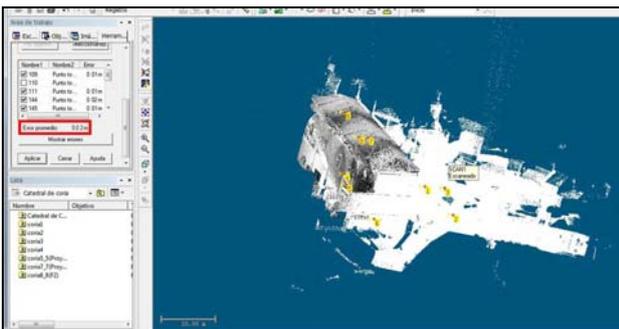
Using the program Trimble Realworks the points of the system of coordinates of the laser scanner itself were transformed to the local system performed using the total station. This conversion was carried out using the geo-referencing tool of the program Trimble Realworks such that by selecting the station the coordinates of the placements previously shown were given and thus the scans could be aligned. The mean error obtained using this method was 2cm, which was considered valid. (Figure 10).

Figure 10. Mean error of geo-referencing.

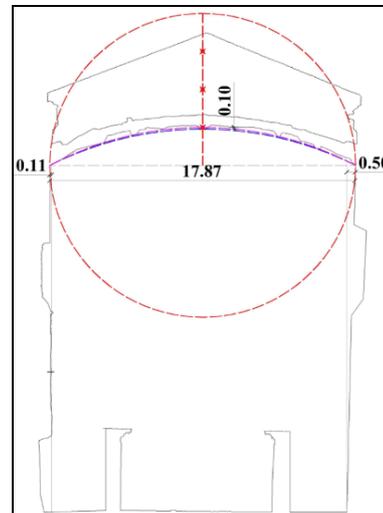
The collapses of the walls have been measured (horizontal displacements of the upper part with respect to the lower). The most significant movements have taken place in the southern wall, which presents an outward collapse that varies between 17cm in vault 3 and 50cm in vault 4 (figure 11), whereas the northern wall remains practically vertical.

Figure 11. Measurements of collapses in vault 4 (values in meters).

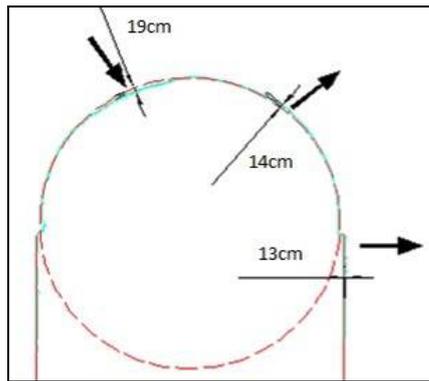
These displacements are in accordance with the wide vertical cracks in the walls of the eastern façade. In the case of the vaults and arches, the comparison between the theoretical and the real geometry provide information on its behaviour. Thus, for example, in the traverse arch of vault 2 (figure 12), the area of the middle in the arch of the southern side, the deformation is displaced towards the exterior of the theoretical geometry by 14cm. On the northern side this displacement is 19cm, but towards the interior. This indicates that the vault behaves asymmetrically, with greater thrust towards the southern side, which is the wall with collapses.

Figure 12. Displacements of vault 2.

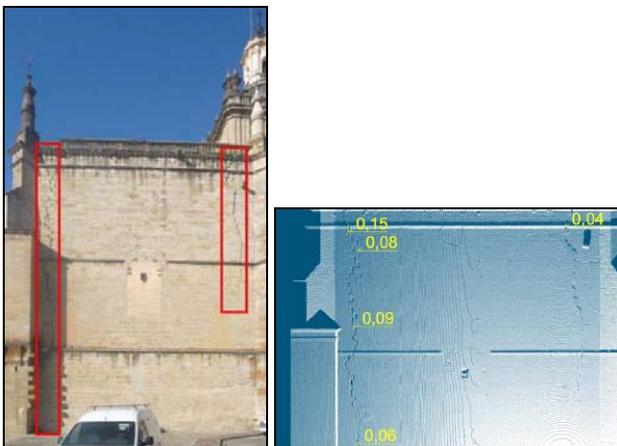
In addition to data relative to the deformed geometry of the structure, data were also obtained on the cracks in the monuments, the trajectory of these cracks and their size. For example, figure 13 shows the façade of the eastern side, which is the one with the most damage, and the laser scanner measurements of the width of the cracks in this façade.

Figure 13. Eastern facade and inventory of cracks (values in meters).

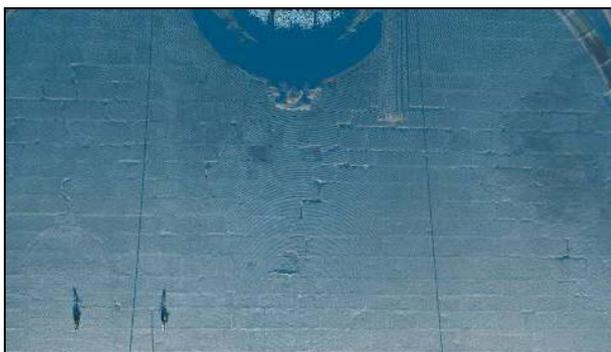
Figure 14. Track of the cracks in the eastern wall.

Using the laser scanner technique the real trajectories of the cracks (figure 14) as well as their widths were obtained. Moreover, these displacements and cracks were related to those of the eastern façade and to the displacements in the vaults, allowing the analysis of the overall behaviour of the structure. In this way, this data collection has enabled us to follow the evolution of these cracks to know the area that is settling and the displacements that both the wall and the vaults are suffering.

The southern facade presents cracks with an arch shape, denoting settling of the land in this area.
