SURVEY METHODS FOR EARTHQUAKE DAMAGES IN THE “CAMERA DEGLI SPOSI” OF MANTEGNA (MANTOVA)

KEY WORDS: Earthquake, Laser scanner, Cultural Heritage, Camera degli Sposi, Mantegna

1.1 The Emilian earthquake and the damages in the Castello di San Giorgio in Mantova

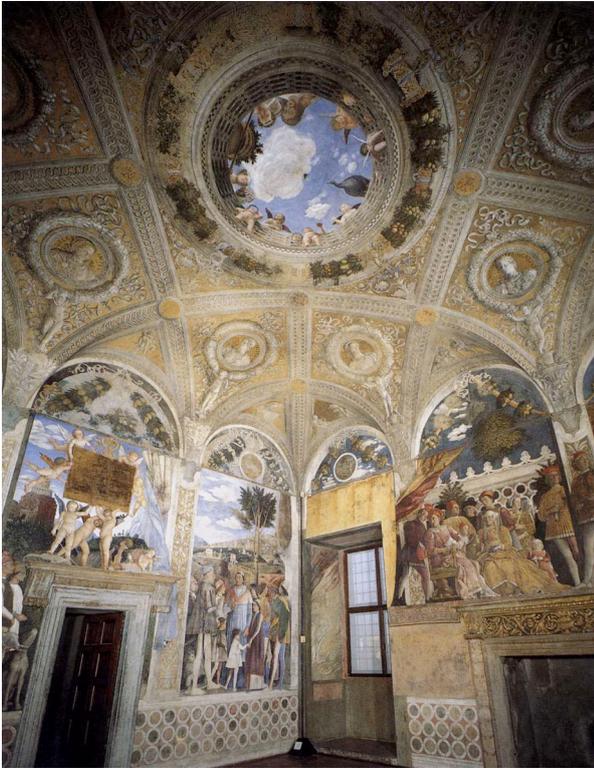
Figure 2. The Camera degli Sposi

The room is located inside the northern tower of the castle; the north-east wall, decorated with the so-called “Scena della Corte”, suffered of the detachment of some parts of plaster due

to the reopening of a previous injury, probably caused by an earthquake occurred in the past. The concern rose from the fact that the fall of plaster had led to the loss of some parts of the ancient fresco and by the fact that it was not clear whether the crack was superficial or it involved the wall structure of the tower.

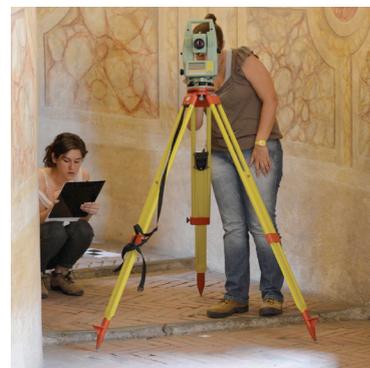
Figure 5. Total station Leica, TCR 1103

The reference system for the whole survey was determined by creating a closed loop with a topographic Total Station Leica TCR 1103.

This operation has allowed the definition of a topographic net that, during the data processing phase, allowed the georeferencing of all the scans obtained with different laser scanners into a single reference system.

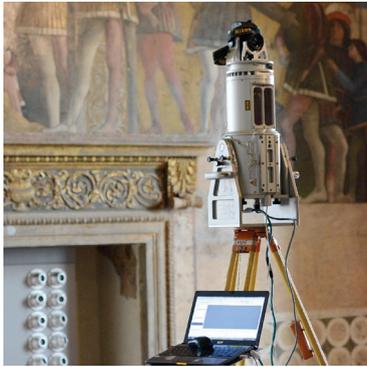
Figure 6. Laser scanner RIEGL, LMS-Z 390i

- Riegl LMS-Z 390i, a Time of Flight, long-range terrestrial laser scanner. It was used to acquire three-dimensional data on the external parts of the castle's walls and in the Camera degli Sposi;

The laser scanner LMS-Z 390i works with time of flight technology: the distance between the measured point and the center of the instrument is calculated by the difference in time between the emission of the laser signal and its return. This instrument is also able to acquire information on the color of the

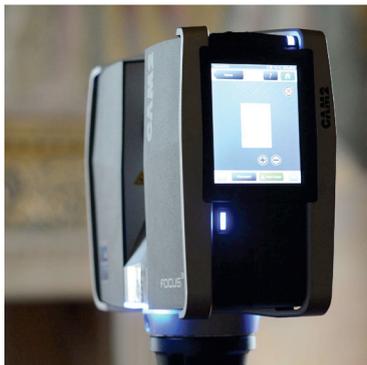
Figure 7. Laser scanner CAM2, FARO FOCUS 3D

- CAM2, FARO FOCUS 3D, a phase-based terrestrial laser scanner, used for the scans of all the interiors;

This type of instrument uses phase shift measurement technology to measure the distance to a surface: an infrared laser is sent out and, upon contact with the surface, reflected back to the instrument itself. The distance is measured by analysing the shift in the wavelength of the returning signal.

The Faro laser scanner allows distance accuracy up to 2 mm, in an operating range from 0.6 to 120 meters, and can acquire up to 976,000 points per second. It is very light and easily transportable and therefore particularly suitable for fast acquisitions. It is considered a "hybrid laser-photogrammetric scanner", as it offers the opportunity to acquire not only the three observations necessary for the determination of the X, Y, Z coordinates of each point, but also to the R, G, B (radiometric) values corresponding to each measured point.

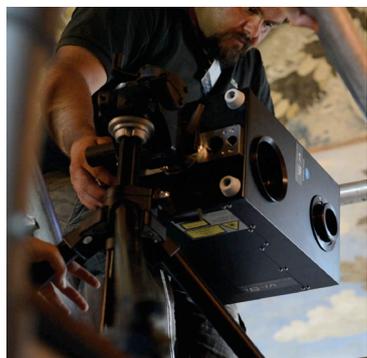
Figure 8. MINOLTA, VIVID 9i

- MINOLTA VIVID 9i, a triangulation based laser scanner, used to perform a high accuracy survey of the crack in the Camera degli Sposi.

This kind of range camera is composed by a light source and a sensor plane, which are rigidly bounded. The laser source generates a thin beam of light that produces a bright line on the surface to be measured. Through a sensor device, such as a digital video camera, placed next to the light source, the image of the line of light is captured. In this way, the source, the centre of projection on the sensor and the point of light reflected from the surface form a triangle. If the base (distance between the light source and sensor, which is fixed) and the two base angles are known, all the other parameters can be calculated, and consequently the 3D coordinates of a point on the surveyed surface are acquired.

The camera has three types of lenses: TELE, MIDDLE, WIDE, that can be used depending on the size of the object to be scanned. It has a range that goes from 0.5 to 2.5 m. Depending on the optics used, areas ranging from a size of (x, y, z) 93x69x26mm up to 1495x1121x1750mm can be scanned. The accuracy is (in x, y, z) ± 0.05 mm (with lens TELE, at a distance of 0.6 m). The time elapsed for a single scan is approximately 2.5 seconds and it can acquire more than 300,000 points for

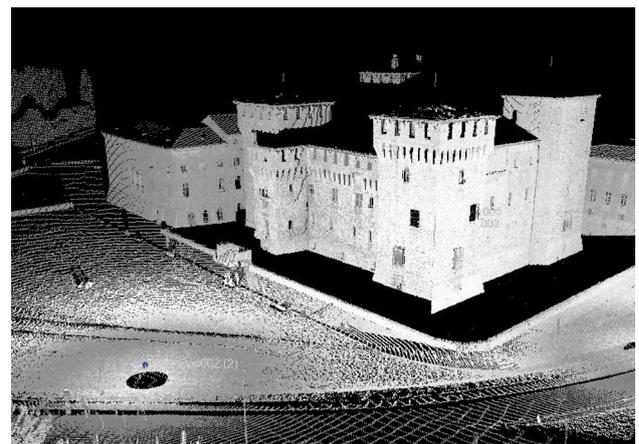
Figure 9. Point clouds of the external of the castle

The second team, with the Riegl laser scanner, focused on the acquisition of three-dimensional data on the external walls of the north tower: 4 scans were performed, in order to define the digital shape in the space of the external surfaces of the tower. With the same laser scanner point clouds for the entire Camera degli Sposi were also acquired.

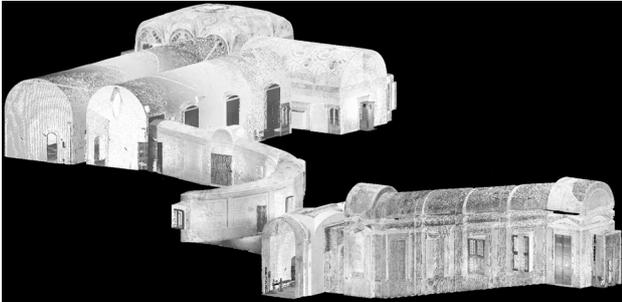
Figure 10. Point clouds of the path from the Scalone di Enea to the Camera degli Sposi

The third team worked with the Faro Focus 3D laser scanner, and performed scans of the path that from of the Scalone di Enea leads to the Camera degli Sposi. Scans of the room itself were also performed. With this tool 24 scans were performed.

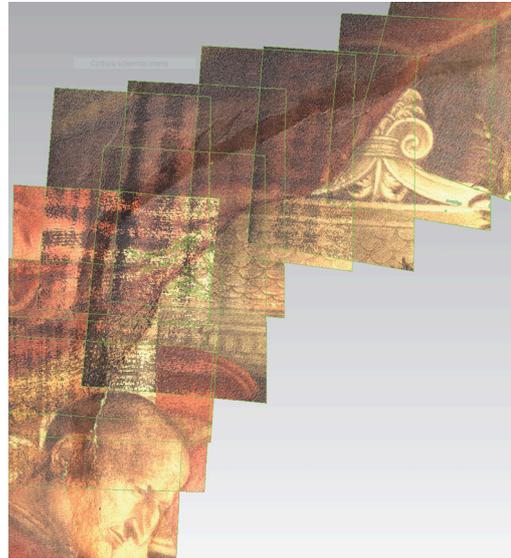
Figure 11. Detail of meshes acquired along the crack

40 detailed scans of the crack on the wall called "della Corte", were acquired with the Vivid 9i, in order to obtain the complete shape of the damage along the wall and to have a measurement of any deviation from the mean plane of the surface of the area affected by the crack.

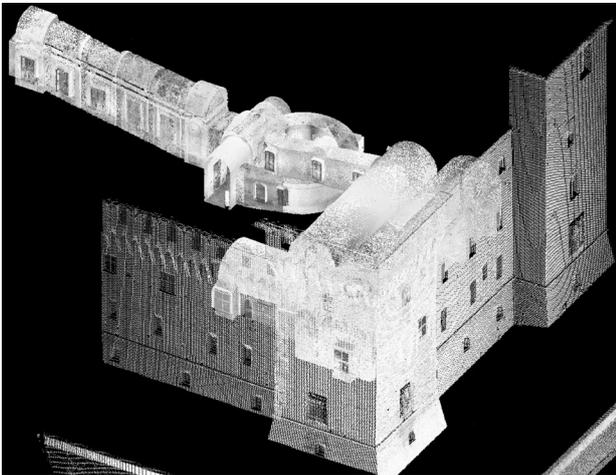
Figure 12. Whole point cloud

simple text file that contains a list of all the points that make up the cloud. For each point the name of the point itself is indicated (1, 2, 3, etc.), the three coordinates (X, Y, Z), the three radiometric values (R, G, B) and the reflectance value. At the end of this process the result is a point cloud constituted by millions of points that describes the shape in the space of all surfaces detected in an almost continuous, but in a still discrete way.

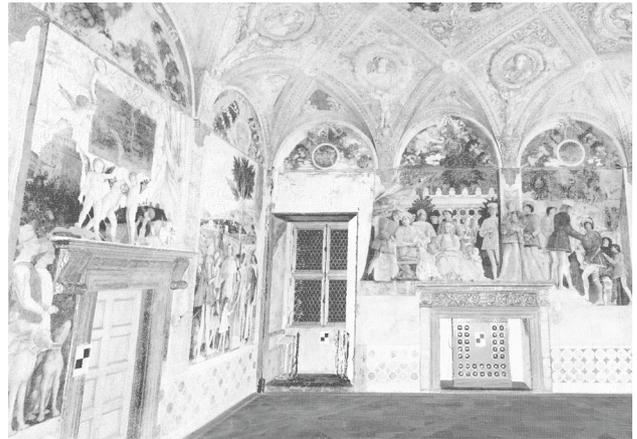
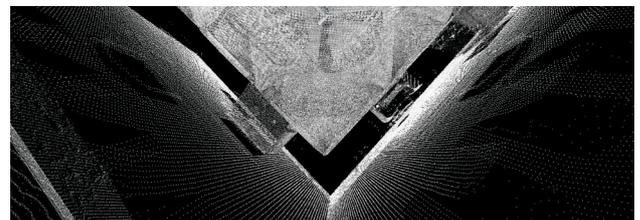
The work has focused primarily on the Camera degli Sposi and in particular on the damages on the north wall also known as "della Corte". Since all the scans were registered in the same reference system, it was possible to immediately verify the thickness of the perimeter wall of the tower.

Figure 13. Point cloud of the Camera degli Sposi

Figure 14. Top view of the point clouds

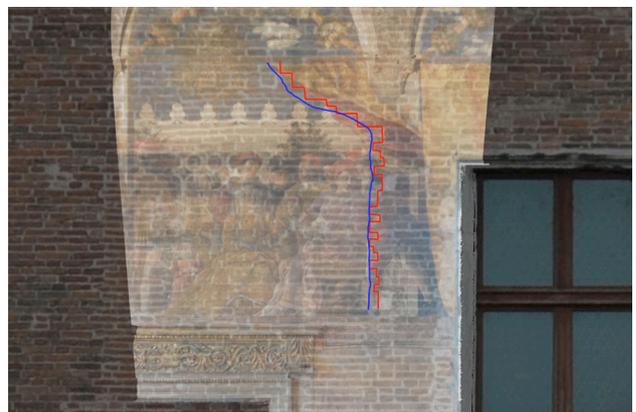
Figure 15. Overlapped orthophotos

Secondly, orthophotos from the inside and outside walls were overlapped to check if the internal damage had affected the outside area as well: it was soon clear that the damage occurred on a bricked up window on the wall.

Because of this, the outer wall was no longer continuous: this caused the earthquake to generate a different movement between the body of the tower and the bricked up window; the previous crack re-opened. However, the observations derived from this first analysis did not give a complete picture of the situation. Other representations were then obtained with the false colour depth mapping of the damage. As we did for the orthophotos, the two images were overlapped and compared. The operations just described have shown that the external wall did not present considerable discontinuities and therefore that the earthquake had not caused harmful effects. On the other hand, the internal

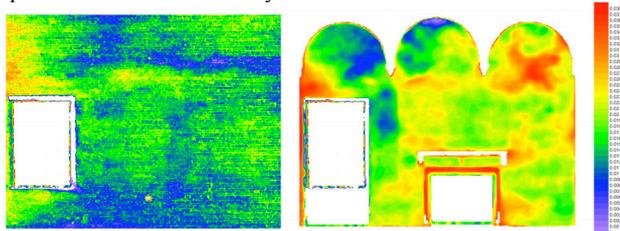
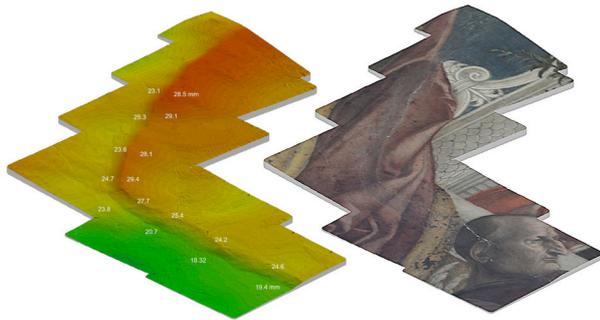
wall, in correspondence to the damage, presented deviations of up to 5 cm between the body of the tower and the infill.

Figure 16. Depth maps

Figure 17. DSM

Two fundamental considerations can therefore be made. The first is that, due to the different behaviour between inside and outside walls, there is definitely a gap. The second consideration concerns the discontinuity of the inner wall: after a careful analysis of the data obtained, it emerged that the damages had not been caused by the earthquake of May 2012, but by an earthquake which occurred in previous centuries. As can be seen in the DSM (Digital Surface Model) obtained from the point clouds, the infill had a forward movement of even 5 cm in the top area, causing significant damage, which was later plastered and repainted. Most probably, the Emilian earthquake just caused a superficial damage to the plaster of the previous crack.

As a result of considerations explained in this research, Mantegna's fresco has now been restored to its original beauty. For what concerns the path from the Scalone di Enea to the Camera degli Sposi, technicians were provided with orthophotos of plans, fronts and sections, useful for subsequent re-design or analysis of the cracks in the walls.
