THE APPLICATION OF SURVEY IN ER WANG TEMPLE RESTITUTING

KEY WORDS: The stage in Er Wang Temple, Survey, 3D laser scanning, Site exploration, Residual components

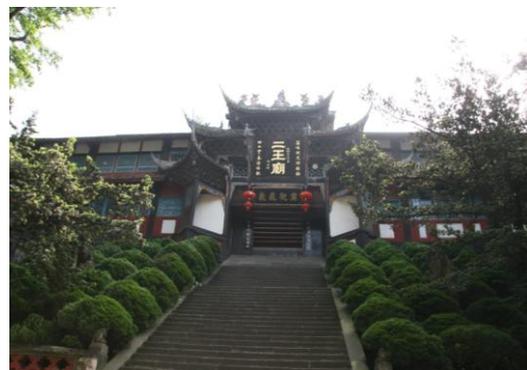
Photo 1. The picture of the stage before Wenchuan earthquake

The stage is located in the center of the central axis of Er Wang Temple, is the main door of the main shrine. This building have two functions, the gate and the stage. In addition, the structure of the stage is exquisite, and the modelling of the roof is full of novelty and complexity. In short, it plays a very important role in the Er Wang Temple. The stage buildings are made up of the stage, East-West Corridor, the east sitting room and west guest room. (Photo 1,2)

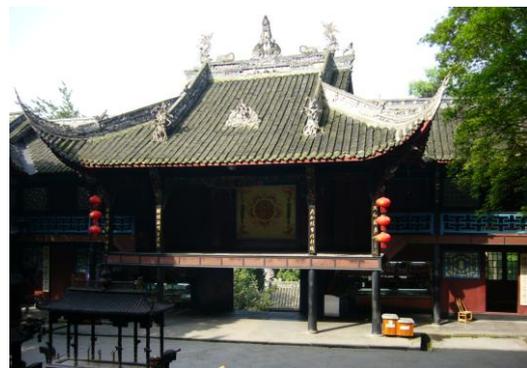
Photo 2. The north facade of the stage

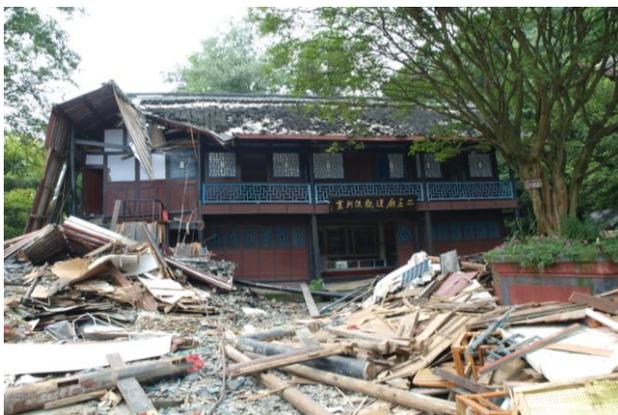
Photo 3. The picture of west guest room after the earthquake

Stage is located in the southeast of the main shrine. The earth's surface dislocation in this area, cracking and uneven settlement of foundation, artificial platform and building foundation collapse, result in the stage and both sides of the corridors and the east sitting room collapsed in the quake, the west guest room roof destruction and structural deformation. It is a group of buildings suffering the most serious earthquake damage in Er Wang Temple. (Photo 3)

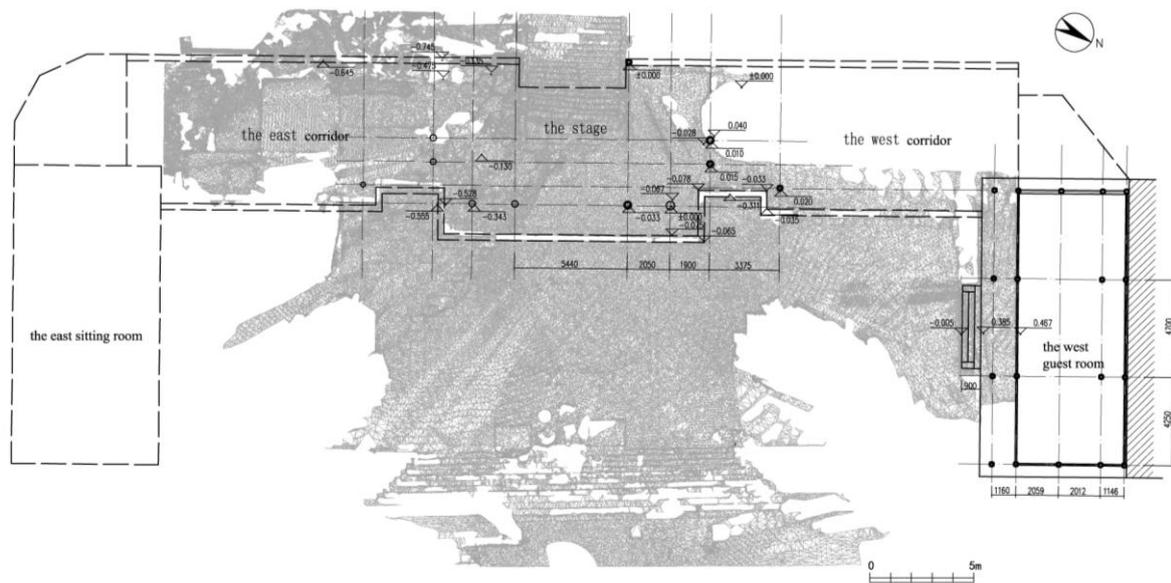
Figure 1. 3D laser scanning for the stage site

The stage were completely disrepair in the earthquake, and the southeast corner of the ground partly disrepair. We use 3D laser scanning to survey the existing site, five plinths are not affected apparently by the earthquake and remained, they are located in the northeast corner of the stage and the west corridor. By observing, each plinth carved small hole in the central location. Basing on this hole, we measure the existing plane data.

This scan for the stage field measurement has also carried on the plane elevation measurement. Made the northwest corner of the stage as the basis, we measured the elevation of object remained of the stage, such as plinths, and ground plane (including the collapsing ground affected by the earthquake), and drains etc... According to analysis of stage terrain deformation data after the quake based on 3D laser scanning, we could clearly understand the scope and degree of the southeast corner of foundation subsidence, we could also clearly see the original position of plinths on 3D model. With detailed terrain drawings by scanning, the graphic data and ground elevation data provides reference for the restoration of the stage. (Figure 1)

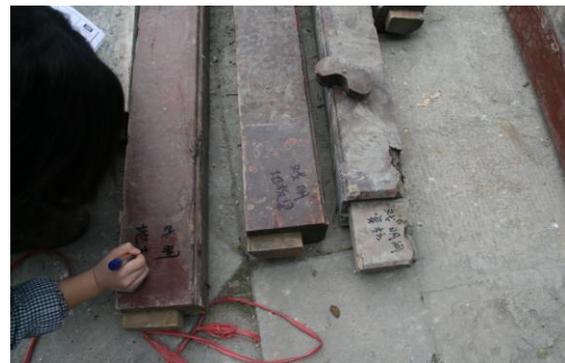
Photo 4. Classification of the components by type

3. Then we classified the retained components belonged to the stage buildings by type (such as girders and pillars, plinths, purlins, etc.) (Photo 4). According to the location of the mortise and tenon joints on the components, we could roughly judge components belonged to which part of the building. Contrast with the existing components' size data and the original survey map, we tried to get more detailed data, in order to support the recovery work.

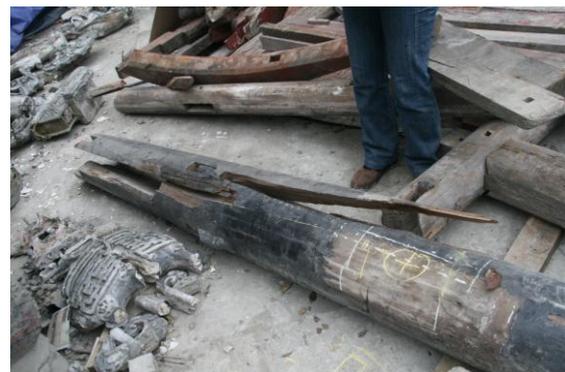
Photo 5. The component which may continue to be used by strengthening and maintenance

Intact components in the stage buildings are little, most of them are the connection components, such as fang, LouLeng, the main load-bearing components all have suffered from damage in different degrees, like pillars, girders, purlins, etc. The familiar damage are splitting, which locations are almost at the mortise and tenon joints which is connected with other components. Bug infestation phenomenon is relatively common. According to the damage degree and the location, we remained more components and strengthened and maintained them to be

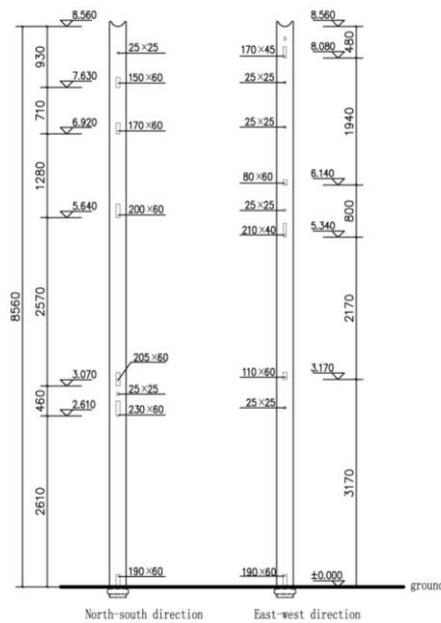
Figure 2. The survey map of the center pillar of the stage

used in repair project, as much as we can to retain the more original components. The size of the key structure components such as pillars and girders of the stage and the positions of mortise and tenon joints are important basis to the stage buildings' restoration, such as pillar Z01-04 (Figure 2), girder L01-03 are the direct basis of the stage structure elevation and chapters distance.
