DOCUMENTING A COMPLEX MODERN HERITAGE BUILDING USING MULTI IMAGE CLOSE RANGE PHOTOGRAMMETRY AND 3D LASER SCANNED POINT CLOUDS

Maria Lucia Vianna Baptista
Documenta Fotogrametria Arquitetural
www.documenta-mlvb.com

Commission V, WG V/2

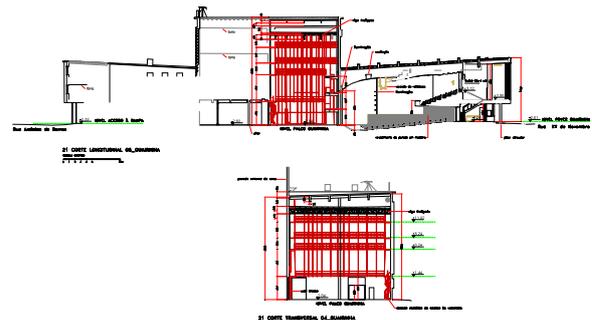
Figure 4. Small Auditorium "Guairinha" - Longitudinal and Transversal Sections

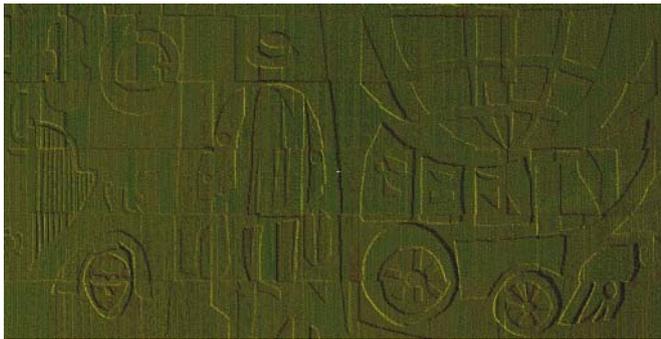
Figure 7. 'Intensity Map' Point Cloud of Poty Lazarotto art panel.

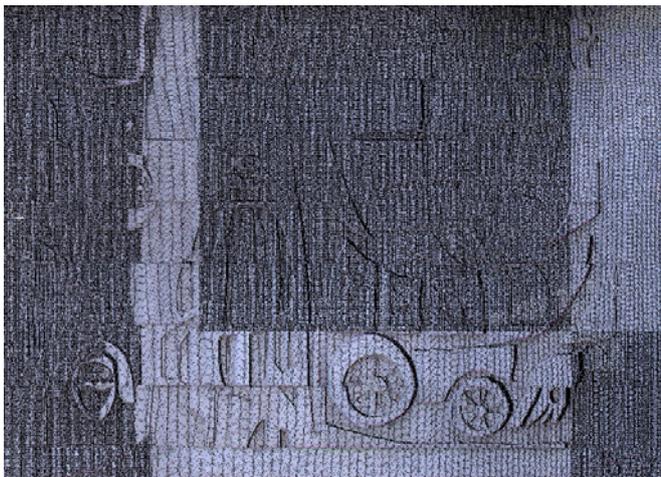
Figure 9. Poor details visualization when zooming into a 'Colours from Scanner' Point Cloud

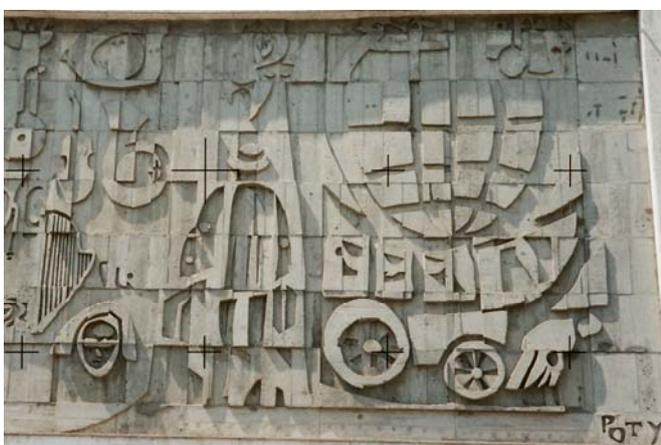
Figure 10. High resolution photograph taken with a close-range photogrammetric camera

In this case, for part of the walls and also for the concrete art panel from Poty Lazarotto located in the main façade of the Theatre, photogrammetry was a better choice in terms of details visualization. (Figure 10)

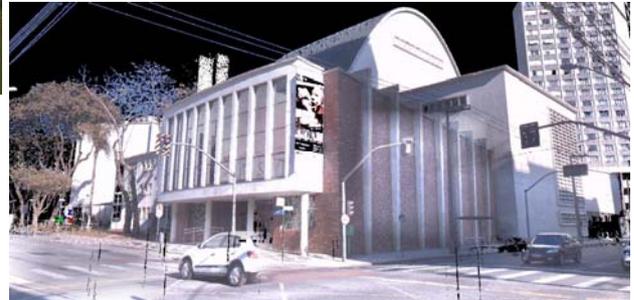
Figure 11. Image Texture Map on Point Clouds: structural faults and tiny cracks on walls were not visible

Photogrammetry was definitely the best option to complete the Damages Mapping drawings (building pathologies mapping) on top of the final architectural marks. In the pictures we can easily identify humidity marks, growing plants on small holes and cracks, different textures, missing or broken parts.

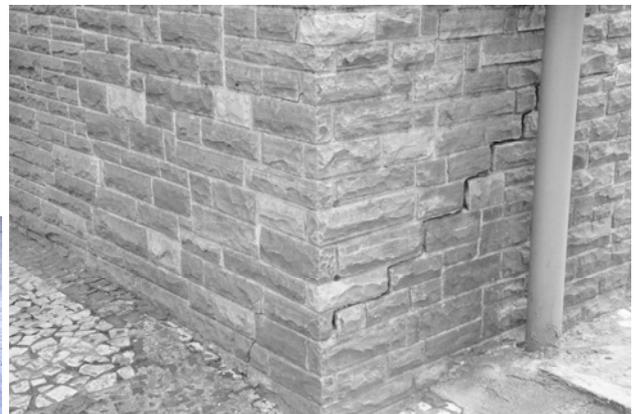
Figure 12. Regular photography showing structural damages on the wall

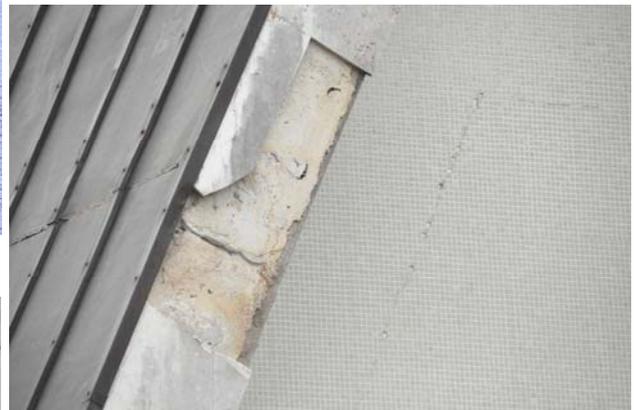
Figure 13. Regular photography from structural damages and missing or broken marble plaques
