RECORDING AND ANALYSIS OF THE REC YARD AT ALCATRAZ ISLAND

KEY WORDS: Laser Scanning, Photogrammetry, GPR, Preservation, Non-destructive Testing

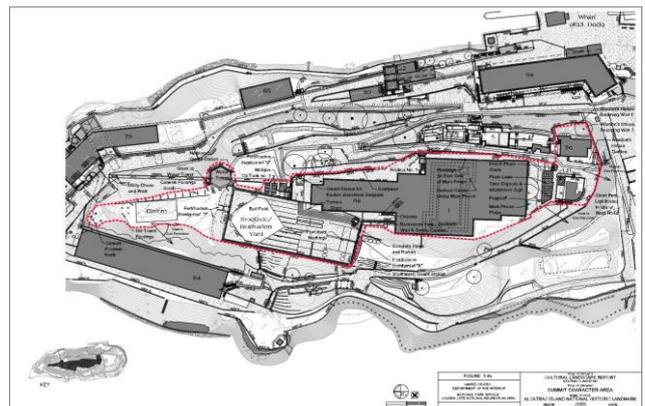
Figure 2. Stockade/ Recreation yard Drawing (ACLR 2010)

The recreation yard was constructed in 1912 to give the military prisoners some relief from the harsh conditions of prison life. Originally it consisted of reinforced concrete walls 20 ft. high surrounded by catwalks for guards and guardhouses on three corners. The unreinforced concrete floor of the yard was

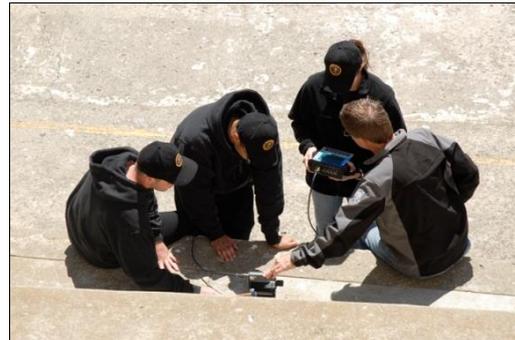
Impact Echo (IE): Used for rapid flaw detection (voids, honeycombing, and cracking damage) and thickness evaluation of concrete structural materials. The method requires access to only one side for testing. Olson Instruments' Concrete Thickness Gauge (CTG) uses the IE principle with an automatic solenoid impactor and displacement transducer (Figure 3).

Figure 3. CSU Chico & Texas A&M University Students Learning to use Olson Instruments' Concrete Thickness Gauge

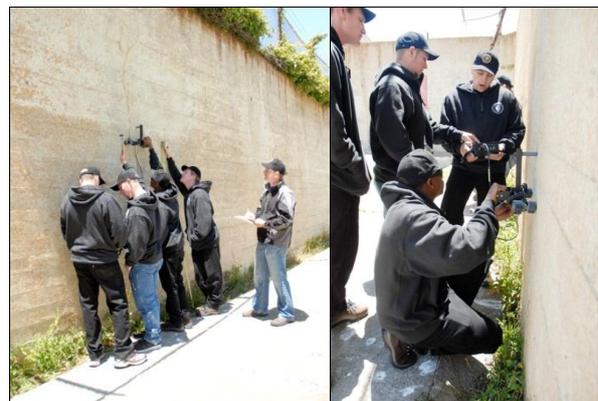
Figure 4. Chico State Students with Olson Instrument Engineer taking SASW measurements across a crack in the wall of the Rec Yard

Spectral Analysis of Surface Waves (SASW): Used for determining concrete velocity (quality) and integrity from one side without having to know the thickness of concrete member being tested. Olson Instruments' SASW is the same base unit as the CTG (from above) with an added 20 cm long arm containing a second displacement transducer. The unit combines IE thickness and flaw detection with SASW velocity measurement (Figures 4 & 5).

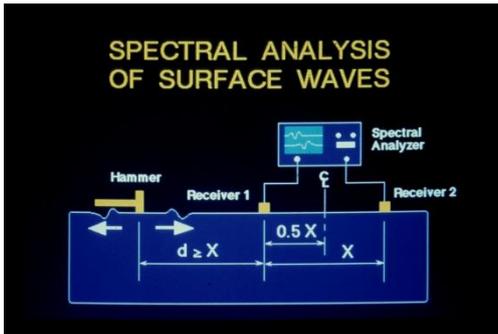
Figure 5. SASW Process (Diagram courtesy of Olson Instruments)

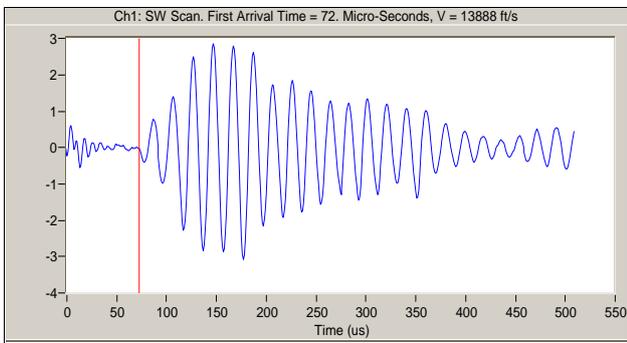
Figure 6. Sample data from UPV showing pulse travel distance of 12", compressional wave arrival time of 0.000072 seconds for a resulting velocity of 13,880ft/sec, which typically indicates good quality concrete

Ultrasonic Pulse Velocity (UPV): Measures velocity of an ultrasonic pulse through concrete to determine strength and integrity. Faster velocity typically correlates to material with greater strength and better integrity. Olson Instruments' UPV uses a .2 lb instrumented hammer and accelerometer for thicker material (Figures 6 & 7).

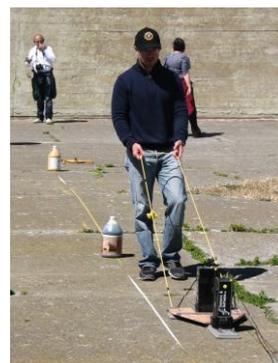
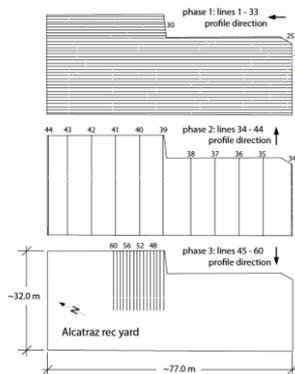
Figure 8. (left) GPR data acquisition in cross-dipole mode; (right) GPR survey geometry.

The GPR survey at the rec yard used the Sensors and Software PulseEKKO system (www.senssoft.ca) equipped with 200 MHz dipole antennas separated by 0.5 m. The selection of GPR frequency and acquisition parameters is guided by site-specific resolution and penetration depth requirements. Briefly, spatial resolution is a measure of how far apart two radar reflectors must be for them to be recognized as distinct buried objects, or distinct aspects of the same buried object. The highest achievable vertical resolution is roughly one-quarter of the dominant wavelength λ of the propagating electromagnetic signal, but in practice it cannot be better than twice the chosen time interval Δt between each sample of the radar trace. The across-track and in-line lateral resolutions are of the same magnitude as, respectively, the chosen line spacing ΔL and chosen station spacing Δx . These are the distances between adjacent profiles and between adjacent recorded traces along a given profile. The depth of penetration d is limited either by the chosen acquisition time window of the recordings, as in the present case, or by the intrinsic loss of GPR signal energy as it propagates into electrically conductive ground. The latter is the controlling factor if a sufficiently long acquisition time window is chosen. The stack number s is the number of times that the pulse is repeated and the resulting traces are averaged. A higher stack number enhances the signal-to-noise ratio, since random noise is averaged out, but extends the acquisition time at each station and requires more power from the batteries. A photo of the data acquisition is shown in Figure 8, left.

Shown in Figure 8, right, are the three phases of GPR data acquisition. Phase 1 consisted of 33 lines directed SE→NW spaced $\Delta L=1.0$ m apart and acquired along the entire length of the rec yard. Phase 2 consisted of 11 lines directed SW→NE spaced $\Delta L=8.0$ m apart and acquired across the entire width of the rec yard. Phase 3 consisted of 16 shorter NE→SW lines spaced $\Delta L=1.0$ m apart and acquired within the focus area

shown in the figure. Data from Phases 1 and 2 were acquired in the standard in-line mode (Everett, 2013) in which both GPR antennas are centered on the profile, with the transmit antenna leading the receiver antenna, and with their long axes oriented at a right angle to the profile direction. Data from Phase 3 were acquired thrice using the in-line, a broadside, and a special cross-dipole mode; these data are not presented in this initial field report. In all cases, the station spacing is $\Delta x=0.1$ m, the sample interval $\Delta t=0.4$ ns, while the stack number is $s=4$. Assuming that the subsurface electromagnetic wave velocity is $v=0.1$ m/ns, a value typical for construction fill and earthen embankments, the dominant wavelength at frequency $f=200$ MHz is $\lambda=v/f=0.5$ m, indicating that vertical resolution is roughly $\lambda/4 \sim 0.1$ m. A fairly short acquisition time window was selected, $\tau=60$ ns. Recognizing that this value corresponds to the longest recordable two-way travel time for signals to propagate downward, reflect off buried objects, and return back to the surface, the maximum penetration depth d is readily calculated to be $d=v\tau/2 \sim 3.0$ m.

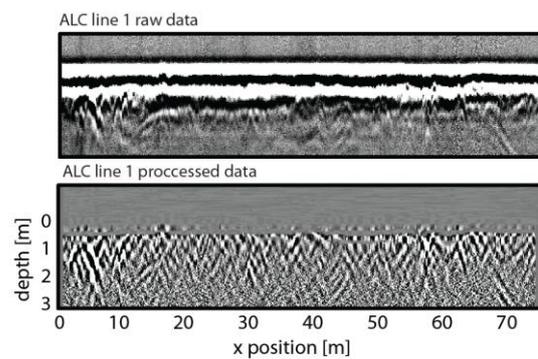
Figure 9. (top) example of raw GPR data; (bottom) after processing.

1. data and file reconciliation
2. low-cut dewow filter
3. background subtraction filter
4. trace equalization filter
5. gain control

An example of raw and processed GPR data sections, before and after the application of the filters and gain control, is shown in Figure 9.

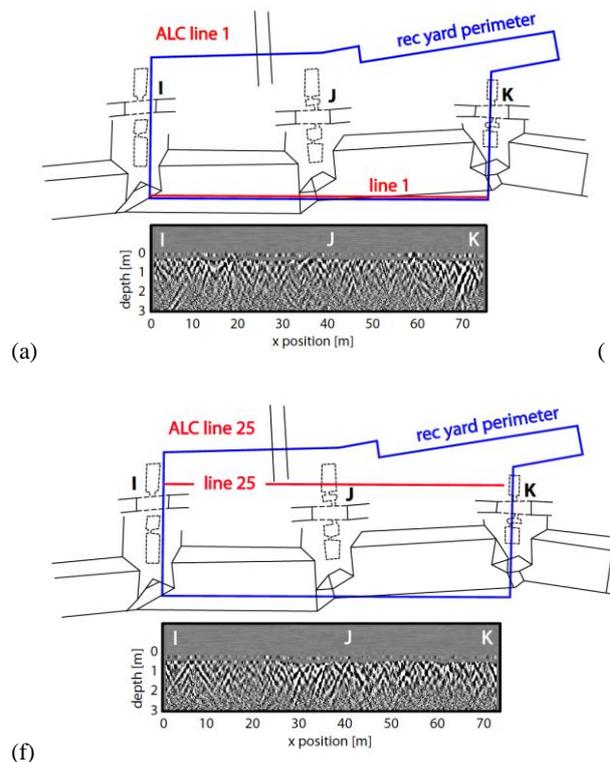
The processed GPR data from selected lines acquired during Phase 1 are shown in Figures a & f. For comparison, we also show the location of each profile with respect to the present-day rec yard perimeter walls, in addition to the locations of the historic earthen fortifications, namely traverses I, J, and K.

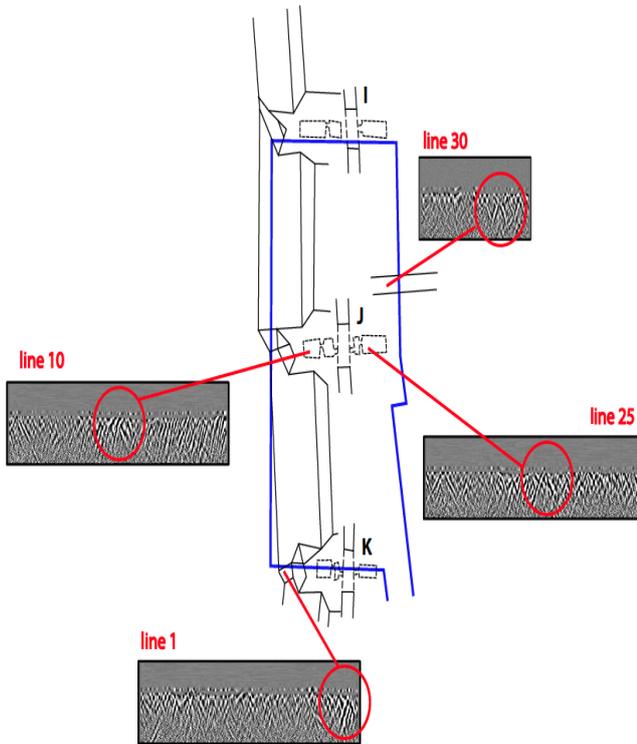
Figure 10. GPR signatures of putative historic structures, from the Phase-1 data acquisition.

In Figure 10, from the Phase-1 and Phase-2 acquisitions respectively, are shown some of the correlations between features observed in the GPR sections and locations of the putative buried historic fortifications.

A GPR survey using 200 MHz antennas, with ~3.0 depth of penetration and ~0.1 m lateral and vertical resolution, was conducted over a 5-day period in June 2012 at the rec yard at Alcatraz in order to image buried civil war-era earthen fortifications. A total of 33 profiles were acquired along the entire length of the yard and a further 11 profiles were acquired across the width. Elementary data processing steps included the application of standard filters and a gain function. The processed GPR sections show good correlations between radar reflection events and the locations of the buried fortification structures derived from historical map analysis. A 3-D data cube was constructed and two of the cut-away perspective views show that traverse K, in particular, has a strong radar signature.

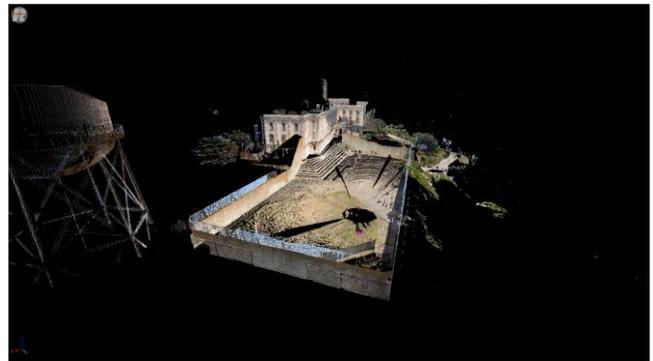
Figure 11. Recreation Yard Scan

Scans were accomplished with a Riegl z390 scanner with a Nikon D200 camera. Scans in the recreation yard were registered with other scans in the yard and around the island through control points located with a total station. Students created the survey network and performed both the scanning and the total station work. One of our goals is to use these scans as foundations for other information. (Figure 11)

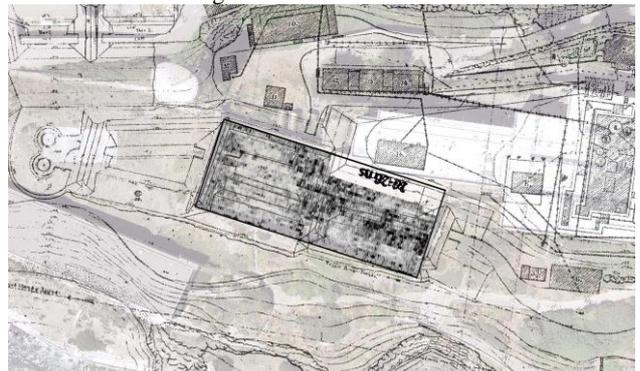
Figure 12. Combined GPR Historical Data and Scan

By taking the information from the scan and aerial photographs and combining that with the GPR time slices and historical maps we begin to get a layered image of the relationship of different datasets. Figure 12

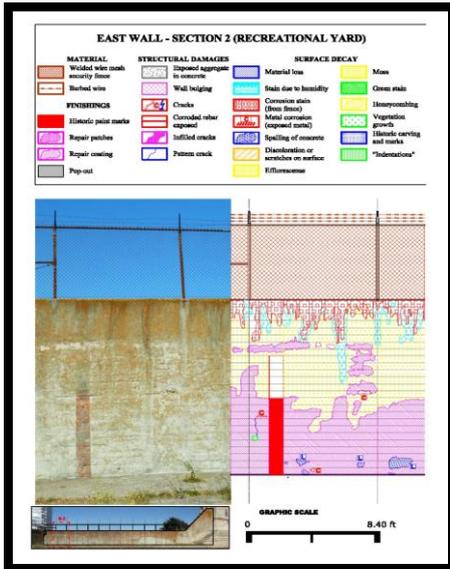
Figure 13. Wall Damage Map

The walls were studied through photography and on site visual analysis. Photographs were taken of short sections of the wall and analysed for various kinds of wear. These photographs were inserted into AutoCad and coded for a visual explanation of the wall's condition. Later these image condition maps were registered with the scans to produce a 3D condition model of the walls. (Figure13.)

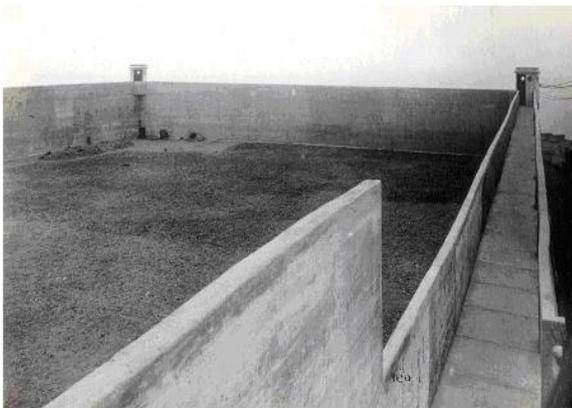
Figure 14. Recreation Yard Walls

The catwalks were constructed along with the wall in 1912 to serve as a way to safely watch the prisoners in the recreation yard. Guard towers were placed on the northwest, northeast, and southwest corners of the recreation yard. (Figure 14) From these locations, a guard would have views of the entire recreation yard to watch the prisoners. Chain-link fencing was added around 1943 to provide further security. (Figure 15)

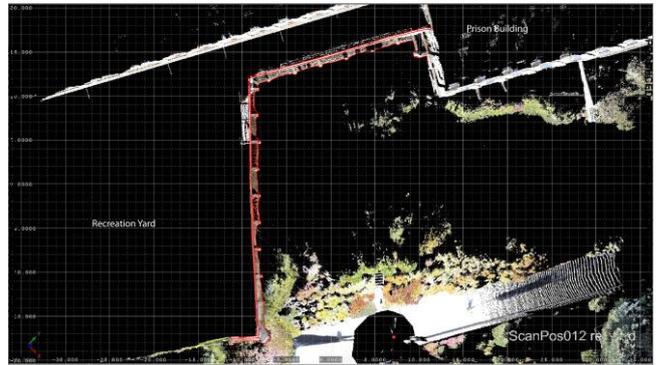
Figure 16. Catwalk scan and drawings

Over the past 40 years, the condition of the catwalks has degraded significantly. The harsh climate has caused many problems with the concrete and the rebar within the concrete.

Figure 16 shows documentation of the decay. A Combination of laser scanning and photogrammetry was used in conjunction with Autocad to demonstrate not only the qualitative but also the quantitative decay of these elements.
