RESEARCH ON THE PROTECTION OF HAIYAN HALL EARTHEN STEREOBATE RELIC SITE AT YUANMINGYUAN PARK

Lin Yanqiu, Xiao Jinliang, Qin Hai

TSINGHUA HERITAGE INSTITUTION FOR DIGITIZATION,
D004, District No. 41 Shangdi West Road, Haidian, Beijing, China.
linyanyqiu@thid.cn, xiaojinliang@thid.cn, qinhai@thid.cn.

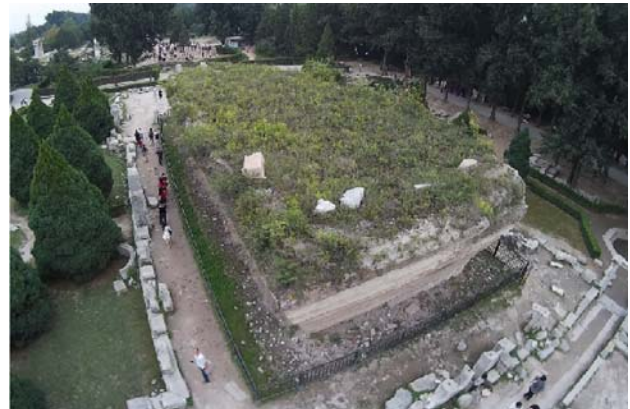
Figure 2. The present situation of the earthen relic site

Now, Haiyan Hall relic site only left some stone parts and one earthen stereobate, which is the largest building structure in the remnants of Yuanmingyuan Park. Having been suffering from severe stress from itself, natural and man-made destruction, it calls for human intervention to achieve the protection purpose. Nevertheless, in the face of such a relic, instead of simply resorting to conventional techniques, we should not only look into its past, but also apply modern scientific and technological means in protection programs.

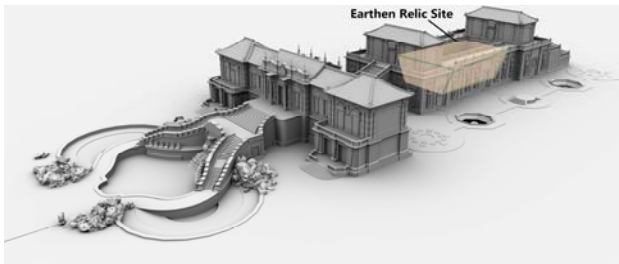
Figure 3. The Restored Map of Haiyan Hall

Based on the pictures of each period and available drawing files, copperplate etchings and literatures, and combined with the actual measurement of the site by 3D laser scanning technology, it can be inferred that the Haiyan Hall and its attached landscape covers an area of about 8,100 m². From west to east, it is composed of the main building, corridor, West Water Carriage House, Xi Sea, East Water Carriage House, and Eastern Steps. The overall architectural style is baroque while the detail sections is merged with traditional Chinese elements and Chinese-style hip roof is pervasive in the building. The appearance of the western and eastern ends of the H-shaped Water Storage Building presents as a two-tiered Water Carriage House and the middle platform a reservoir, commonly known as Xi Sea. The current earthen relic site is at the bottom of the

Xi Sea. The preliminary archaeological study proves that it shall be the bedding part of the sea.

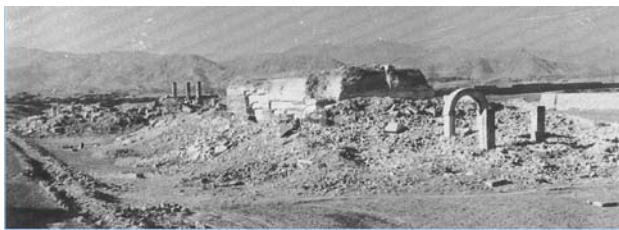
Figure 4. Exposed site of rammed earth station after the block collapse at 1940s

It is obvious that the now earthen relic site is only a small part of Haiyan Hall. Seen from sea historical photos, the surroundings of the earthen relic site were originally enclosed by packaged bricks which were dismantled by people gradually, causing the special form that the outward extending rammed earth in the upper part had no vertical retainer. The two north-south arched gates at the western and eastern ends of the first floor of the Water Storage Building are true doorways while the other arched gates and windows are blank, whose inner parts are enveloped by bricks. For the external walls, the arched structure, gate post, pilaster plinth, and window arched stone are stone components while the other parts like pilasters and filler walls between pilasters are built with bricks and plastered surface.

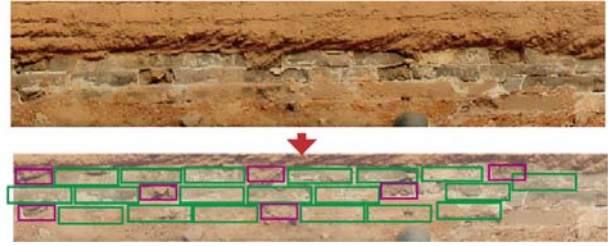
Figure 6. The stretch map for construction with bricks

The earthen stereobate was built simultaneously with the external enclosed bricks in a hierarchical way, namely constructing a length of bricks while punning a layer of soil. The wall body used the same type of bricks with the size of 420*210*85mm and was built in the form of alternating three stretchers with one header.

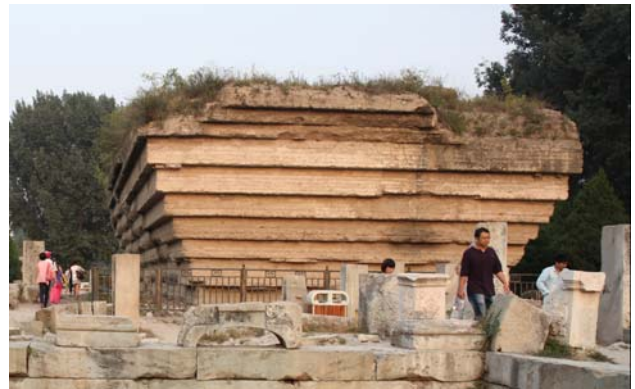
The external appearance of the earthen stereobate looks like an inverted tetrahedral pyramid. The residual is about 6.3 m high and the length of the top is 27 m. Nine layers can be obviously seen from the outside with dense soil texture, presenting the formal feature of building with layers of rammed earth. The lines on bricks and even blue bricks coated on the earthen relic site can be clearly observed from the root and the parts of the site. There are a large number of long horizontal and vertical cracks on the body and lush plants growing at the top of the earthen stereobate.

Figure 7 The present situation of the earthen relic site

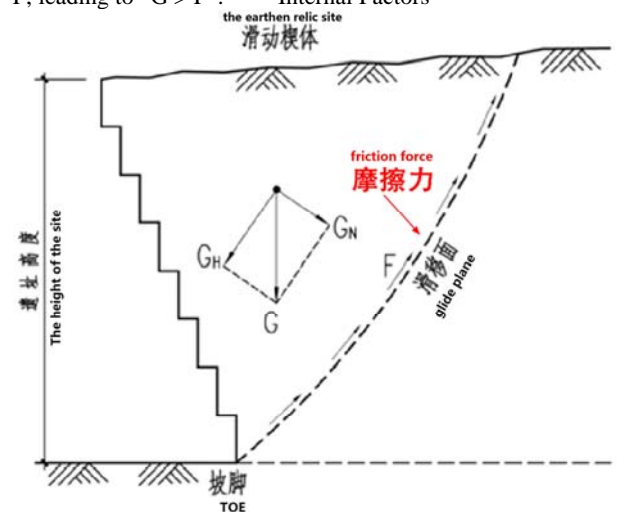
In the checking calculation of the structural safety analysis

The gravity of the sliding wedge (G) > the force of friction of slip surface (F)

- (1) Additional load at the top will increase the value of G , causing $G > F$; ——External Disturbance
- (2) In raining and snowing days, the soil water content will go up, reducing the soil shear strength, namely the diminution of F , leading to “ $G > F$ ”; ——Natural factors
- (3) Fracture extension breaks the internal balance of soil, causing the reduction of the shear strength, namely the diminution of F , leading to “ $G > F$ ”; ——Internal Factors
- (4) The rammed earth binder (such as egg white etc.) ages over time and the bond strength decreases, namely the diminution of F , leading to “ $G > F$ ”. ——Internal Factors –

Figure 8. The analysis chart of structural stress

According to the analysis of stress field, the risk of slippage and damage exists in all sides of the rammed earth; for the position of four corners, the superimposed effect of stress will cause slippage and damage to corners because of the bidirectional slip plane, which is consistent with the present situation of rammed earth that fissures are concentrated on the corner position. Although, the upper layer of the central section and the entire rammed earth stereobate bear relative small stress and represent slighter surface breakdown, it will also face the risk of slippage over a long period of time owing to the same stress-carrying pattern with the four corners. As diseases aggravate, cracks will continuously extend, causing severe collapse to the rammed earth platform. Therefore, it is imperative to carry out rescue and reinforcement measures to Haiyan Hall earthen relic site.

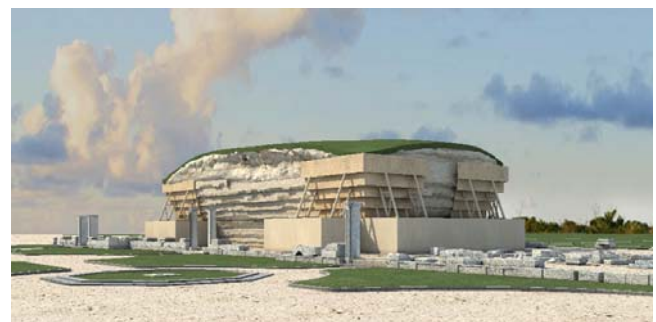
For this, horizontal steel plates are used to enclose the bottom and sides while vertical steel columns (bracing) to support and fix steel plates. At the foot of the steel column, a concrete independent foundation was built, whose own weight will produce frictional force when contact the ground, and form a steady support system. Those three parts constitute an independent stable supporting system.

With this method, the steel structure support component will not exert pressure on the earthen body of the relic site under the condition of no collapse occurring. When it collapses, the steel structure support component will be able to bear the weight of the site itself. Checking calculation shows that the size of the independent foundation plane is 3.0 m * 5.0 m with the height of 1.6 m.

Figure 9. Effect drawing for the holder enforcement method

The characteristics of the soil on this relic site require the single block board has larger contact area against the site to ensure even stress, or the earthen stereobate will be subjected to secondary loading resulting from local stresses. Nevertheless, it is difficult to guarantee average stress between contact surfaces for the irregular shape of the earthen relic site. Steel column support features a large amount of materials and massive work amount which needs, but the foundation directly built on t on the ground will bring negative influence on the landscape of the relic site.

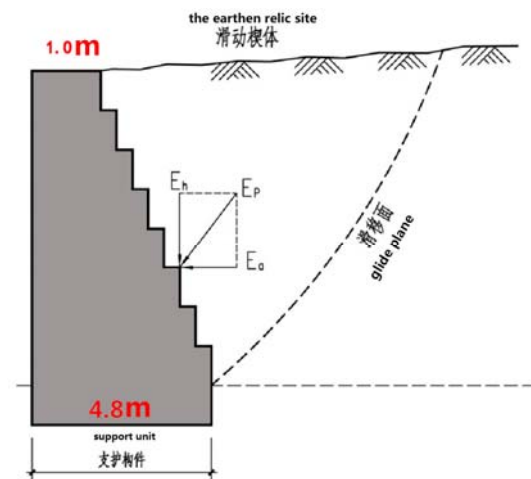
According to the original structure and material of the Water Storage Building, the brick-enclosed method was adopted to first offer support for the four corners, parts bearing weakest stress and most easily going collapse. Fill the reserved space of 20mm between brick-enclosed walls and the earthen relic site with polystyrene or the same soil with that on the relic site.

Figure 10. The analysis chart of structural stress

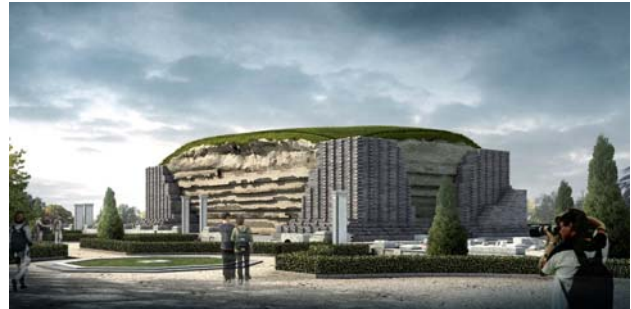
The calculation of the weight of the soil body and side thrust indicates that the height of the brick is 6m; the minimum thickness of enclosed bricks at the top is 1m and that of the bottom is 4.850m; the self-load weight of the brick setting protection walls is around 120kN/m² and the total load of the bottom wall is of about 351kN/m; the position of the newly-built foundation is identical with that of the brick-enclosed structure in history and the quantity and the load capacity of enclosed bricks are quite larger than in history, so it can be sure that the newly-built protection walls exhibit favorable basic load capacity.

Stocky as the brick-enclosed body is, a single building block is small, making it combine with the earthen relic site flexibly and obtain even stress. It can increase or decrease the range of brick enclosed support according to changes of the relic site. As for style, enclosed bricks can be fully distinguished with the relic site, but maintain the supporting method in history, greatly enhancing the readability of the earthen relic site.

Figure 11. Effect drawing for the brick-enclosed reinforcement method

Judged from the residual brickwork on site, it can be inferred that the masonry material is baked bricks in cinerous. Pointing uses the white lime. Report on specific compositions has been completed. According to the actual measurement on residual building blocks, the size of a full block is 420 mm long, 210 mm wide, and 85 mm high and the width of the pointing is 8-10 mm. The existing relations between the residual brick blocks on the earthen stereobate contributes to the preliminary judgment that there was no isolation layer between them, but it is uncertain whether other bonding or water proof coatings had been used on the surface of brick blocks in masonry process and calls for further experimental analysis in the process of archaeology. The base at the south of the stereobate reserves relatively neat building blocks. It can be seen from the present situation that the method of brick masonry is alternating three stretchers with one header, constructing with staggered joints.
