SYSTEMS BASED ON PHOTOGRAMMETRY TO EVALUATION OF BUILT HERITAGE: TENTATIVE GUIDELINES AND CONTROL PARAMETERS

J. Valença ^{a,*}

Commission V, Working Group V/2

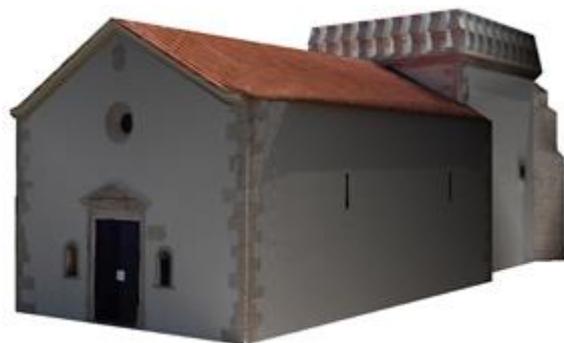
Figure 1. Chapel of S. Jorge of Aljubarrota (3D image-based rendering model).

In this section, photogrammetric projects of two constructions have been selected to analyse: Chapel of S. Jorge of Aljubarrota (Fig. 1) and the Stone Bridge of Vila Fria (Fig.2), in Portugal. In both cases, a multistation approach was applied (Valença et al., 2006) and the geometric model obtained was used to build the numerical model for structural analysis. The equipment and condition of the photographic survey is shown in Table 3. In these cases, the major part of the points used were natural targets and just 24 and 48 photogrammetric targets were used in the Chapel of S. Jorge of Aljubarrota and in Stone Bridge of Vila Fria, respectively.

The Chapel present a rectangular nave with circa 12.3 m and 7.8 m, and an articulated quadrangular body, measure between 5.9 m and 6.7 m aside. The photogrammetric survey of the Chapel of S. Jorge de Aljubarrota was used to produce 3D models both in DXF format and image-based rendering. The surrounding area had no significant restrictions to the photogrammetric survey. The points used reach a RMS precision of 1.15 pixel. However, the photogrammetric survey proved to be reliable since average difference of 0.35% were achieved when comparing with a topographic survey, the traditional technique commonly used (Fig.4). A structural analysis was performed using the Finite Elements Method.

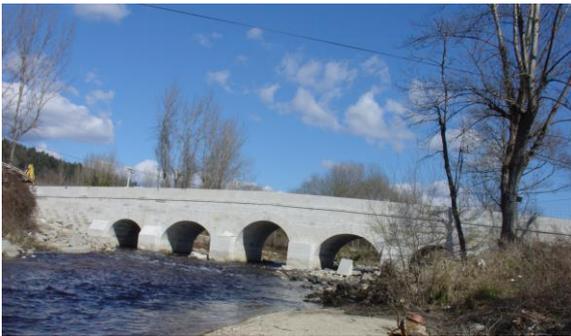
Figure 2. Stone Bridge of Vila Fria

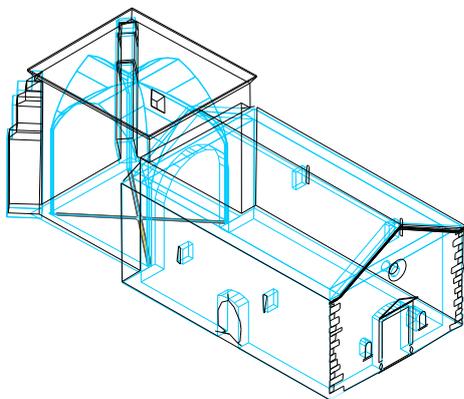
Figure 4. Overlapping 3D models generated by photogrammetry and topography of Chapel of S. Jorge

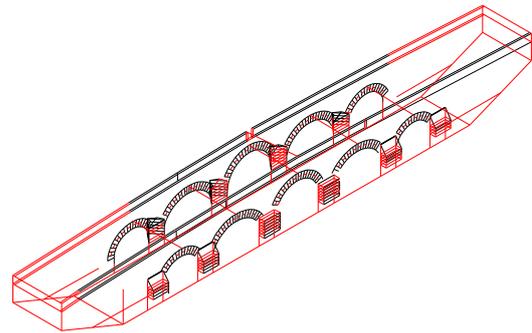
Figure 5. 3D geometric models of the Stone Bridge of Vila Fria

The procedure followed in the Stone bridge of Vila Fria consisted of producing individual projects for each arc, and then assembling the individual projects into a global project. The 800 points used reach a RMS precision of 1.26 pixel. The comparison with the project plans results in average differences of 1.7% and 1.2% for the radius and spans of the arches, respectively. The total span of the bridge shows a variation of 0.7% (Fig.5). The values decrease to 0.14% in the 48 precision targets. A consequent structural analysis, carried out using the Discrete Elements Method, showed that photogrammetry models lead to safer estimates of the failure load, due to the

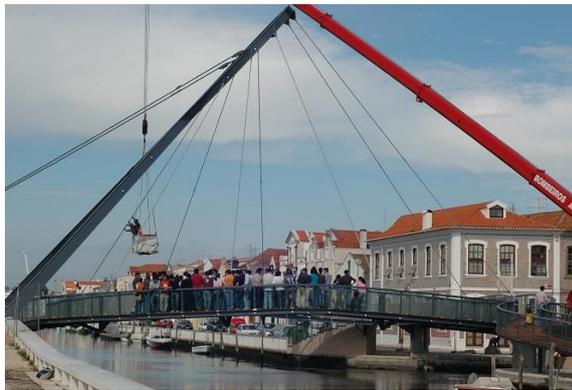
Figure 7. Footbridge in Aveiro's estuary

Photogrammetry was applied to measure vertical displacements in two bridges during load tests: a Steel Footbridge linking the sides of São Roque and Botirões channels in Aveiro's estuary (Fig.7) and an Iron Bridge in Praia do Ribatejo, over Tejo river (Fig.8), both in Portugal. The equipment and condition of the photographic survey is shown Table 6.

The deck of the Footbridge in Aveiro presents an unusual circular configuration in plan with a radius of approximately 13 m, made of a 2 m wide wooden floor supported by a steel structure composed of 55 modules (1.5 m each) consisting in a grid made of longitudinal, radial and diagonal steel profiles. Before the inauguration, the structural behaviour of the bridge had to be assessed. In this case, static and dynamic tests were performed. After discarding the traditional monitoring, due to the difficulty of implementing, it was decided to use photogrammetry to measure the displacement of the bridge subjected to static load tests (Valença et al., 2012). For that purpose, a total of 83 targets were glued to external steel beam that supports the wooden deck. Three photogrammetric projects were analysed: (i) before loading; (ii) with the bridge loaded; and (iii) after unloading. The orientation and the scale of the projects were determined using static points (RMS precision of 0.48 pixels), with known coordinates, placed in the abutments. The photogrammetric projects achieved a RMS precision of 3.07 mm for vertical displacements. Since is not possible to evaluate the relative accuracy, and the test was conducted under materials elastic stage, the target position before loading and after unloading was compared: 3.1 mm, in SE side; 2.7 mm, in SW side; and 1.8 mm, in NE side, on average. These values can be assumed as the experimental precision and are all equal or

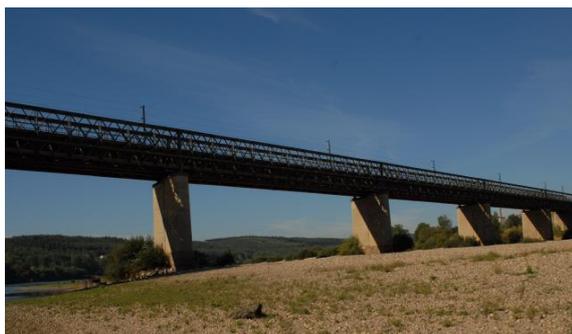
Figure 8. Bridge in Praia do Ribatejo, over Tejo river

The Iron Bridge in Praia do Ribatejo has a length of 501.5 m, in a total of 8 spans. The supports and columns, in limestone, making an angle of approximately 60° with the axis of the bridge. The bridge has two plan principal trusts with 6.0 m height, organized in modules with 5.0 m long in the spans and 2.5 m on the supports. In this case, the characterization of the structural behaviour of the bridge, aiming to assess the need for consolidation and/ or strengthening, was required. In this scope, the experimental displacements during static load test were achieved by photogrammetry (Júlio et al., 2011). Photogrammetry was applied to measure vertical displacement in the sixth, seventh and eighth spans (from the left margin). Eight of the 17 targets placed where also monitoring with a total station Leica TS02 (precision of 5 mm) to compare the results. The photogrammetric projects achieved a RMS precision of 2.0 mm. The difference for the total station were, on average, 1.6 mm, which represents 15% of the displacement measures, which is lower than the precision of any of the methods used. This fact ensures the reliability of the results.

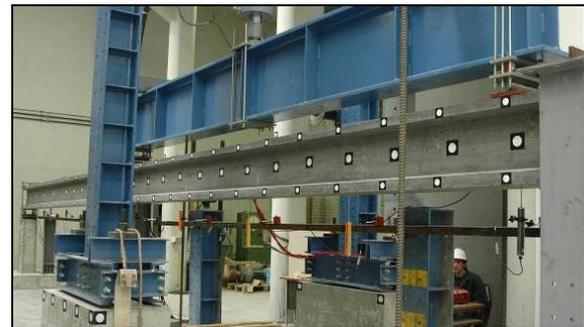
Figure 9. Long span HSC beams

Two High Strength Reinforced Concrete (HSC) beams with 20 m span and an I cross-section with a width of 0.30 m and a height of 0.50 m were tested and monitoring with photogrammetry (Valença et al., 2012). One of the beams is

monotonically tested until failure and the remaining one were subjected to a permanent load to study their time-dependent behaviour, mainly due to creep (Fig.10). A multistation approach was applied and photogrammetric surveying was performed at three and six stages in creep and failure test, respectively. The coordinates of the ~140 targets per stages were evaluated with a RMS precision (image plan) of 0.14 mm in both test. The tests were also monitored with five and nine Linear Variable Differential Transducers (LVDTs) in creep and failure test, respectively. These sections were considered control points and were used to estimate the relative accuracy of the methods. The standard deviation and the average difference between photogrammetric and LVDTs results were 2.00 mm and 2.19 mm, respectively. In percentage, this corresponds to an average difference of 1.0%.

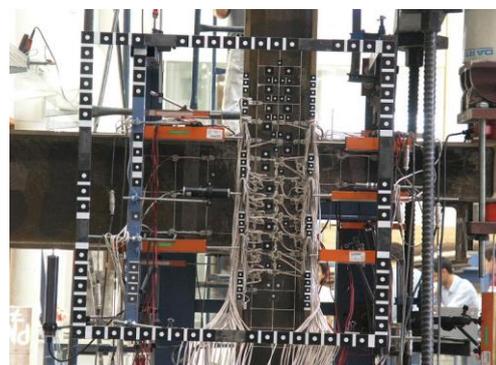
Figure 10. Steel connection

Two 'strong beam/ column/ weak beam' steel connections were tested and the displacements measure by photogrammetry (Fig.10). The methodology used consisted in framing the steel connection, considering 60 static targets used as ground constraints and control points, and monitoring over 70 movable targets glued to the flanges and to the web of the column (Valença et al., 2012). The multistation photogrammetric surveying was performed at 5 distinct stages and using 6 convergent images per stage, in a total of 1450 point evaluated. An RMS residual error of 0.12 pixels was reached in the image plan, corresponding to 0.02 mm. The experimental precision in the image plan, i.e the displacements of the static points that frame the steel connection, was 0.04 mm, twice the theoretical precision.

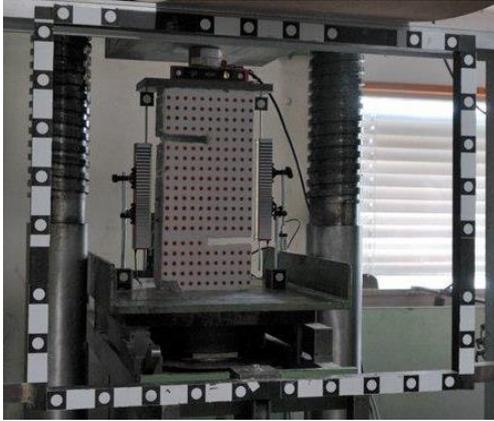
Figure 11. Push off test

A set of push-off specimens of reinforced concrete were tested until failure. The push-off specimens are anti-symmetrical and composed by two identical 'L' shape halves with prismatic envelope of $254 \times 546 \times 127 \text{ mm}^3$. Photogrammetric procedure, using, multistation approach,, was applied to obtain the

displacement field during the test (Dias-da-Costa et al., 2011). The surveying was performed at six distinct stages and using 6 convergent image per stage (Fig.11). A total of 1356 points were evaluated. The photogrammetric projects achieved a RMS precision of 0.33 mm in the image plan. The experimental value obtained with the static points was 0.05 mm, completely within the theoretical precision achieved.

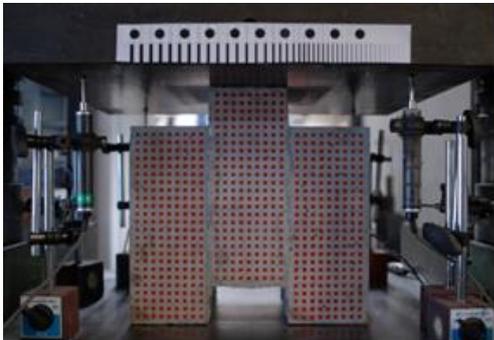
Figure 12. Direct Shear Test specimen

The Direct Shear Test (DST) was performed in specimens with three concrete layers, each with $100 \times 250 \times 200 \text{ mm}^3$. The middle layer was cast with a 50 mm gap at the bottom (Fig. 12). A grid of 649 targets was painted in the surface of the specimen. A total of 6490 points were detected with an experimental precision of 0.12 pixel, corresponding to a precision of 0.03 mm.

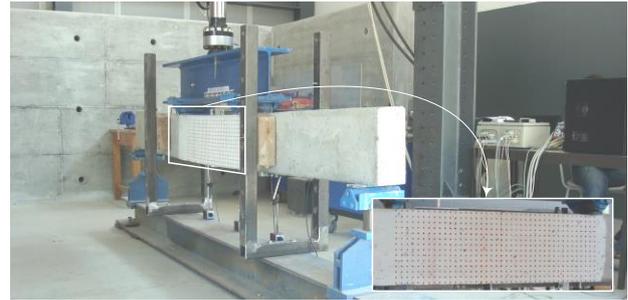
Figure 13. LWRC beam

A lightweight reinforced concrete (LWRC) beam, 3.0 m long and with a rectangular cross-section of $0.12 \times 0.27 \text{ m}^2$ was tested until complete failure (Fig.13). A grid of 560 targets was painted in the surface of the specimen. A total of 5600 targets were detected with an experimental precision of 0.15 pixel, corresponding to a precision of 0.04 mm. The vertical displacement measure with LVDTs (placed in the opposite surface of the beam) reach an average differences of circa 1 mm, corresponding to 2% of the values measured.

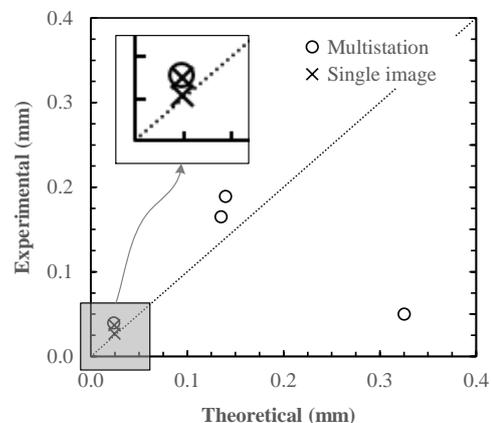
Figure 15. Theoretical vs. experimental precision in experimental tests.

The ration between the experimental precision and the theoretical precision, computed for the last four tests was represented in Figure 15. The values obtained allows to conclude that the experimental precision measure obtained was similar to the theoretical values. The exception was the ration achieved in the push-off tests, where the experimental result is better than the theoretical. This fact allows a high confidence in the experimental results. Furthermore, all the four tests reach an experimental precision lower than 0.2 mm, and 0.05 mm excluding the HSC long span beams tests.

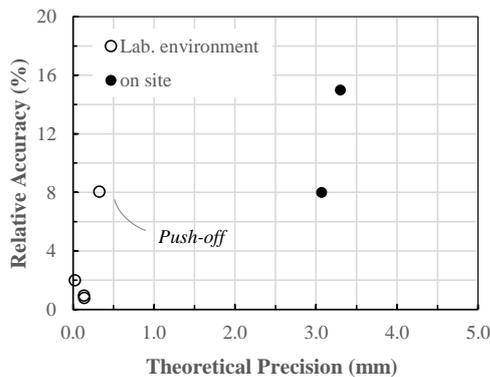
Figure 16. Theoretical precision (mm) vs. relative accuracy (%).

The displacement were always obtained by the coordinate differences between the stages evaluated. The ration between the theoretical precision (Eq.(1)) and the relative accuracy for all the cases studies discussed in Section 4.2 is represented in Figure 16. In general, the higher precise results on higher percentage of displacement accuracy. Once again, the results of the push-off test does not follow the trend of the results of other tests (the borderline value on Lab. Environment series in Fig.16). However, this trend does not occur when comparing the theoretical precision with the absolute value (Fig.17)

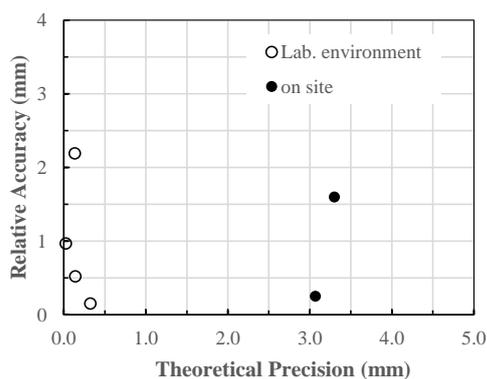
Figure 17. Theoretical precision vs. relative accuracy (in mm).
