## USE OF IMAGE BASED MODELLING FOR DOCUMENTATION OF INTRICATELY SHAPED OBJECTS

**KEY WORDS:** Image Based Modelling, Timber Roof Truss, Spiral Staircase, Historical Furniture, Folk Costume.

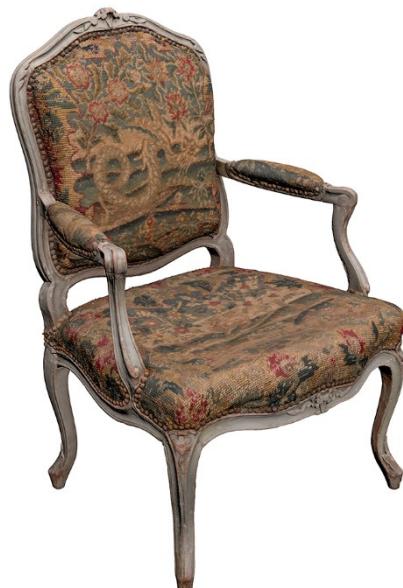
Figure 1. A historic chair with arm rests - 3D model.

Scanned objects were 7 pieces of rococo originals from around 1760 found in state collections/repositories in Austria and Hungary (2 desks, 1 sofa, 2 chairs, 1 stool + 2 marble desktops), (Figure 1, 2). Some objects were heavily golden plated and all were in a pre-renovation state (some chairs without upholstery). All had to be scanned on site in a regulated environment and in a limited time window.

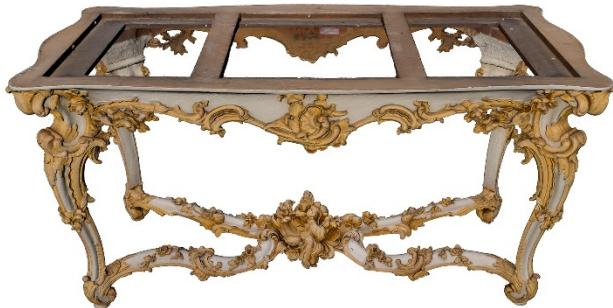
Figure 2. 3D model of the original rococo desk.

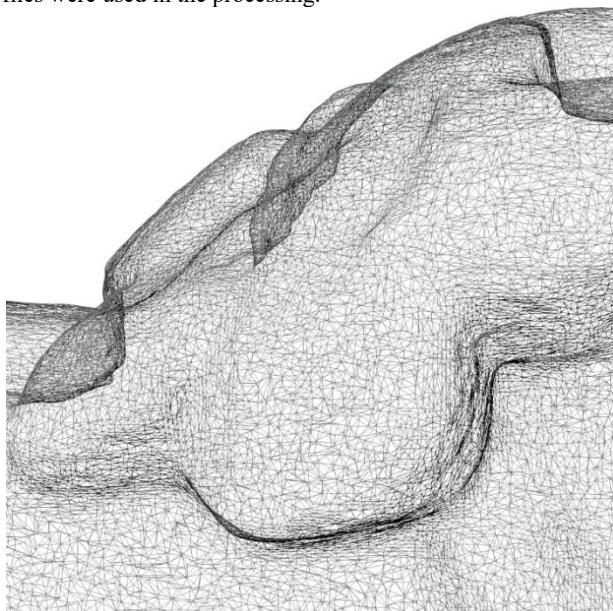
Figure 3. A 3D model of a rococo detail of the wooden chair frame.

The resulting 3D models were calculated with an average surface resolution (GSD) of 0.3 mm (Figure 3) while the resulting spatial accuracy was ~0.5 mm.

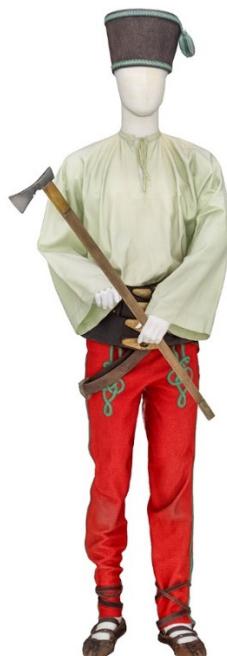
Figure 4. 3D model of a folk costume (2 models merged)

A historic (archival) theatre male costume (Figure 4) was selected for scanning as a special recognition of the actor and popularity of the play it was used in. The final 3D model was to be used for public presentation purposes of the owner (Slovak National Theatre, Bratislava, Slovakia). Since a single camera sequential scanning was to be used, the project proved to be challenging given the particular setup and costume manipulation limitations. The final 3D model had to be as close to a model of a dressed person as possible.

The final model was digitally assembled from two separate models (body and the axe). It fully met the object owner's expectations and the project served as a benchmark and test example for further similar non-solid theatre stage object modelling.

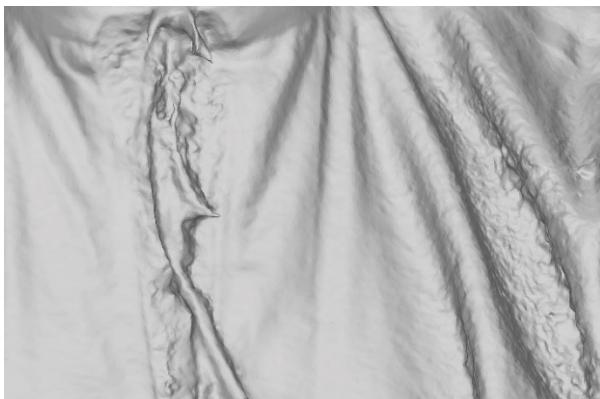
Figure 5. Detail of costume 3D model where details (laces, cloth folds) proved to be problematic due to lack of spatial separation and difficult accessibility.

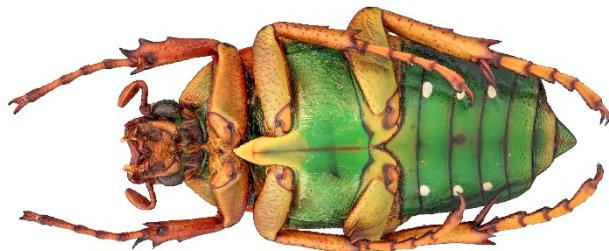
Figure 6. Textured 3D model of the Spotted Flower Beetle.

The specimen of Spotted Flower Beetle (*Stephanorrhina guttata*, Figure 6) was mounted on a special holder of electronically controlled rotating head.

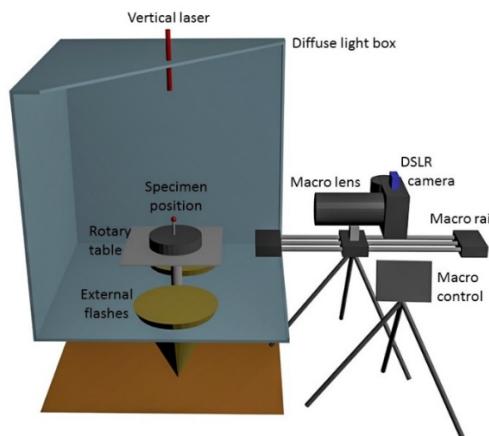
Figure 7. Schema of the macro scanning bench setup.

Camera was then placed on a separate electronically tethered bench that was to provide change of focus plane without having to refocus using the lens electronic system (Figure 7).

The number of stack shots was calculated based on the total depth of field to be covered and the effective optical depth of a single shot. The theoretical figure was then verified and confronted in a series of trials as the geometric configuration of the particular shooting position (object against the lens optical axis) plays a major role in getting the two subsequent shots without any blur inbetween.

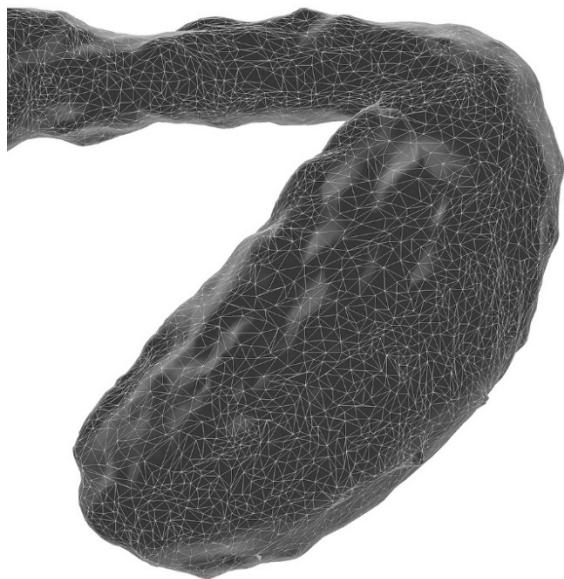
Figure 8. Detail of antenna of the 3D insect model illustrating the level of detail attained (~ 0.04 mm).

After some fine tuning of the scanning process, the level of clear detail reached was 0.1 mm with finest discernible details going down to around 0.04 mm. This in turn allowed a rather detailed morphology study of separate insect organs (Figure 8).

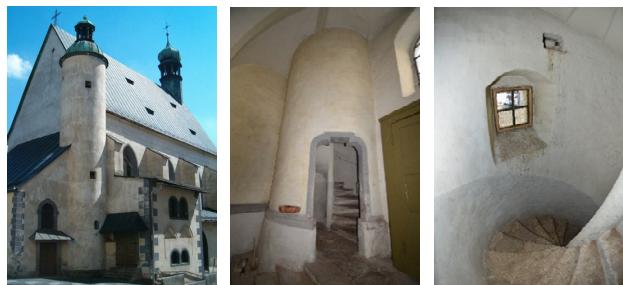
Figure 9. Exterior scene of staircase, entry and interior (from left to right)

A planned reconstruction of given staircase was the leading reason for its metric documentation. Staircase (Figure 9) is located on the north side of the Saint Catherine church (15<sup>th</sup> century) in Banská Štiavnica, Slovakia, a town on the UNESCO World heritage sites list. The staircase provides access to the chorus and the loft of the church and a little bell is located on top in the loft of the staircase. The stair tower is of about 20 m height and has 50 steps in 3.5 turns. The height of a single step is 25 cm. The limited width of the staircase (1 m) is a major obstacle for laser scanning application. The surface of the walls and ceiling has rather flat and featureless texture of a white plaster while the steps are carved in tuff and andesite material rendering an ideal surface texture for image scanning.

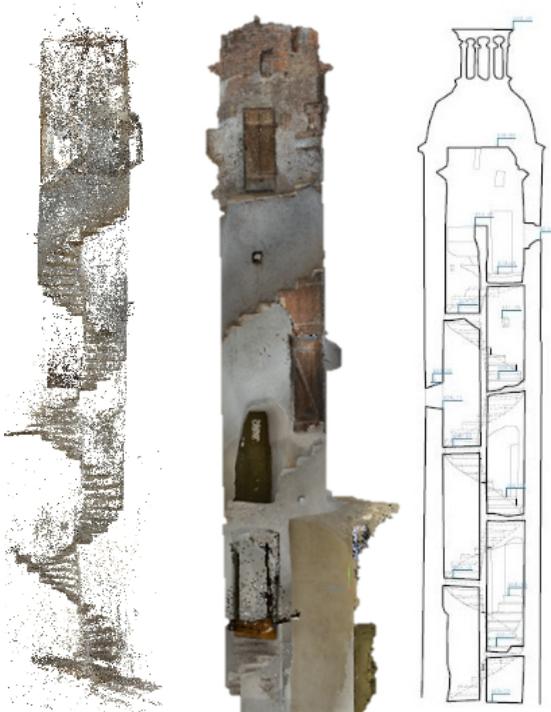
Figure 10. From left to right: Tie point cloud (PS sw), dense cloud (RC sw) and 2D draw of vertical model section

The mesh 3D model generated from point cloud provided suitable base for required 2D metric drawing/documentation (Figure 10, 11). The control points residuals (located at the top and bottom of the staircase only) didn't exceed 10 mm. As a consequence of the object geometry and texture, this example presents a viable and efficient combination of both technologies - image based modelling and laser scanning.

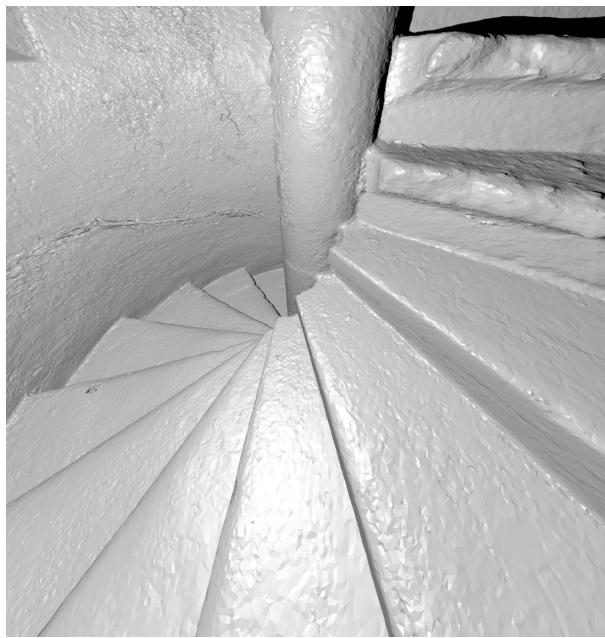
Figure 11. Rendered model of the staircase interior

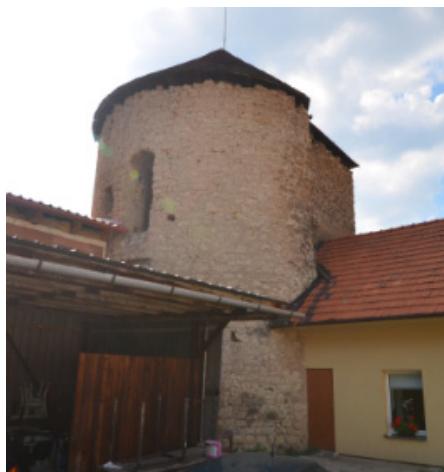
The bastion (Figure 12) is one of the oldest objects in the town, it was built around the 15<sup>th</sup> century and is a National heritage site (cultural monument). In the past 100 years it was rarely used, so an idea to reconstruct the object and create an ecclesiastical museum in it was developed.

Figure 12. Hussite bastion, exterior view

The image based modelling was used to document the entire object with its 3 floors, exterior walls and wooden roof. The imagery of the truss was taken with two cameras - a medium-format PhaseOne 645D camera with a Leaf Aptus II-7 digital back and a 45 mm 1:2.8 PhaseOne lens and a Nikon D5100 DSLR with Tamron DiII SP 10-24 mm 1:3.5-4.5 lens. The latter was used at a 10 mm focal length to get a sufficient overlap of the truss and interior walls that would then enable the processing of the whole interior in one block. This allowed for the reference coordinate system of the timber truss 3D model to be defined without terrestrially measured control points located directly on its construction. The control points were located on the interior walls and surveyed through windows from the outside using a total station. After the transformation of the entire object into the reference coordinate system, the residuals on these points were under 5 mm.

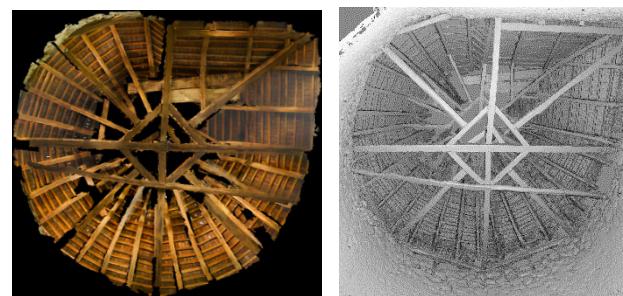
Figure 13. Orthophoto (left) and 3D model of the timber truss (right)

Upper sides of the beams were not digitally reconstructed since the resulting model (Figure 13) was sufficient for vector drawing documentation production. Eventually, it would be possible to cover upper parts too using telescopic tripod able to get the camera higher and between the beams.

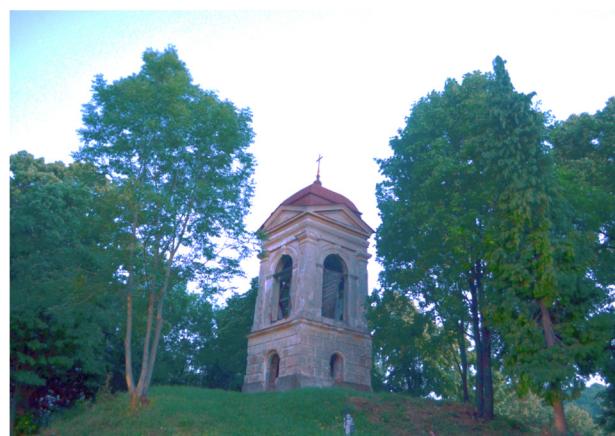
The object is approx. 12 m high tower structure. It contains a partially damaged wooden bell landing similar to the timber truss in its design. A complete set of digital blueprints of the interior and exterior was needed for the reconstruction project.

Figure 14. Belfry on the Bell hill

The location geometry was complicated by many factors: tower's surrounding (steep slope, tall vegetation), the tower's height,

limited interior space (2.8 m), poor light conditions inside and the inner timber structure itself. The tower is surrounded by trees, thus the image recording had to be a rather close range one (ca 2 m). This led to a wide angle lens being used. Camera used was a Nikon D5100 DSLR with a Tamron 10-24 mm lens. A telescopic tripod reaching up to 7 m high was used in the scanning prosecco (Figure 15). Part of the roof was scanned using a drone equipped with a GoPro Hero 4 camera, but using it for outer walls proved to be difficult due to the vegetation obstacles.

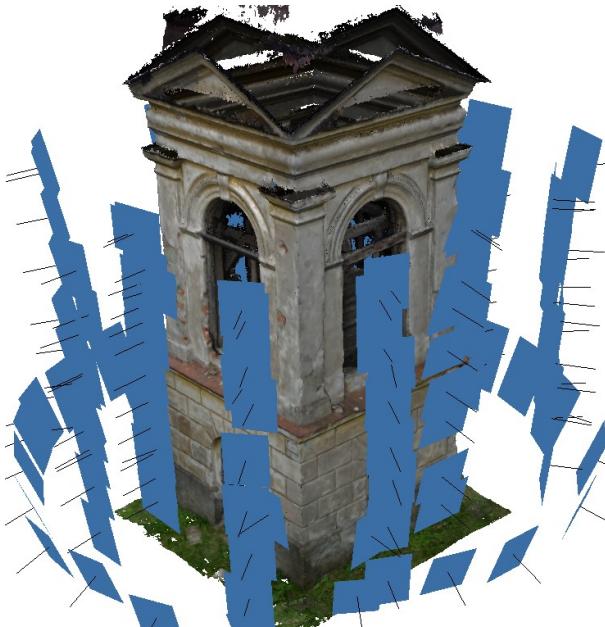
Figure 15. Image configuration using telescopic tripod (PS software)

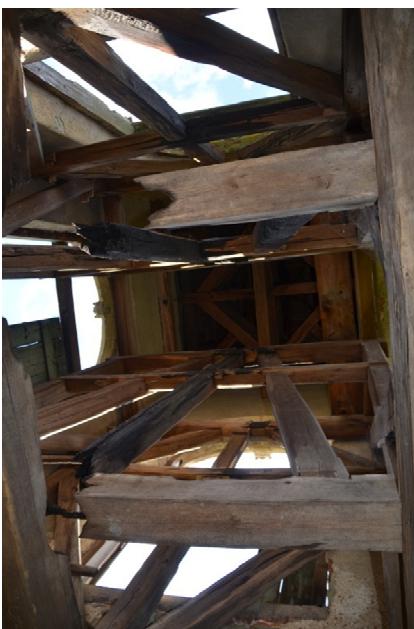
Figure 16. Bottom photo view of wooden bell landing

The interior (Figure 16) scanning was conducted in a way so that all lower interior walls were covered and in overlap with the upper timber structure scans. The same 7 m high-reach tripod was used to reach upper spaces between the beams while keeping the incremental rise intervals constant. The tripod allowed for bottom side of the roof to be scanned too.

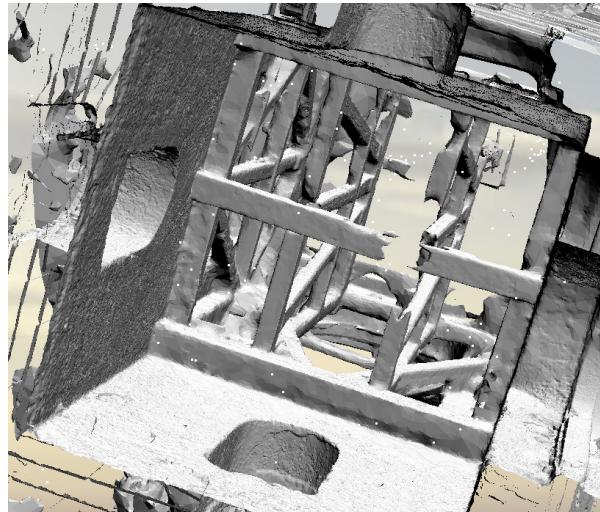
Figure 17. Partially damaged wooden bell landing – 3D model of bell landing (ContextCapture software)

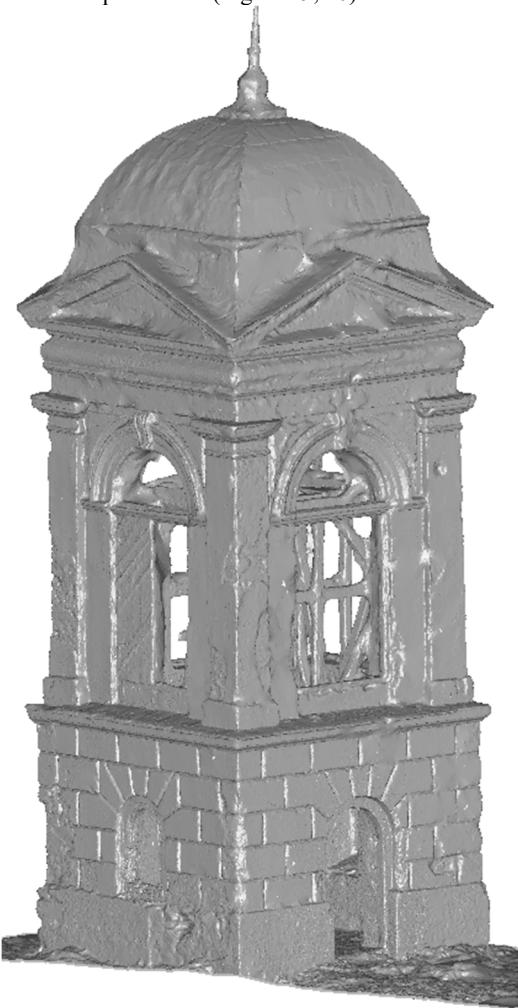
Figure 18. 3D model of belfry

The photogrammetric processing resulted in a 40 M points strong 3D TIN model (Figure 18). The model was georeferenced using control point yielding residuals under 10 mm on check points, which is sufficient given the application. 3D model then served as source for production of various orthophotos and section views that were in turn utilized in a subsequent 2D vector documentation production (Figure 19, 20).

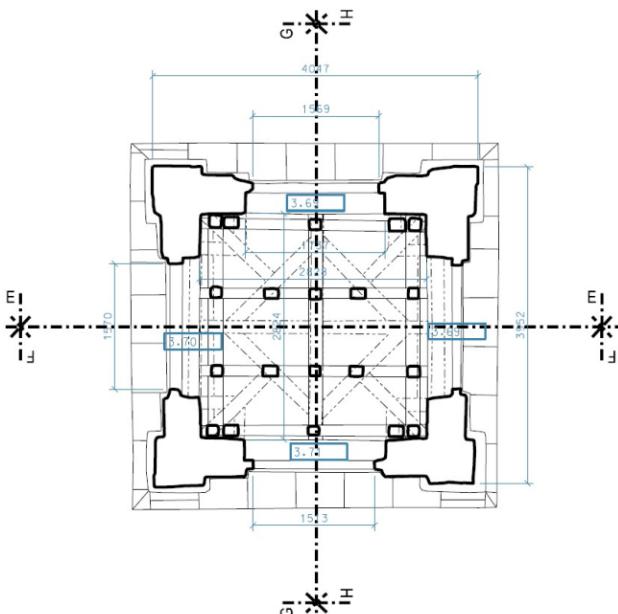
Figure 19. Horizontal section view

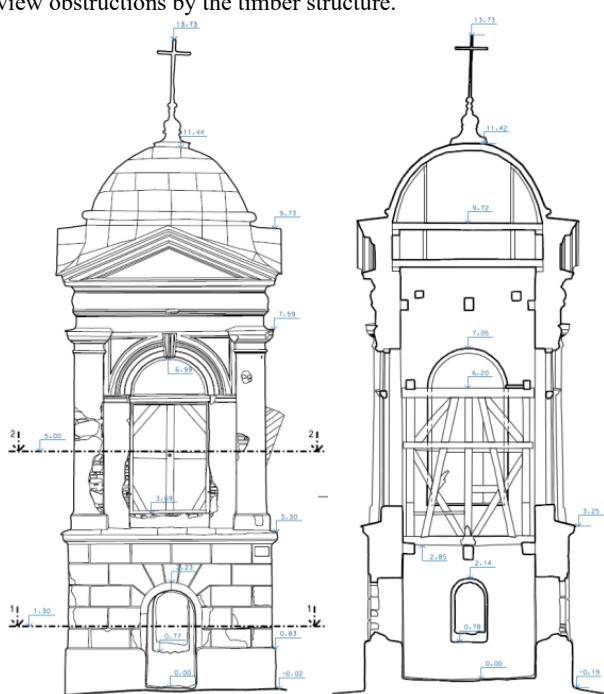
Figure 20. Vector plan of the exterior wall (left) and vertical section view (right)
