ANALYSIS OF JURE LANDSLIDE DAM, SINDHUPALCHOWK USING GIS AND REMOTE SENSING

KEY WORDS: Landslide, Dam, GIS, Remote Sensing, Jure, Nepal

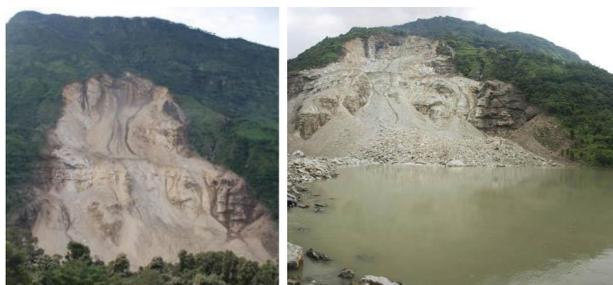
Figure 2. Jure landslide ground view (left) and lake formed by debris (right). (Source: Internet)

On 2nd August 2014, at around 2:36 am, a rainfall-induced massive landslide hit Jure village, Sindhupalchowk killing 156 people. It is located at 27°46'1.55"N latitude and 85°52'17.10"E longitude. The landslide was a typical slope failure with massive rock fragments, sand and soil. It deposited large volume of debris on the Waterway of Sunkoshi River and blocked it. It took nearly 12 hour to fill the lake and overflow the debris dam and, lead to the potential threat of Lake Outburst flood. The lake was released by blasting off part of the landslide blockade and facilitated release of water from the lake.

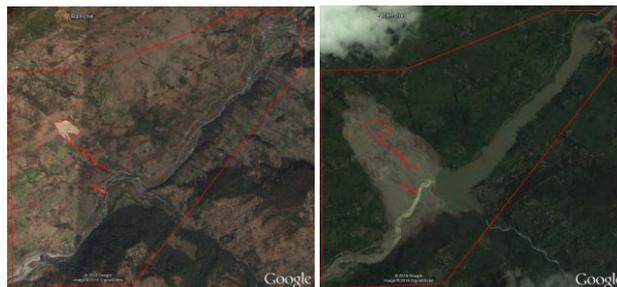
Figure 3. Google Earth view pre landslide acquired on Nov. 10, 2013 (left) and post landslide acquired on August 10, 2014 (right) landslide event with old landslide polygons.

In case of Jure Landslide event, a quick view of past imagery from USGS Landsat archive or Google Earth showed that the site has multiple old landslides and was very vulnerable. Following figure 3 shows the pre and post satellite view of landslide event.

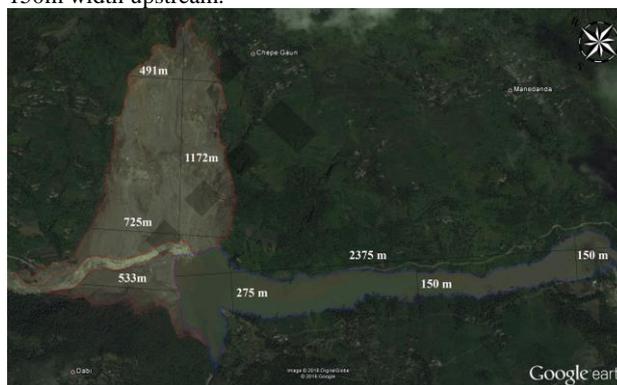
Using high resolution imagery provided in Google Earth all necessary polygons and length measurements were done. Figure 4 shows the measurement done for the disaster. A total of estimated 6 million cubic meters debris fall from 11762m tall and 717,218 m² chunk of hill raised more than 100 m from the water level and affected opposite side of the bank. The width of the top of landslide was around 491m and base 725 m on approximation. Similarly, the deposition on the opposite river bank was 533m wide and area of 130,368 m². The landslide blocked the Sunkoshi River completely forming an estimated 8 million cubic meter lake approximately 3km length and 275-150m width upstream.

Figure 4. Measurements of Landslide characteristics using Google Earth

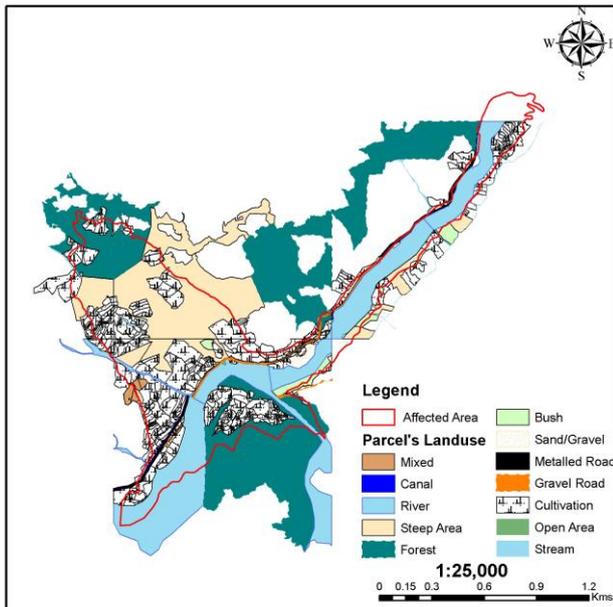
After the extraction of all the characteristics of landslide, the features were overlaid with topographic and cadastral map for the analysis of damage in the area. The lake affected five VDCs namely Kalika, Kadambas, Yamuna Dada, Pulchodanda and Thumpakhar. With available 5 cadastral sheets of the affected area, a total of 631 parcels were affected by the slide or by the lake formed. The landuse map of the affected parcels is shown in Figure 5, of which most affected is cultivable land and steep slopes and forest area.

Figure 5. Landuse map of affected parcels in Jure Landslide
