PRELIMINARY RESULTS OF EARTHQUAKE-INDUCED BUILDING DAMAGE DETECTION WITH OBJECT-BASED IMAGE CLASSIFICATION

KEY WORDS: Ercis-Van Earthquake, Object-Based Image Classification, Building Damage Detection

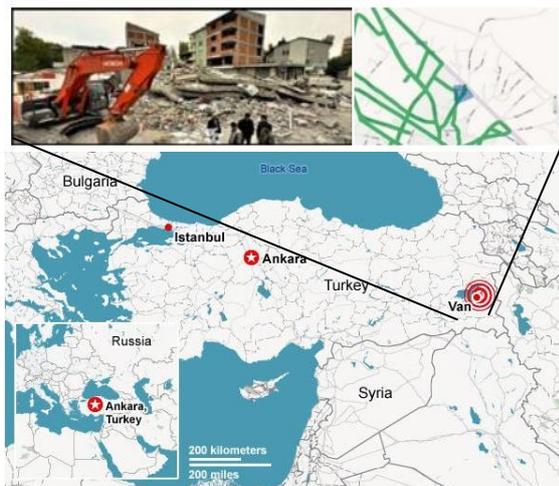
Figure 1: The map of the study area (Van city centre) with the streetview data taken after the earthquake.

The Van-Ercis earthquake occurred on 23 October 2011 at 13:41 local time (10:41 GMT) in the eastern part of Turkey along the city of Van with Mw=7.1 (Figure 1). The epicentre coordinates of the earthquake at 38.75N-43.36E near the Tabanlı village where is northern part of Van city centre (Kalafat, et.al., 2014). It is recorded that 604 people died and approximately 4000 buildings

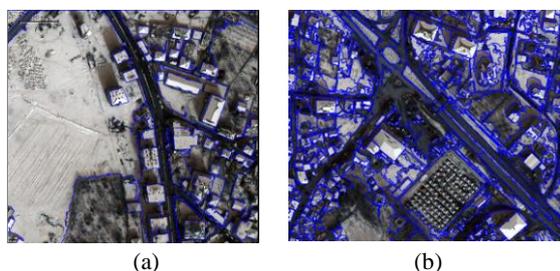
Figure 3: Image segmentation in the (a) homogenous, (b) heterogeneous area.

image segmentation methods, is used in this study (Batz & Schaepe, 2000). The quality of segmentation directly affects the object based classification results. Hence, in the segmentation step, some criteria such as scale, colour shape, smoothness and compactness need to be assigned as accurate as possible. As shown in Figure 3, the segmentation is performed by weighting of all bands equally and by using the parameters given in Table 2.

Criteria				
	scale	colour	shape	smoothness	compactness
Case study area I Homogenous	150	0.3	0.7	0.4	0.6
Case study area II Heterogeneous	80	0.5	0.5	0.1	0.9

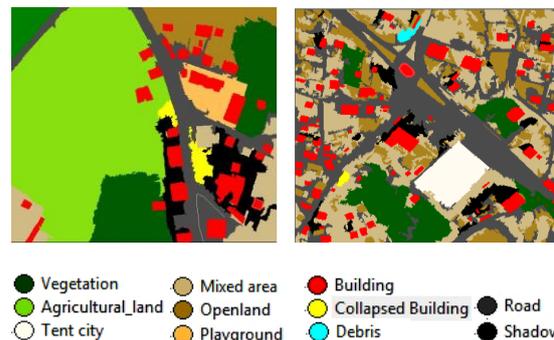
Figure 4: Classification results; Case area 1 (left) and Case area 2 (right).

The results of the land use classification for both case areas are shown in Figure 4.

1. Ercis town consists of different variety of complex urban patterns; therefore the detection of the damaged buildings from satellite images is a complex issue. Besides, irregular sizes of buildings also affect the classification results and lead to misclassification in some parts of the study area.

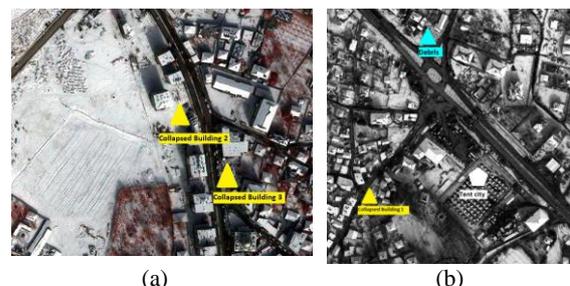
Figure 5: The collapsed buildings, debris area and tent city extracted from the streetview images for (a) Case area 1 and (b) Case area 2.

The collapsed buildings, debris area and tent city extracted from the streetview images for both case study areas are used in the verification of the classified images visually (Figure 5).
