## DIAGNOSIS PROCESSES FOR DESERT ROSE DOMES OF THE SOUF REGION IN ALGERIA

**KEY WORDS:** Souf region, Desert Rose stone, dome, damage, diagnosis, FEM analysis

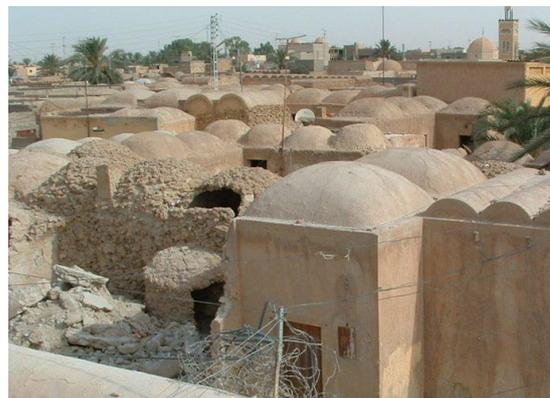
Figure 1. Old center of Guemar, Souf.

In agreement with (Coté, 2006), the amazing, peculiar and unique landscape of the Souf region does not count only in the movement of erg dunes, but also in unexpected human creation. In fact, using local materials, the ancient builders invented a building technique and an urban architecture of great interest, where the dome is the protagonist (Figure.1).

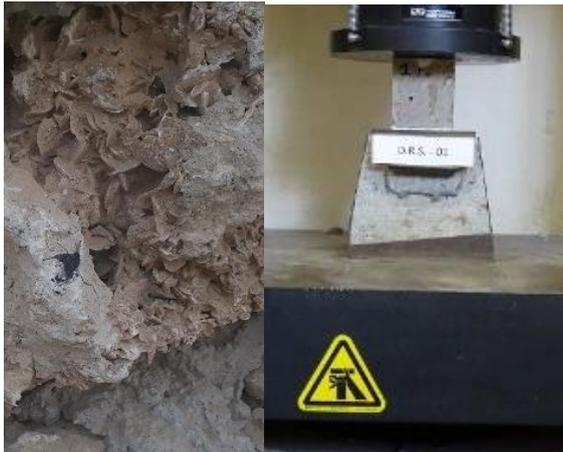
Figure 2.(a) The Desert Rose stone. (b) Compression test on Desert Rose stone sample.

Compression test on Desert Rose stone samples allowed to determine 10 MPa for the compressive strength and 1350 MPa for the Young modulus.

The experimental analysis highlights that the block material is characterized by rather low mechanical characteristics with very dispersed experimental values. These results depend on the very heterogeneous nature of the material which also has a high porosity. The texture of the masonry is very chaotic, being the employed desert rose blocks very irregular. In fact, the blocks are not squared and different sizes of the blocks are used. In figure 3, the really chaotic texture of the walls is represented. For these reasons it is easy to assume that the mechanical characteristics (compressive strength and elastic modulus) of the masonry (blocks and mortar) are much reduced compared to those of the blocks.

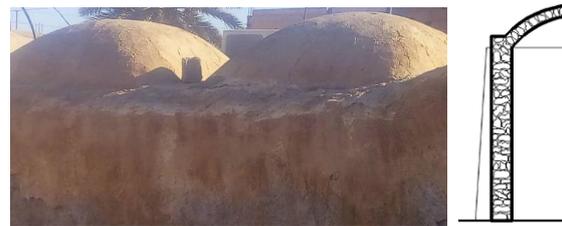
The walls are usually 0.30 m thick, and the domes are about 0.20 m thick (Figure 3). The dome is set at a height between 2 to 2.5 m.

Figure 3. (a) Domes of a building in Guemar. (b) Section of wall and dome.

The construction of the dome is done without formwork, thanks to the use of gypsum-based mortars that quickly set. The execution starts from the square base and grows progressively on the same level carrying out in the corners small mortar squinch. Using the Desert Rose stone blocks and gypsum based mortar, without the use of the formwork, the mason rises the successive courses, one above the other, until the center. The shape of these domes is close to a cloister dome, but the discontinuities in the edges along the diagonal arches is very

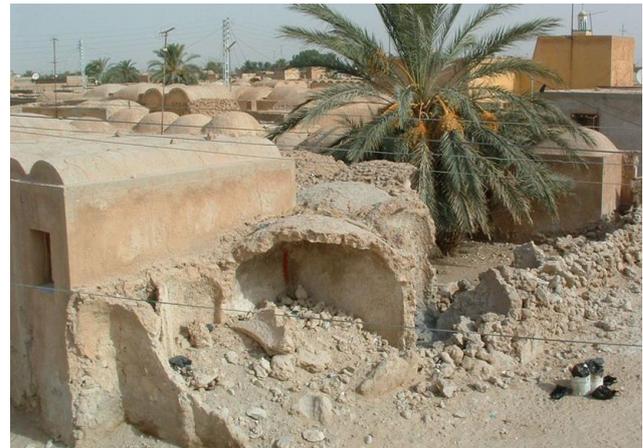
Figure 4. The degradation states of building in the Guemar.

Currently, the degradation state of the architectural heritage of Souf region are very remarkable. Such degradation states are widespread and is characterized by different levels of gravity.

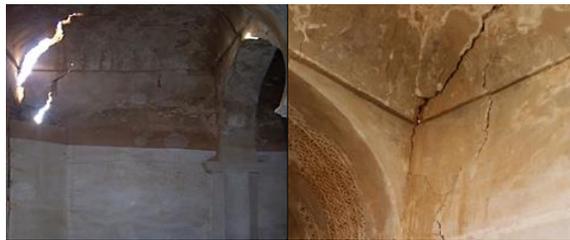
In many cases serious structural damages are evident. In particular, in many buildings partial or total collapse of the domes happened. In many other buildings, it is possible to detect serious cracks that involve the domes (Figures 6 and 7). In particular, there are large fractures at the corners of the domes (along the diagonal arches), determining fragmentation of the domes (Figure 6). These fractures allow the dangerous passage of water and the degrading action of atmospheric agents and can lead the domes to collapse if not repaired.

Figure 6. Fractures at the corners of the domes, along the diagonal arches.

At the diagonal arches, there is a geometric-constructive discontinuity which determines structural weaknesses. Further weakness is generated in the middle of the building unit sides where the horizontal thrust of the flying buttresses arches is maximum. Such thrusts can cause the overturning of the top part of the walls and the partial collapse of the dome (Figure 6).

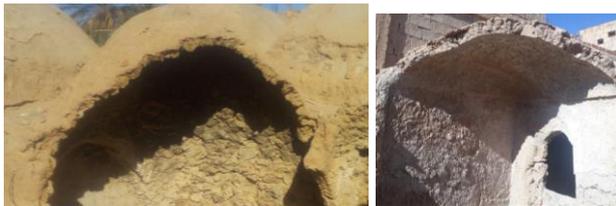
Figure 7. Partial collapse of the domes.

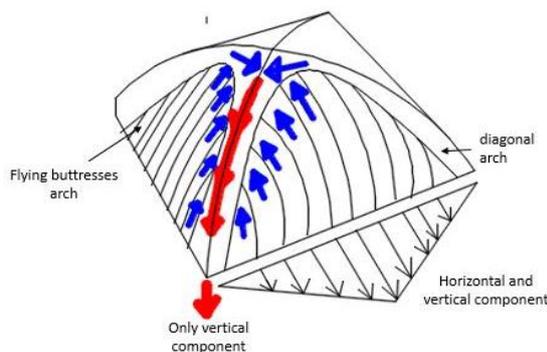
In agreement with ( Borri et al,2011) the structural behaviour of the cloister dome can be explained considering the dome consisting of two diagonal arches that transfer the vertical weights, but not the horizontal thrust, at the corners of the building unit and a series of flying buttresses arches that discharge the vertical weight and the horizontal thrust along the load-bearing walls (Figure 9).

Figure 8. The structural behavior of the cloister domes.  
 Elaboration from (Borri et al, 2011)

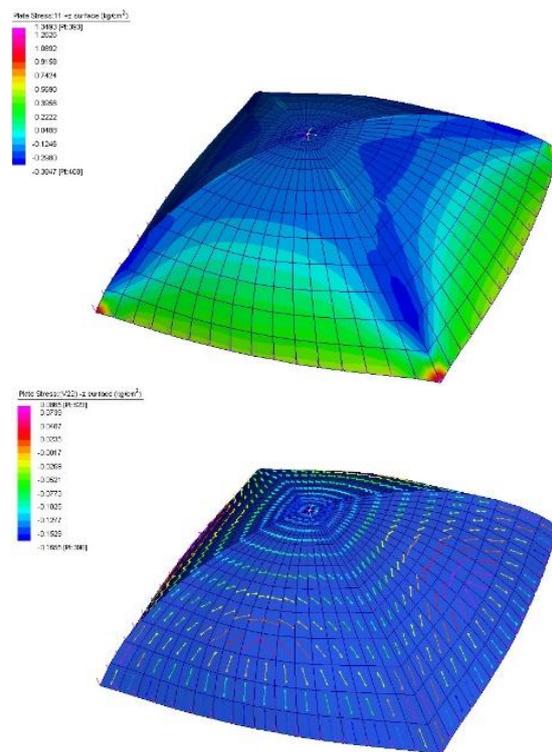
Figure 9. FEM analysis: stress 22 in extrados and stress 11 in intrados

The results of FEM analysis confirm the typical structural behavior of the pavilion vaults: diagonal arches and flying buttress arches.

The compression stress is variant along diagonal arches and shows a progressive increase from the key to the abutment. The maximum values of the compressive stresses at the diagonal arcs are 0.1 MPa, values absolutely compatible with the compressive strength of the material.

The maximum tensile stress value, 0.05MPa, are present on the sides of the diagonal arches at the abutments. These values are high for the characteristics of the material and justify the triggering of visible lesions in the studied domes.

The “Straus7” software was employed in order to carry out a numerical analysis by means of the finite element method (FEM) of a typical dome of Souf region. This software permits performing linear elastic analyses using plate/shell finite elements, characterized by both membrane and bending behaviour.

The elements (called Quad4) are characterized by four nodes with six degrees of freedom for each node. Each element is characterized by a thickness that takes into account the real thickness of the dome, which varies with the height. The nodes at the springing of the dome were restrained with hinges. For the elastic modulus, experimental results on samples of desert rose were employed.

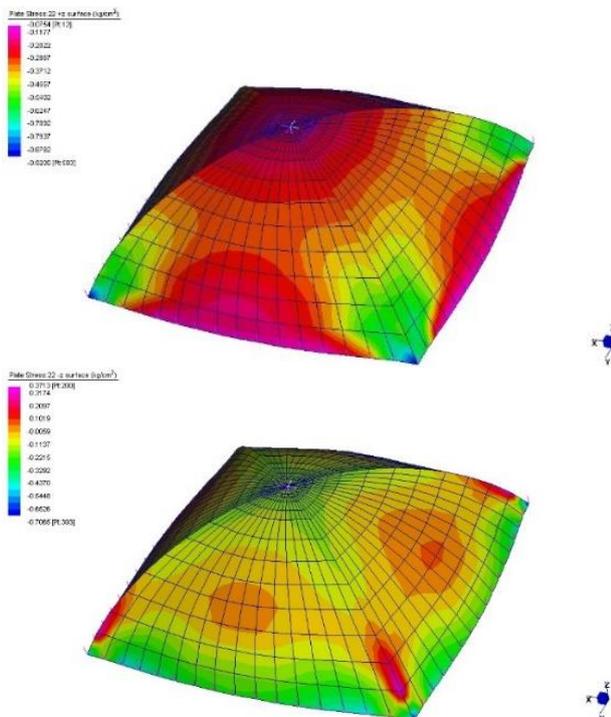
Figure 10. FEM analysis: stress 22 in extrados and stress 22 in intrados

Because of its shape, the cloister dome has weakness zones where fractures can occur. These zones are at the abutments of the diagonal arches. In addition, the cloister dome generates pushes at the mid-points of the underlying walls. These structural weaknesses are amplified in the case of the domes of the Souf region because the shape is very low and the material has low mechanical characteristics.
