## BUILDING SURVEY AND ENERGY MODELLING: AN INNOVATIVE RESTORATION PROJECT FOR CASA DEL FASCIO IN COMO

**KEY WORDS:** Modern Architecture, Restoration, Energy Efficiency, Building Survey, Energy Simulation

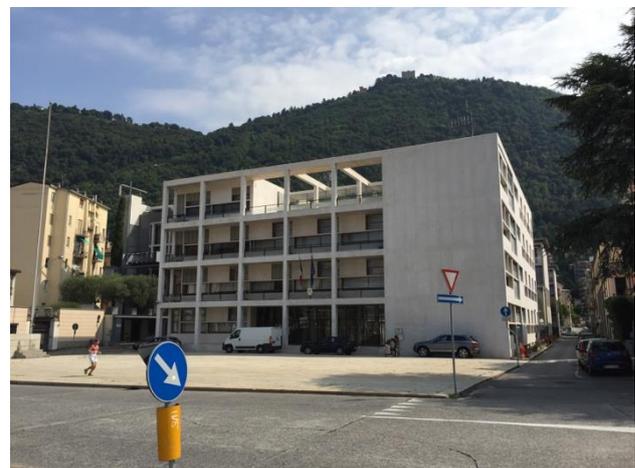
Figure 1. Casa del Fascio (Authors’ capture, 2016)

The main characteristic of the intervention should have been to preserve the building as much as possible with low-impact interventions (Figure 1).

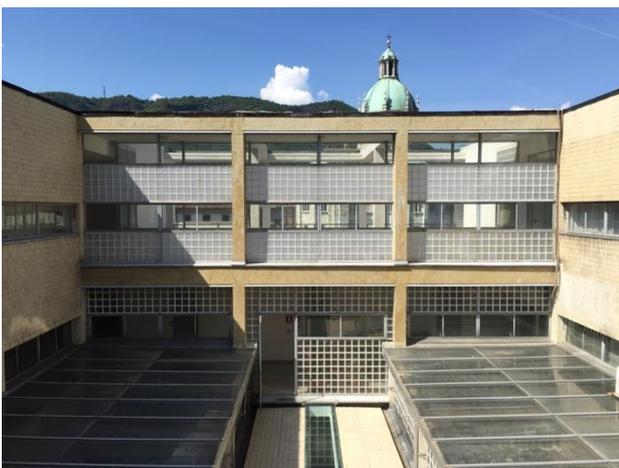
Figure 3. External atrium (Authors' capture, 2016)

The second floor follows the distribution system of the first; the difference is that the gallery opens onto the roof of the internal atrium, characterized by a walkway that crosses it in the middle. From the corridor it is possible to access the rooms originally used as offices, administration and library (Figure 3).

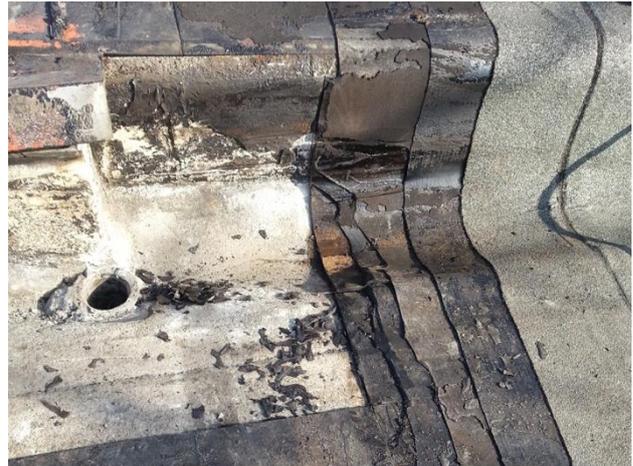
Figure 4. Non-accessible roof (Ambrosini's photo, 2016)

The remaining part of roof is flat, partly used as a terrace, with a marble floor, and partly non-accessible, covered with a finishing layer of white cement grit tiles now replaced with eight bituminous sheaths layers (Terragni, 1936b) (Figure 4).

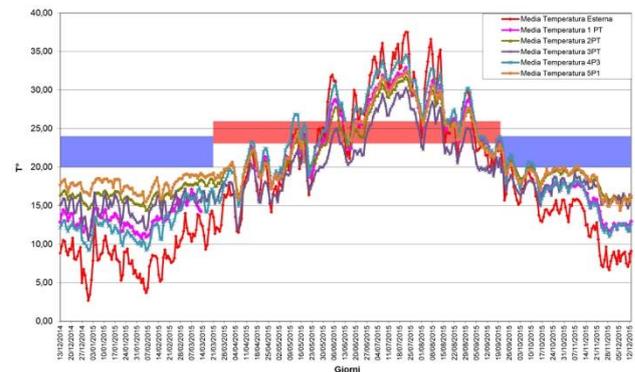
Figure 5. Temperature graph. Monitoring period from 13th December 2014 to 5th May 2016 (Busnelli et al., 2016)

The monitoring phase shown a strong influence of the external climate on the building thermal behaviour. The low thermal inertia characterizing the envelope doesn’t correspond to an effective barrier against thermal and relative humidity variations. From the observation of the annual graph of daily average temperatures (Figure 5) it is clear expressed that the

days in which the values fall into the winter and summer comfort zones (provided by current legislation) are very limited. In winter, the heating system is only partially able to guarantee such comfort conditions; the summer period results to be the most critical, because there’s no possibility of limiting overheating, due to the absence of solar shadings and to the disposal of the air conditioning system designed by Terragni. The highest recorded temperature within the building is around 35°C. The graph of daily average relative humidity (Figure 6) confirms a strong sensitivity to external variations during the year, to which significant fluctuations of the indoor conditions correspond (Busnelli et al., 2016).

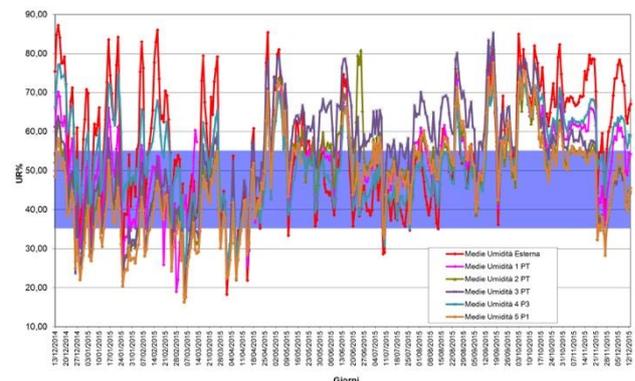
Figure 6. Relative Humidity graph. Monitoring period from 13th December 2014 to 5th May 2016 (Busnelli et al., 2016)

However, the internal microclimatic investigations have confirmed a strongly oscillating behaviour of temperatures and relative humidity. Anyway, it could be considered as “normal” for a structure such as the Casa del Fascio: large windows and thin walls in fact favour a strong thermal loss and, at the same time, guarantee a gain of thermal radiation during the raising of external temperatures and humidity.
