# GEOMATICS AND ARCHAEOOMETRIC INVESTIGATIONS FOR THE SUSTAINABLE REUSE OF RUINS. THE SANTA CHIARA CONVENT RUIN IN CAGLIARI (SARDINIA)

The ruined convent of Santa Chiara, a nodal urban space connecting three historic quarters of Cagliari, has had a key role in the urban life of the city since medieval age. After the suppression of the mendicant orders in 1864 and the violent bombings during the World War II, this monument became a neglected and ruined shell of masonry with no roofs and floors, losing its central role. Several interventions for its conversion as temporal local market and the following restoration and integration works have contributed to stratify these structures nowadays not accessible but valuable benchmarks for reconstructing the history and evolution of the fabric, still unclear. Starting from the archival and bibliographic investigations, then a geomatics and archaeometric investigations of the fabric have allowed to understand and study the building's forms, geometries, materials, developments, and chronologies. They have also permitted to recognise characteristic features or anomalies, structural morphology, and other structural issues, significant for the d

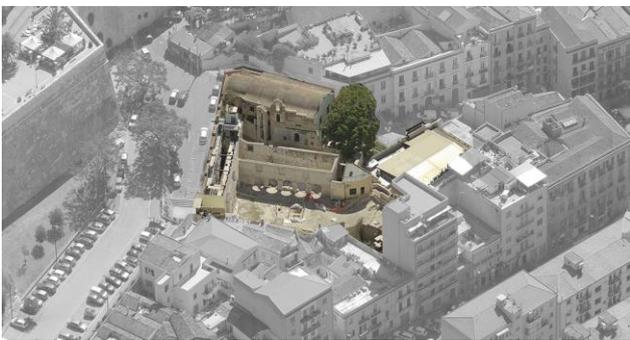
Figure 2. Aerial view on 45° of the ruins (Pilia E.).

In 1957, a temporary local market was installed inside the convent transforming the space with new roofs, floors and partitions (fig. 2). At the time, the area became important again, although in a different way from its previous religious role, having been a point of convergence for Castello, Stampace and Marina. Due to this significant role, and the convent's importance, the Council moved the market close to the Church access stairs where, in 1984-85, the Superintendence carried out important archaeological excavations on the structure; it also performed some structural renovations and repairs with compatible materials. In the 1990s, the decision to install a lift in the space between the church and the convent, the original location of the confessionals and oratories, raised additional issues in terms of the legibility of the structures, perceived as two different buildings. Today's disuse of the lift has intensified

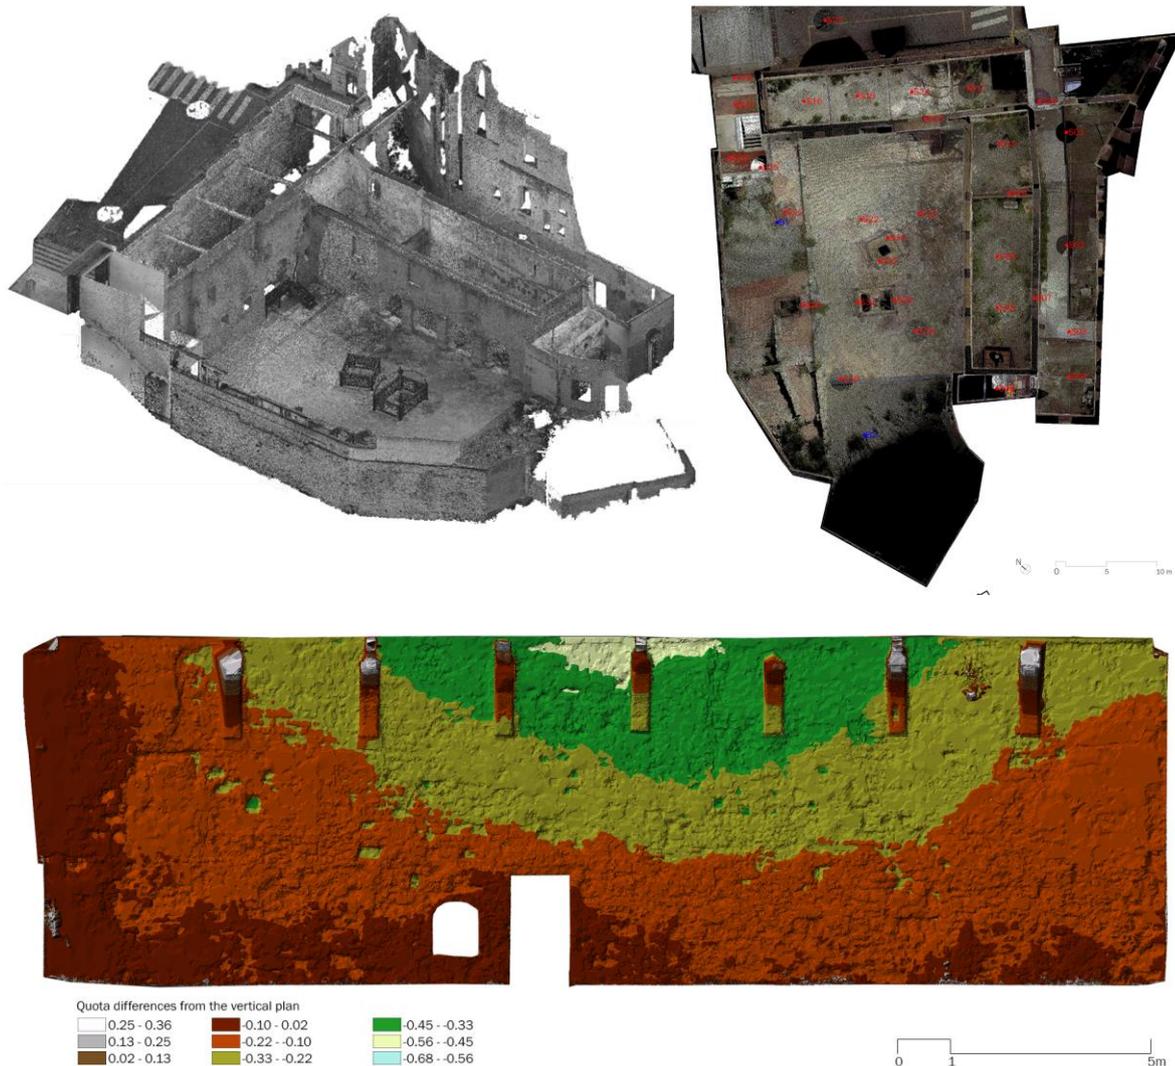
Figure 3. a) 3D non structured view of the complex; b) map of the scanning sessions; c) analysis of verticality of a masonry with ArcGis: model of verticality for a front (TLS Surveys coordinated by Vacca G.; data processing and 3D model: Dessì A., ArchGis model: Deidda M.; graphic elab.: Pilia E.).

With its versatility and light weight, the laser Focus 3D allowed us to perform 33 scans (figure 3b) with density point of 3 mm, up to 120 m distance with high speed point acquisition up to 976.000 points/second. For all stations, the resolution was 1/4, with quality 3x, distance mm/10 m and 6.136. Only for S23 and S24, performed in the stairs, the resolution was 1/5. Overall, for accuracy and precision, the survey was compatible with a restitution of drawings in scale 1:10 such as those required for archaeological investigation.

These were useful in reconstructing several significant plans that could better explain the stratigraphies of the structures such as the addition of walls, opening or closing of windows and so on. In addition, vertical sections were used for analysing the depth of the cisterns as well as for studying the verticality of some walls. Especially one wall (figure 3c) different in thickness from the others, was analysed in depth and a series of vertical sections were processed every 1cm in order to obtain the map of vertical anomalies.

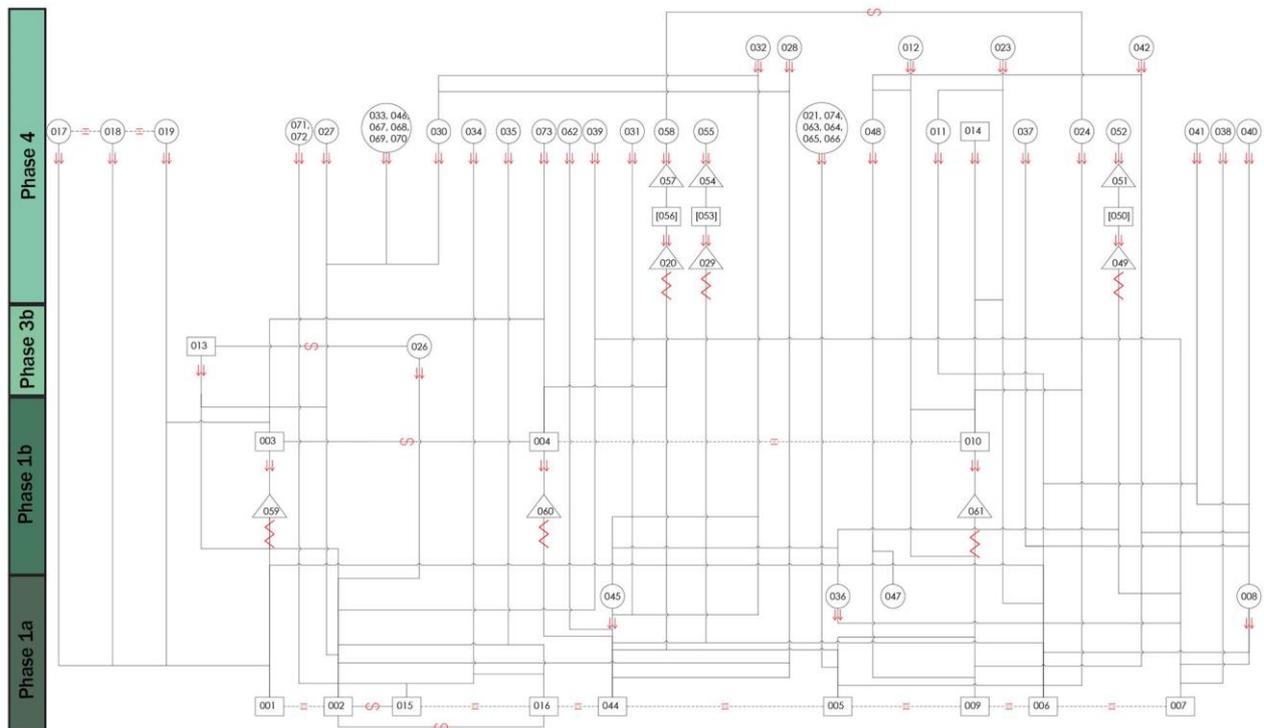
Figure 4. a) Stratigraphic analysis of a masonry; b) Harry's diagram with the relative chronology (the stratigraphic analysis has been carried out in collaboration with the Masterclass in Architectural Restoration a.a.2017-2018, prof. Fiorino D.R., tutor Pilia E. (graphic elab.: Loi M.).

Overall, this analysis was carried out both on the elevations and in plan. Concerning the analysis of the elevations, it sought to identify homogenous areas in the masonries in terms of materials and building techniques. These are called USM (Masonry Stratigraphic Units), USR (Facing Stratigraphic Units) and USN (Negative Stratigraphic Units) that represent all subtractions from and cuts or additions in the masonry. As it can be seen on fig. 4a, after the individuation of all the homogenous areas (US) and their numbering, it has been essential to understand their relative temporal relations such as contemporaneity (is linked to/ A is contemporary B),

posteriority (A is later than B, or A covers B), anteriority (A is earlier than B, A is covered by B). The stratigraphic Units (US) were named according to room numbers and elevation letters and have been identified giving special attention to the edges of each US. All the masonries have been carefully studied under this archaeological perspective, arriving at the definition of the Harry's diagram (figure 4), the matrix, and at the interpretation of a general chronology divided in 'relative phases' because of the absence of certain benchmarks. Looking at the analysis of the plan sections, they have instead allowed understanding of important geometries such as those linked to the additions. In this case, the 10 main significant plan sections (table 1) were drawn in order to better understand the structural morphology and codify a hypothetical plan chronology (figure 5).

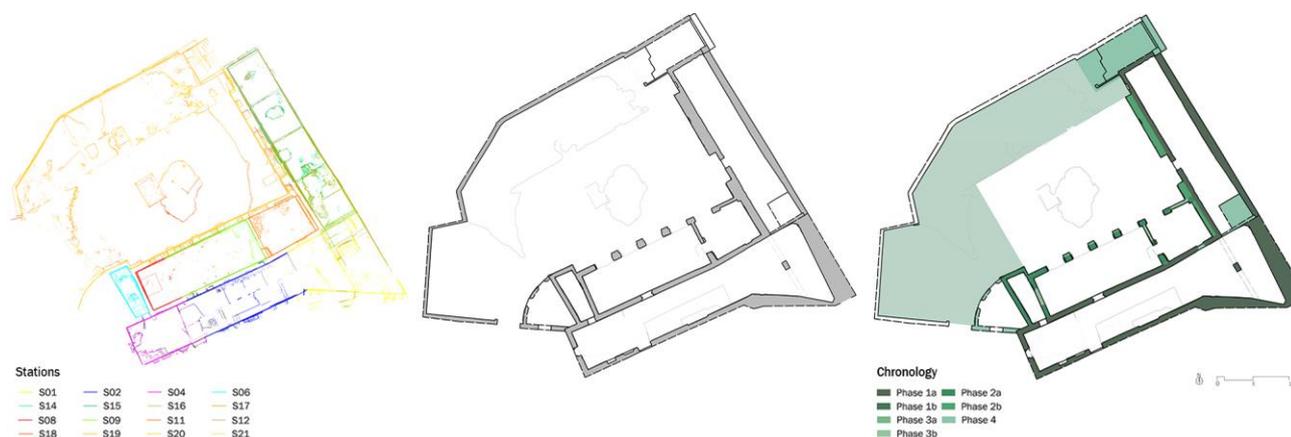
Figure 5. a) Map of the 10 main significant plan sections used to draw the plan b); c) summary of chronologies (research and graphic elab.: Pilia E.).

Immediately thereafter, in phase 2b, as clearly evidenced by the analyses carried out with the 3D model of the convent and from analysis of the vertical sections, can be reported a portion of wall that could have been added as support of the unstable original wall and as consequence, it overlaps the arcade 6b. With the erection of this wall, all the openings of the wall 7c were closed and the new ones adapted to the pre-existing conditions. At this point the building's configuration was the same as the one represented in 1908 by the surveyors.

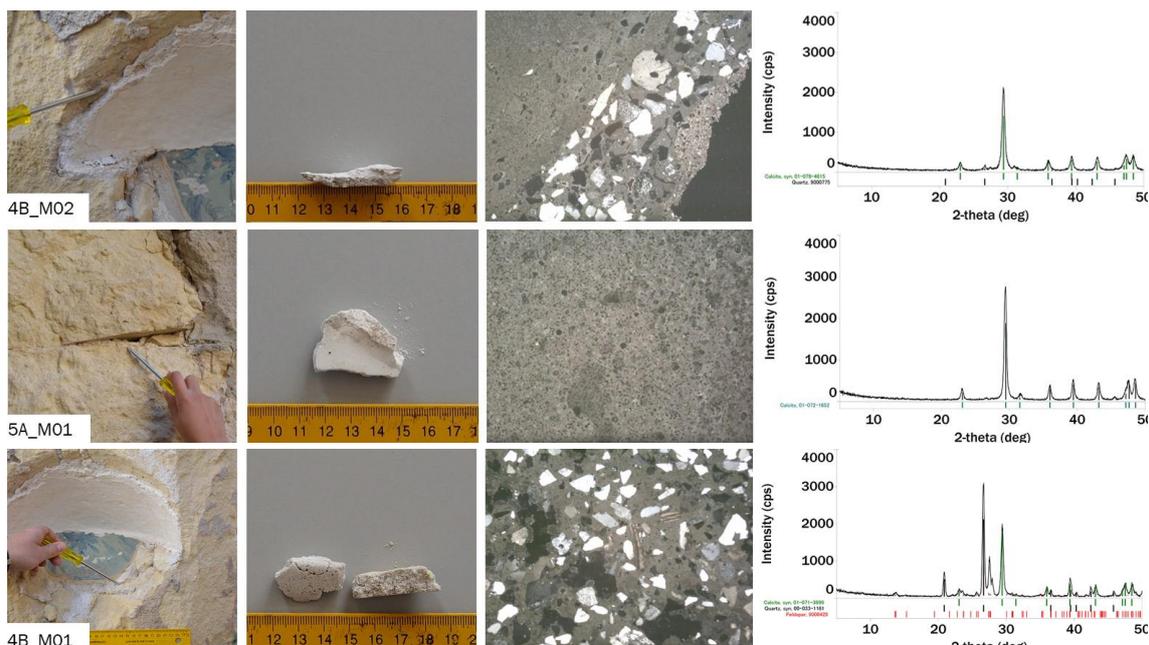
Figure 6. Minero-petrographic analysis. From the left: a) localisation of the sample; b) macro photo; thin sections under the optical microscope in Transmitted Light and X-Ray diffraction analysis (Laboratory analysis: Grillo S.M., LabMaST. Graphic elab: Pilia E.).

Differences can be found in the relationship binder/aggregate, presence or absence of lumps, "remnants of burning", and so on. From these properties come different ways of reaction to the weathering processes. In figures 6 are presented three of the most representative mortars. In details, the first one 4B\_M02, macroscopically compact and with cream colours shows the presence of bioclastic components and small millimetric black aggregates. The thin sections present a homogenous structure

with low presence of very small aggregate. This type of mortar can be connected to the first phases of construction.

The second one, 5A\_M01, is characterised by the exclusive presence of lime as a binder component while aggregate is absent. In this case, the thin section shows a fat mortar that justifies the function of this mortar used to fill the joints in refined construction elements such as entrance arches.

The third one instead, corresponds to a second phase of restoration with the addition of new walls. In this case, this typology of mortar 4B\_M01, shows the presence of an unrefined mixed aggregate and calcite as binder. The presence of cracks and voids distinguish these mortars from the others. Three typologies, according to the presence of calcite, can be recognised in a hypothetical new phase.

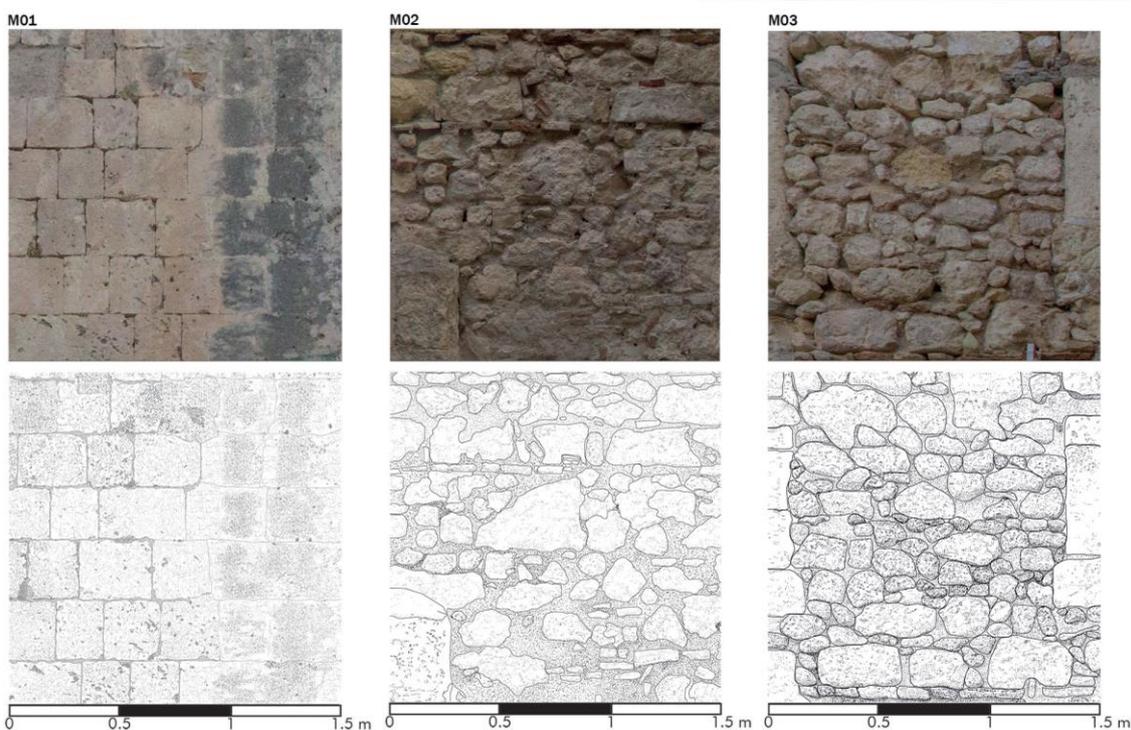
Figure 7. Masonry typologies (the analysis of building techniques has been carried out in collaboration with the Masterclass in Architectural Restoration a.a.2017-2018, Fiorino D.R., tutor Pilia E., (graphic elaboration: Loi M., Pinna M., Mura G.)

In particular, the exclusive use of the pietra cantone, an easily workable stone harvested in the nearby San Guglielmo quarry, characterises the building technologies used in the Santa Chiara Convent. Starting from stratigraphic analysis, the investigation highlighted three main categories of historical building techniques depending on the typology, shapes and patterns of the stonework (figure 7): in squared blocks M01, in rough stone M02 and M03.

The M01 typology is characterised by squared blocks (25x40-25 cm). This technique characterises all the older masonries although in some rooms, numerous restoration interventions highly modified the original appearance with several additions of other facings in pietra cantone as well. Squared blocks, although of different dimensions, were also used for constructing the arches and portico openings.

M02 instead, is widely used in all the rest of the building. This rough typology, certainly plastered, was realised with an irregular pattern with ashlars of different dimensions and shapes. Finally, a third historical building technique, M03, is present in all the arches closed off at the beginning of the 20th century. These masonries were certainly realised with reutilized materials from the same building and built without proper techniques. The mortars of this typology were based on lime
