## THE “CARA VALLE” ABBEY AND ITS REFECTORY

G. Guarisco<sup>1</sup>, D. Oreni<sup>1</sup>

The purpose of this paper is to present the main results of the studies and surveys conducted on the Chiaravalle abbey in the last ten years, focusing in particular on the Refectory.

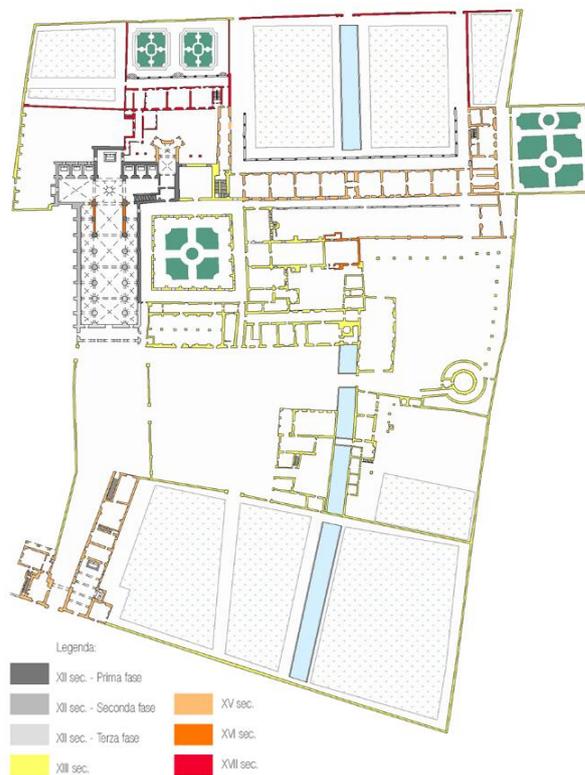
Figure 6. The construction phases of the abbey complex from 1135 to the eighteenth century, with the extension of the Refectory dated to the sixteenth century (Master thesis of V. Olearo, A. Bellinetti, *L'Abbazia di Chiaravalle Milanese e la sua foresteria. Conoscere e valorizzare l'esistente, conservare la fabbrica e progettare nuovi spazi di fruizione*, Prof. G. Guarisco and Prof. N. Lombardini, with architect G. Clerici, Politecnico di Milano, Scuola di Architettura Urbanistica Ingegneria delle costruzioni, corso di laurea magistrale in Progettazione architettonica, a.y. 2016-2017)

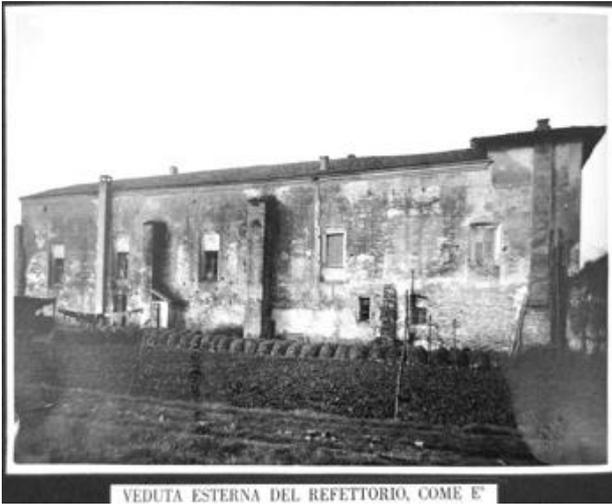
Figure 7. "External view of the refectory, how it is" (Reggiori?, 1952) (SABAPMi, AV, 17)

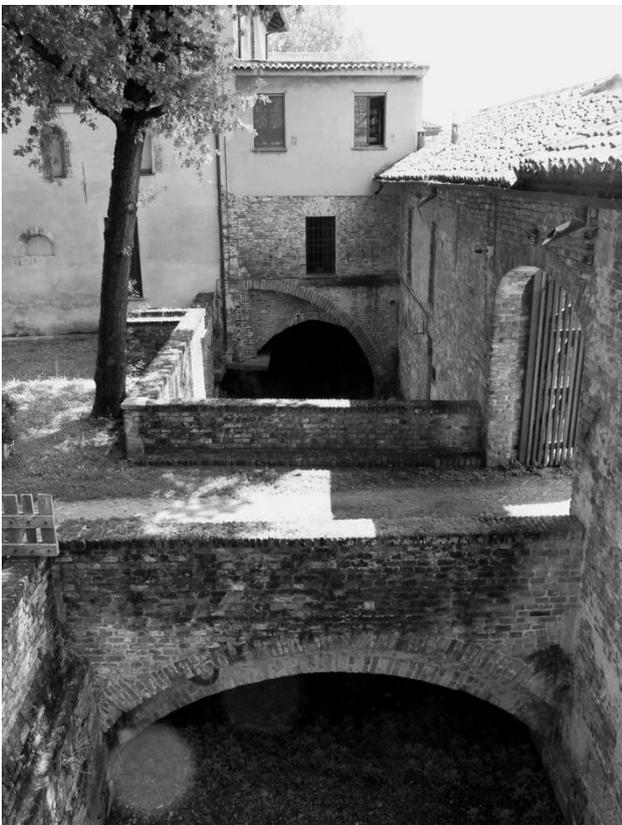
Fig. 8. View, from the mill, of the canal that runs south of the cloister, under the arm of the converts and the Refectory (Schiavi, 2016)

The prevalent form of deterioration in the building is the rising humidity present in all the walls. Referring to other investigations aimed at finding out the degree of absorption of moisture in the walls, it is inevitable to point out that the Refectory (figs. 7-8), or at least its extension, is built above the canal of deviation of the Vettabbia that gave water to the mill. Today that water system, which flow was determined by a very delicate and wise system of sluices, has been partially upset, but recently (2017) the mill blades have been restored and the water has returned to flow in the canal during some events.

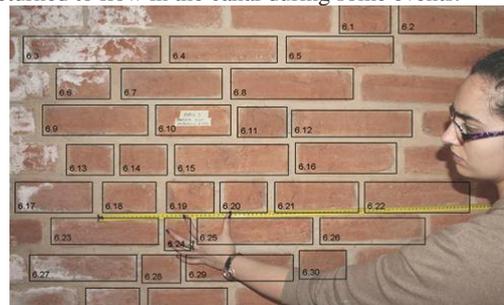
Figure 9. Identification of the bricks (Laboratorio di Restauro I, G. Guarisco and N. Lombardini, laurea Magistrale in Progettazione architettonica, Politecnico di Milano Scuola di Architettura Urbanistica Ingegneria delle Costruzioni, a.y. 2015-2016)

A further investigation concerned building materials: the bricks of the Refectory walls have unusual dimensions (fig. 9), as confirmed by the most recent medievalist historiography (Schiavi, 2019). Considering what was previously sanctioned on the construction rule "*Ad Quadratum*" (Aubert, 1943) (Romanini, 1975) (<sup>3</sup>), in recent years, the research has focused on the Cistercian construction systems of the 12th century, so different from the "Lombard architecture" (so dear to 19th century researchers). In fact, and especially in Italy, where the rule of construction was dictated by St. Bernard, the rooms were distributed around the *claustrum*, usually built on a single level using stone and/or terracotta as building materials. The distribution of the rooms followed the same modular square used to build the church, both in plan and in elevation. Generally, the rooms dedicated to the monastic life have a square or rectangular shape, internally divided according to a scan of pillars and vaults. That scan is the result of a proportional subdivision of the module.

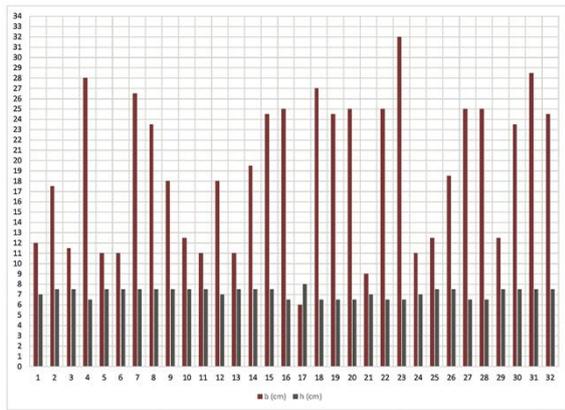
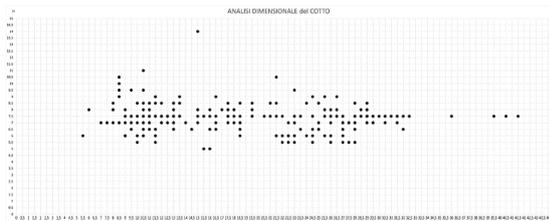
Figure 10. From above: graph of the bricks sizes and dimensional analysis of the terracotta elements (Laboratorio di Restauro I, G. Guarisco and N. Lombardini, a.y. 2015-2016)

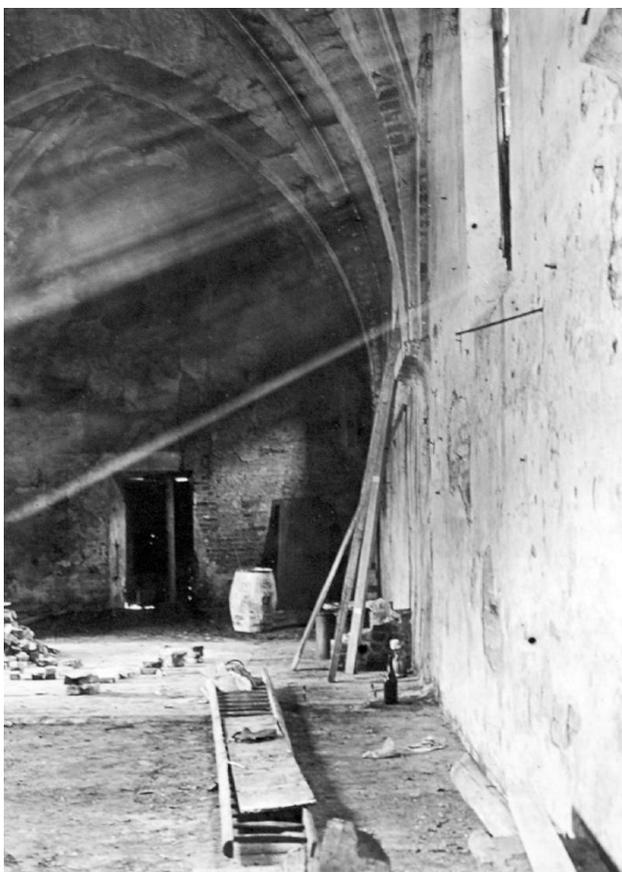
Figure 11. The interior of the Refectory in a picture that documents the state of consistency before the restoration of Ferdinando Reggiori. On the back wall there is still the door then closed and the walls are plastered. Therefore, the photo dates back to the beginning of the works carried out by Reggiori (fig. 12) (AACMi)

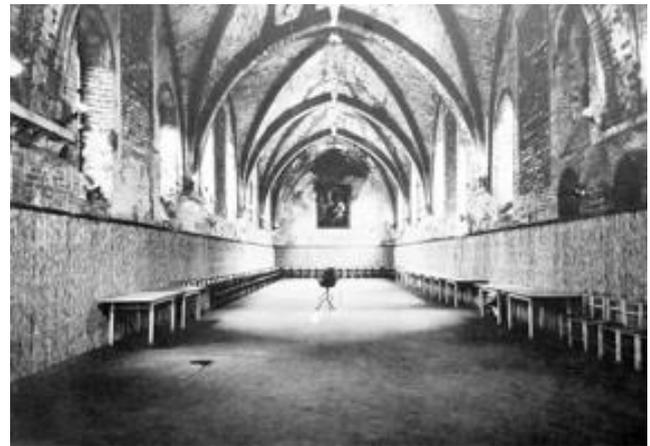
Figure 12. View of the interior of the Refectory after the restoration of Reggiori and before the subsequent restoration by Lamperti (AACMi)

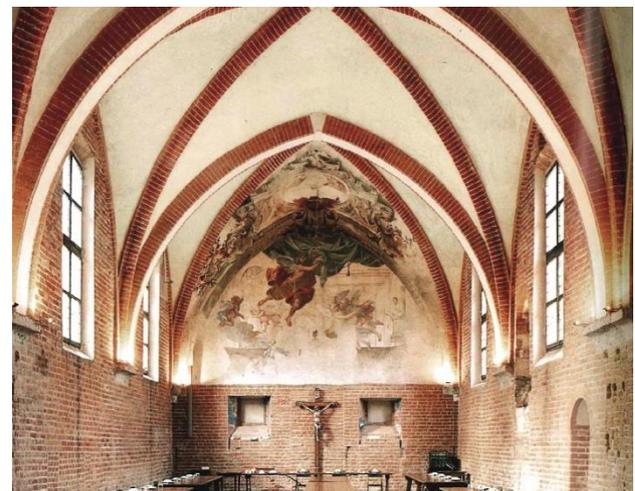
Figure 13. View of the interior of the Refectory with the fresco on the back wall and the closed door where the Crucifix is placed

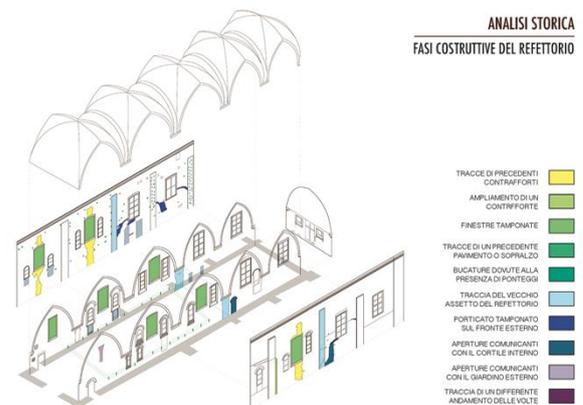
Figure 14. Axonometric representation of the historical evolution of the Refectory (Laboratorio di Restauro I, G. Guarisco and N. Lombardini, with architects G. Clerici and D. Mirandola, laurea Magistrale in Progettazione architettonica, Politecnico di Milano Scuola di Architettura Urbanistica Ingegneria delle Costruzioni, a.y. 2015-2016)

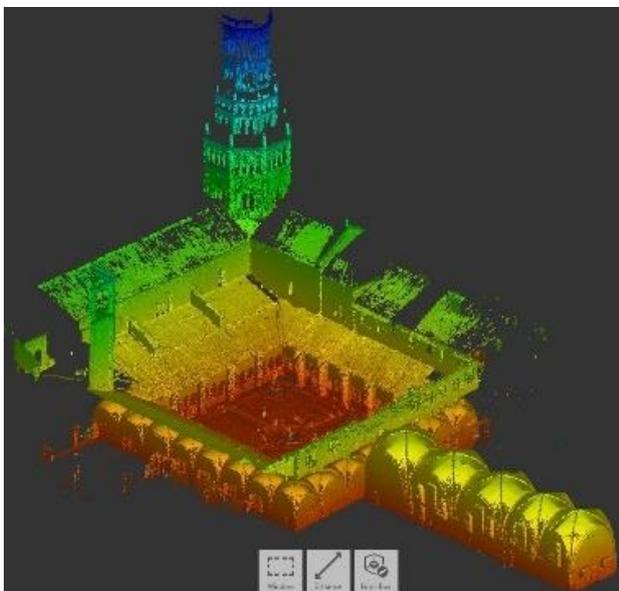
Figure 15. The 3D laser scanner cloud of the Refectory and the cloister close to the church and the "Ciribiciaccola"

The three-dimensional point cloud made it possible to accurately investigate the geometry of the Refectory and its spatial relations with the adjacent buildings and cloister. In particular, after the processing of laser scanner data it was possible to carry out a multiple series of horizontal and vertical sections for the drawing of plants at different heights, sections and elevations. These data have also made possible a series of fundamental measurements for the interpretation of the different parts of the building, to be related to the history of their transformations over the centuries.

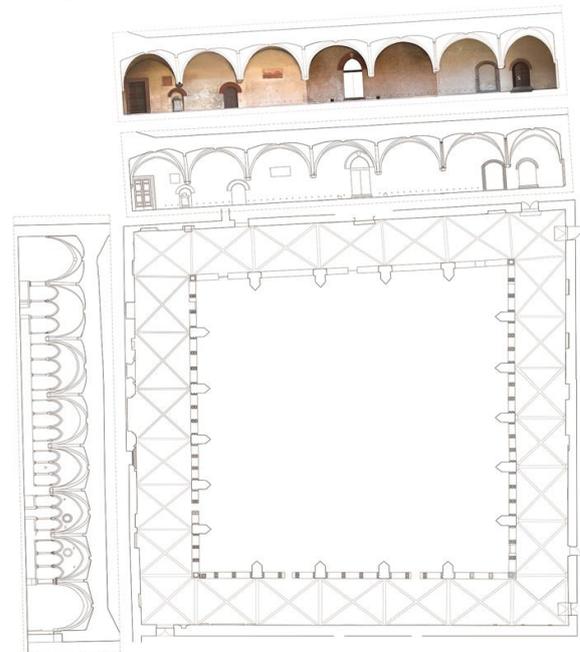
Figure 16. Plan of the cloister obtained from laser scanner data with internal elevation and rectified image of the front towards the Refectory. The central door in the rectified image is the one that gives access to the Refectory from the cloister (Laboratorio di restauro, G. Guarisco and D. Oreni, Politecnico di Milano, Scuola di Architettura Urbanistica Ingegneria delle Costruzioni, Corso di laurea in Architettura, Ambiente costruito, Interni, a.y. 2017-2018)

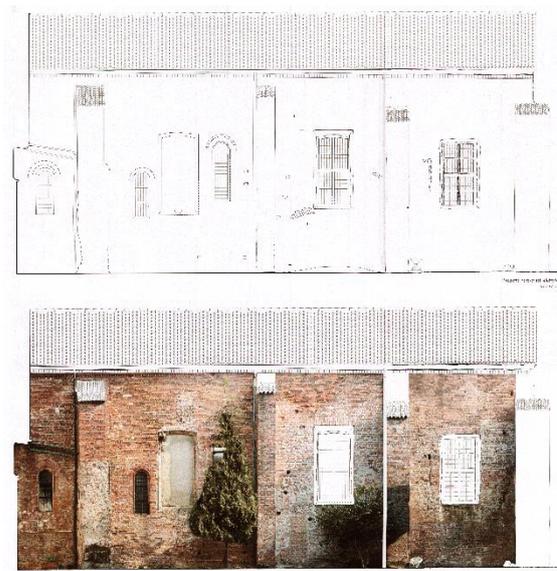
Figure 17. Front and rectified image of the west side of the Refectory, in scale 1:50 (Laboratorio di Restauro, G. Guarisco and D. Oreni, a.y. 2016-2017)

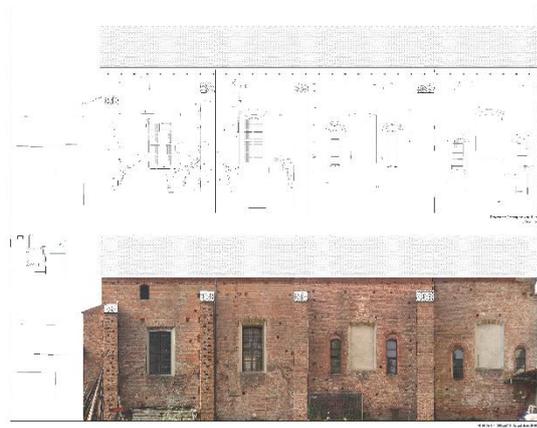
Figure 18. Front and rectified image of the est side of the Refectory, in scale 1:50 (Laboratorio di Restauro, G. Guarisco and D. Oreni, a.y. 2016-2017)

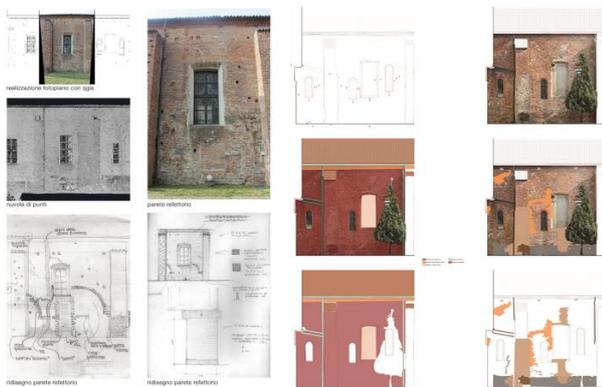
Figure 19. On the left, the process to obtain external rectified images of the Refectory using both direct measurements and laser scanner control points. On the right, the mapping process of materials and degradation pathologies of the west front of the Refectory (Laboratorio di Restauro, G. Guarisco and D. Oreni, a.y. 2016-2017)

The control points used to obtain the rectified images and orthophotos of the internal and external <sup>(8)</sup> fronts were derived from laser scanner points cloud, with the final aim of representing the shape, the geometry and the semantic content of this architecture. The rectified images were obtained following a project of acquisition of the images in scale of restitution 1:50. This scale is fundamental for the subsequent phases of thematic mapping: the analysis of the materials, the

pathologies of degradation (fig. 19) and the volumetric stratigraphy.

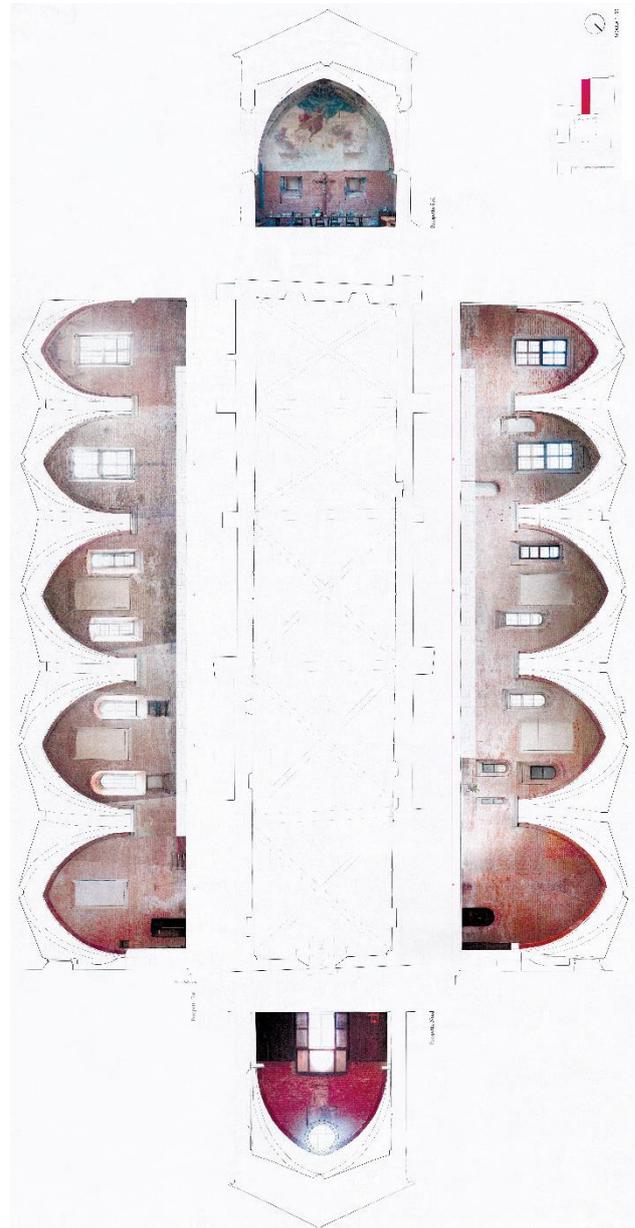
Figure 20. Plan, internal fronts and rectified images of the Refectory, scale of 1:50 (Laboratorio di Restauro, G. Guarisco and D. Oreni, a.y. 2016-2017)

From the planimetric point of view, the Refectory has a single rectangular nave with five irregular spans, and has an internal dimension of about 38 x 8 meters. The five spans (fig. 20) have variable shapes and sizes: the first three (the ancient ones), entering to the north from the cloister, have a quadrangular plan and internal dimension of about 8 x 8 meters. On the other hand, the last two have a rectangular plan, with internal dimensions of about 6 x 8 meters. The thickness of the two longitudinal walls is 72-75 cm in the first three spans, while in the last two of 82-85 cm. The northern wall that divides the Refectory from the

cloister is 62-63 cm thick, while the southern wall is 88 cm thick.

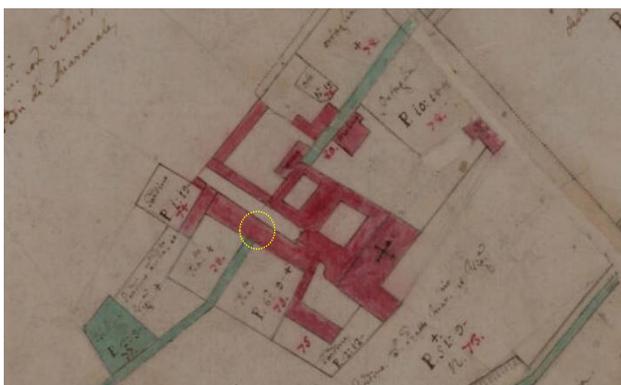
Figure 21. "Catasto Teresiano, mappe originali del primo rilievo", 1720-1723 (ASMi): in yellow the position of the canal under the last span of the Refectory

The south-west corner buttress has an "L" shape; this element closes the Refectory to the south, whose walls, however, do not have geometric irregularities in the vertical direction. The same happens for the two buttresses that close the southeast corner of the Refectory (fig. 22). All the buttresses at the corner of the Refectory, close to the rural buildings, are in exact correspondence with the south bank of the canal that flows under the last span of the building (figs. 21-22-23).

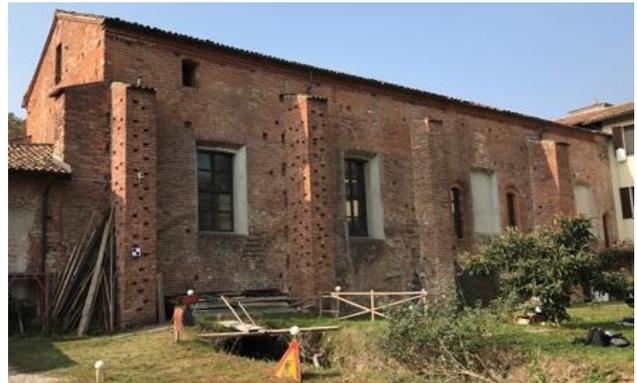
Figure 22. Photo of the eastern front of the Refectory with the canal in the foreground (photo October 2017)

cartography (fig. 22). The artificial vaulted canal runs at only 80 cm from the inner floor of the Refectory and it is 4 metres wide at this point. A round barrel vault covers the visible external part of the canal, but the vault changes its shape in correspondence with the east wall of the building, becoming a lowered barrel vault. The hinge of the external round barrel vault coincides exactly with the level of the internal floor of the Refectory (fig. 23).

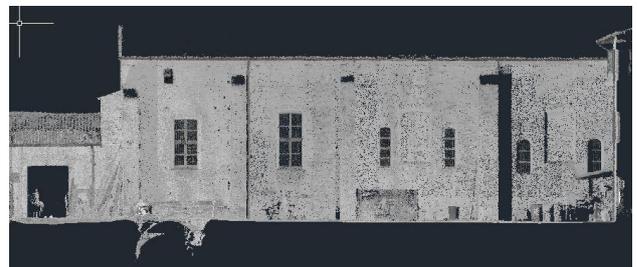
Figure 23. Point cloud of the eastern side of the Refectory with the outline of the canal placed under the last southern span
