RESEARCH ON NON-DESTRUCTIVE TESTING TECHNOLOGY IN RENOVATING PROJECTS OF MUKDEN PALACE

1. MUKDEN PALACE

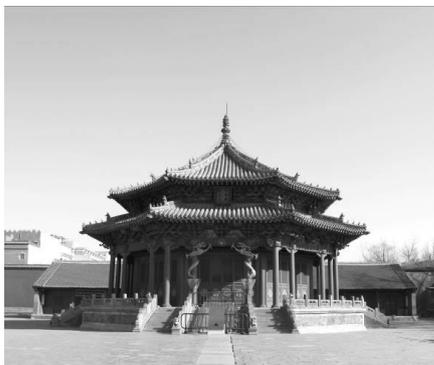
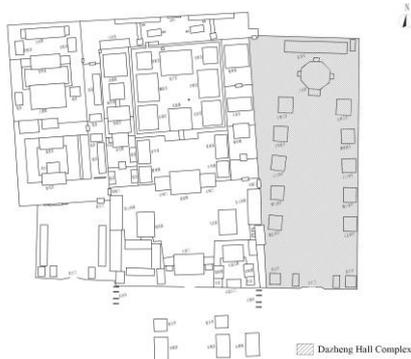
Figure 2. Site of Dazheng Hall Complex in Mukden Palace

There are some problems such as uneven settlement of stylobate, cracking and dislocation of masonry structure, incline of stony frieze panel existing influenced by its own gravity, rain, freezing and thawing, weathering erosion, etc. Combining observing, photographing, measuring, 3D scanning, ground penetrating radar exploring, concrete ultrasonic testing and mineral element analyzing tries to diagnose damage of stylobate all-side, the paper also considers if the process could be a well

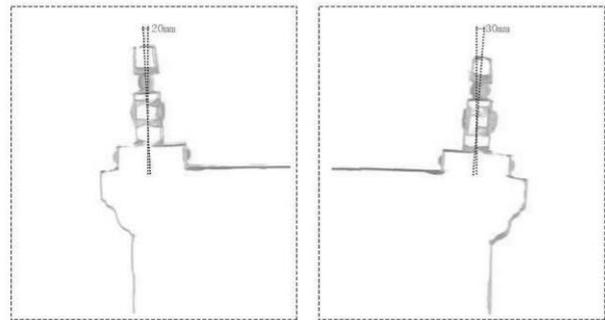
In the process of problem showing, figures of CAD provide convenience for marking problems and dimensional measurement. The point cloud pictures of 3D scanning (Figure. 4) provides accurate images and current situation.

Figure. 4. Part of southwest and southeast stony frieze panel.

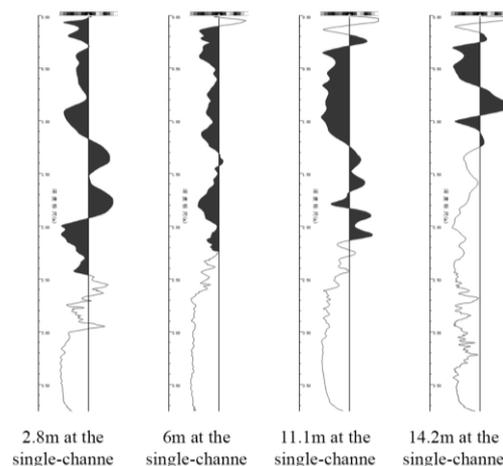
As shown in the Figure. 5 and 6, the ground penetrating radar scanned below stylobate at the southeast corner of Dazheng Hall from north to south. Clear information shows that there are empty phenomena existing approximately at the 2.8 meters depth below 800 mm to 3000 mm, 6 meters depth below 1000 mm to 3200 mm, 14.2 meters depth below 400 mm to 1300 mm.

Figure.6. GPR detection analysis of the southeast of stylobate.

Based on figures from GPR detection and concrete ultrasonic test, fissure and structural joints containing certain moisture. As condensed water and rain to permeate stone inside, water content is raising. Because Shenyang Imperial Palace is located in the cold region, so freezing effect on the erosion of stylobate is obvious. When temperature drops in winter, water inside freezes and volume increases, causing pressure to stone. When the pressure exceeds capability of compressive strength of ordinary bricks and stones, further destruction will occur. The long frost period and the large daily average temperature difference in Shenyang area directly affect the water condensation and volatilization process in stones, resulting in the frequent alternation of dry and wet. Masonry has the property of moisture absorption to expand. So frequent expansion and contraction caused by dry and wet circulation result the surface of brick and stone loose and damaged, as well as lead to the mutual dislocation and deformation between blocks.

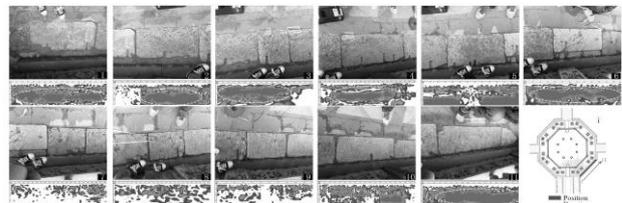
Due to limitation of the antenna of the ground penetrating radar, detection accuracy of the relatively small rectangular stone slabs is unsatisfactory, whereas ultrasonic test is more accurate and objective. In addition to emitting ultrasonic waves, principle is similar to that of ground penetrating radar which uses wave emission and reflection to create highly readable images. Figure. 8 shows concrete ultrasonic testing southeast rectangular stones from southwest to northeast and dark color in the dotted oval means bad condition of stone. It can be seen that the overall texture of southeast rectangular stone slabs of the hall is relatively poor, among which the internal damage of the first, second, third, fourth, sixth and eleven stones are more serious.

Figure. 8. Picture of southeast rectangular stones ultrasonic test.
