## 3D OBJECT RECONSTRUCTION IN A PRE-DIGITAL ERA: CASE STUDY IN THE HISTORY OF RESTORATION

This paper focuses on the approach, methodology and the selected technological aspects of the restoration of cupolas of the Grand Palace, with a view to their interpretation at the time of restoration of cupolas (1950-s) as well as to modern restoration principles. It shows the process and methods of non-digital reconstruction of the shape of 3D object aided by non-digital models, unique decisions and techniques.

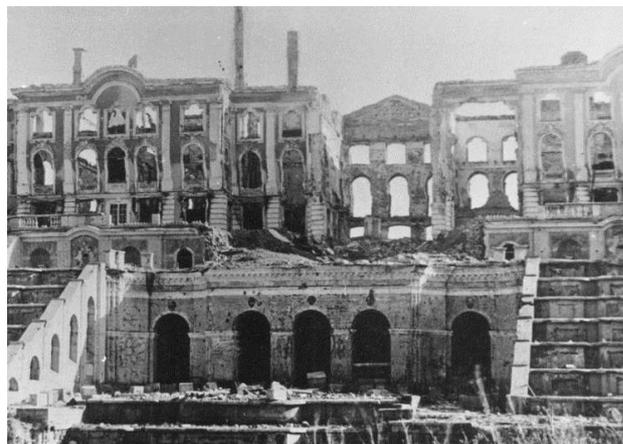
Figure 1. Central part of the Grand Palace and the Grand Cascade of Peterhof after the damages of WWII. © Boris Lobovikov archive

Parks, buildings and fountains were severely damaged. Some part of the works of art were evacuated before the occupation. Many sculptures from the Lower Park stayed hidden in the ground through the years of occupation, and some structures remained in a good condition. However, overall scope of damages was very extensive (Fig. 1).

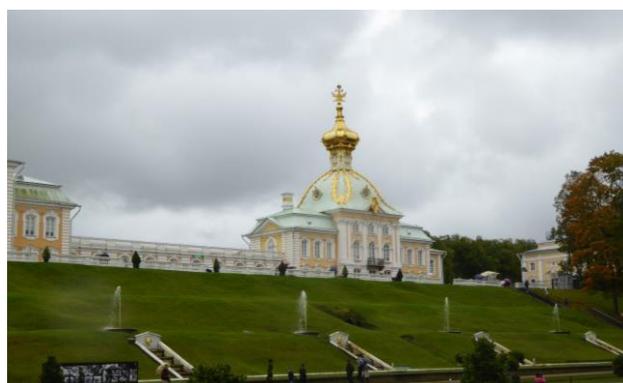
Figure 2. Present day state of cupola and the dome of the Western part of the Grand Palace (photo ©A. Segre, 2016)

Two cupolas flanked the architectural composition of a three hundred meters-long façade of the Grand Palace on both sides (Fig. 2). Each cupola consisted of a dome crowned with a smaller cupola on a lantern. The restoration of the Peterhof ensemble after the war started with general works, restoration of fountains of the central part of the ensemble, and structural works on the Grand Palace. By 1956 the structure and facades of the building of the Grand Palace had been practically fully restored, according to the restoration project by architect V. Savkov, but its two cupolas were still missing.

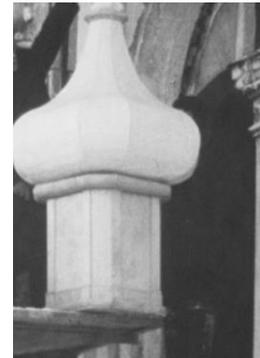
Figure 3. Basic model for a 3D shape reconstruction of a cupola on lantern. Scale 1:5, placed on scaffolding at a relative height  
© Boris Lobovikov archive

The geometry reconstruction of the cupolas can be sub-divided into “macro”-geometry of the overall shape of domes, lanterns and cupolas, and “micro”-geometry of their decorative elements. In order to reconstruct the 3D shape of the cupolas, several steps were undertaken. First, the original pieces of the cupolas which had fallen into the debris of the ruined palace were searched for, sorted and studied. These efforts lasted in Peterhof through almost two decades after the war. Besides that, all available visual material was analysed. On the basis of these two sources of information a series of models of general shape of domes, and of the cupolas on lanterns were made in diverse scales, subsequently progressing from general form (e.g. scale 1:5 - Fig. 3) to partial detailed models (scale 1:1 - Fig. 4). Models were lifted to a height which was in scale compatible with each model, and studied and photographed from an up-to-scale eye level. The photographs were then compared with the original photographs of cupolas before damages taken from the same points of view, which allowed for correcting the models, if needed. The first basic models were aimed at verifying the precise proportions of the general shape, and didn’t include

details (Fig.3). Larger scales models were based on the first models; they already included decoration elements, and often were focused on verifying a specific part of a cupola, or specific type of elements. The later models, unlikely the first monochromatic ones, included colour distinction as typical of the original colour scheme of the palace and its cupolas: greyish metal-covered roof (which included the domes) gilt details decoration elements, including garlands of the domes and elements of cupolas on lanterns.

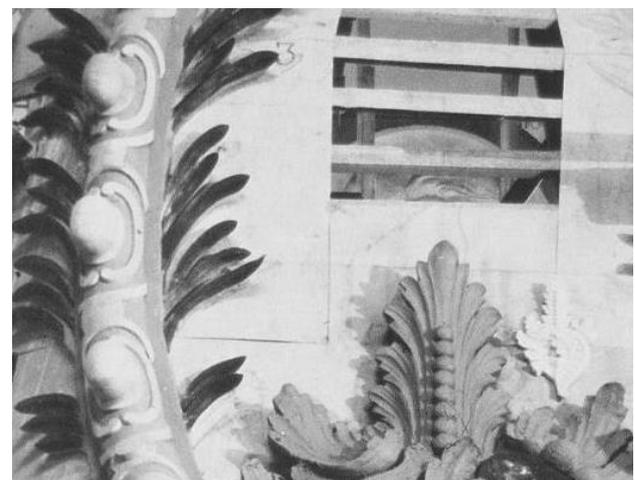
Figure 4. Fragment of a model combining the original and reconstructed decoration elements. Scale 1:1. © Boris Lobovikov archive

With regard to reconstruction of the original geometry of the decorative elements (“Micro”-geometry), the case was easier, because it could be based on the original parts and elements found on site. They were thoroughly studied and put on their original location on a model, e.g. a model of a corresponding part of a dome made to scale 1:1. 3D geometry of missing elements was reconstructed according to the same iterative image-model-image analysis process as of “Macro” geometry reconstruction. The missing elements were then modelled in clay, and incorporated in the same model of a 1:1 scale along with the original elements.

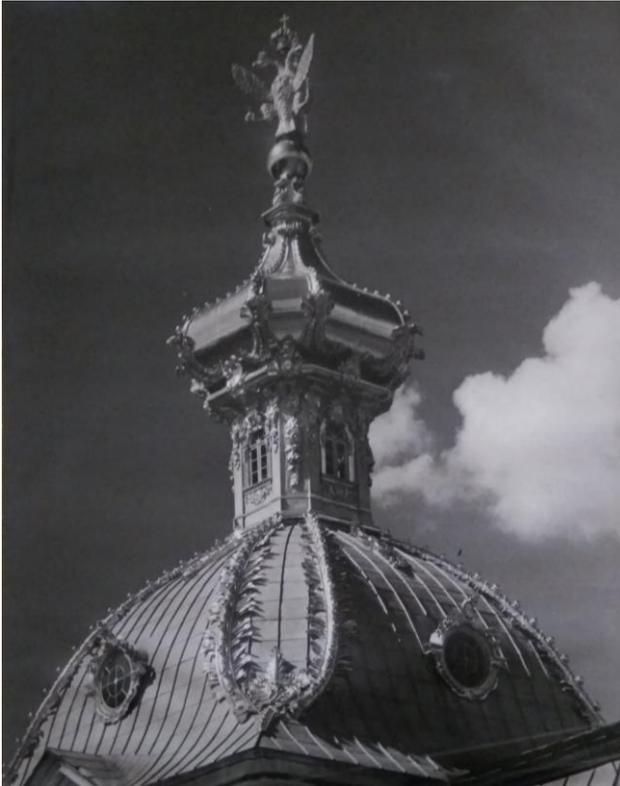
Figure 5. The cupola and the dome of the Western part of the Grand Palace after restoration © Boris Lobovikov archive

included the following stages: clay model, plaster cast, zinc form, final copper elements. Restoration/ reconstruction of cast sculptural elements was of a major importance and also involved clay models as one of the first steps of the process. Gilding work was undertaken in accordance with a scrupulous technological procedure of preparing targeted surfaces before gilding. This was based on the original technology and included a multi-step iterative process of applying layers of lacquer-based cover, drying, and a subsequent polishing of a lacquer-covered surface.
