MODELLING IN HBIM TO DOCUMENT MATERIALS DECAY BY A THEMATIC MAPPING TO MANAGE THE CULTURAL HERITAGE: THE CASE OF “CHIESA DELLA PIETÀ” IN FERMO

E. S. Malinverni ^{1*}, F. Mariano ¹, F. Di Stefano ¹, L. Petetta ¹, F. Onori ¹

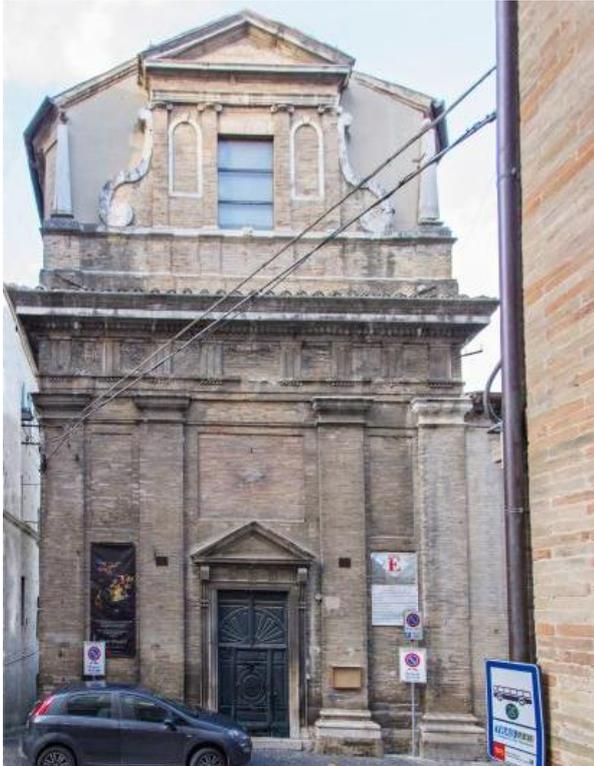
The main façade (Figure 1) is composed of two completely different architectural styles that clearly distinguish the most

ancient basal body of the front from the top of the same that evidence, instead, the awkward elevation created between 1772 and 1838 in order to increase the internal volume of the liturgical hall (Fermo, Archivio Arcivescovile, 1838; Fermo, Archivio Arcivescovile, 1772).

Figure 1. Main facade of the "Chiesa della Pietà" (by Onori F.)

The oldest part of the façade, which is made up of four sturdy Doric columns on which a trabeation protrudes, was designed by the architect Oliviero Spinucci and was performed by the stonemason "mastro Nicolò Veneziano" in the first step and by the "mastro Venturi" in the second one (1606) (Maranesi, 2002).

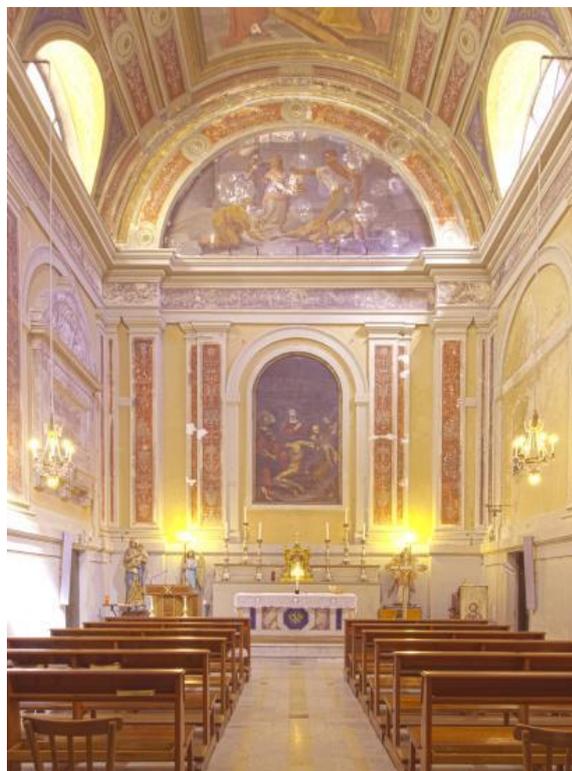
Figure 2. Internal view of the "Chiesa della Pietà" (by Onori F.)

The internal space of the Church (Figure 2) is articulated into a single central nave where the main altar is placed in opposite position to the entrance door and two minor altars are placed adjacent to the side walls. Near the left altar there is also a funeral mausoleum built in 1851 by the roman sculptor Ignazio Jacometti. The interior space is entirely frescoed and decorated with pilasters, arches and cornices that are repeated creating a well-defined rhythmic motif. Of value is the ceiling of the nave made with a barrel vault also completely frescoed with depictions inspired by the life of St. John the Baptist. The decorative part is attributed to Pietro Lucchi, while the frescoes are the work of the painter Giacomo Cordella exponent of the school of purists (1872) (Maranesi, 2002).

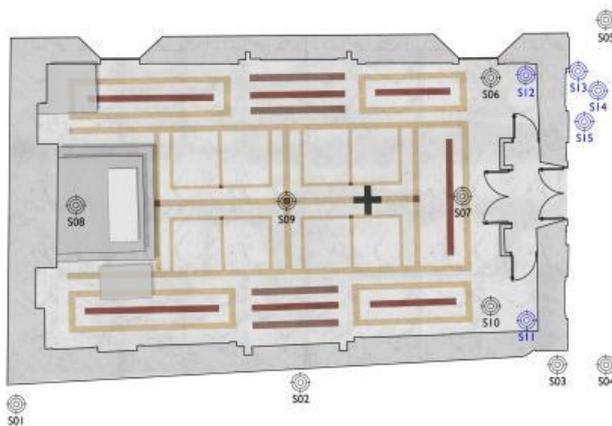
The workflow pipeline starts with the data acquisition developing to the creation of the 3D model. The ground-based photogrammetric survey of interior and exterior environments of the church is carried by the TLS Leica C10 basing on more scans made from different point positioning following a network schema (Figure 3).

Figure 3. The acquisition network schema

For interior environment, it has been created a reference system using targets. For the survey of exterior, instead, the reference system is based on the use of two tripods: the first with the laser scanner and the second one, a viewfinder positioned manually, that has been identified during a 360° scan by the laser scanner. On each scanning position, 360° panoramic photos are made by the reflex camera Canon D80, placed on the top of the tripod (Figure 4). Photos useful to texture the 3D model derived by laser scanner acquisition.

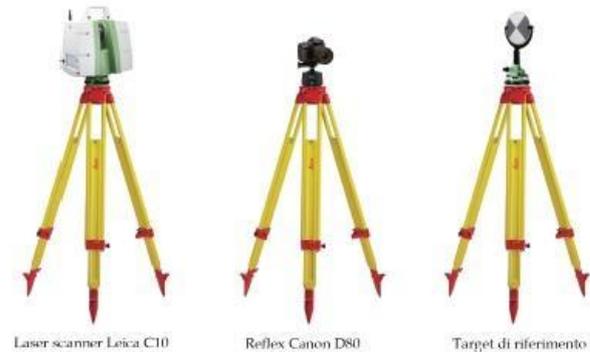
Figure 4. Topographic instruments for the surveying

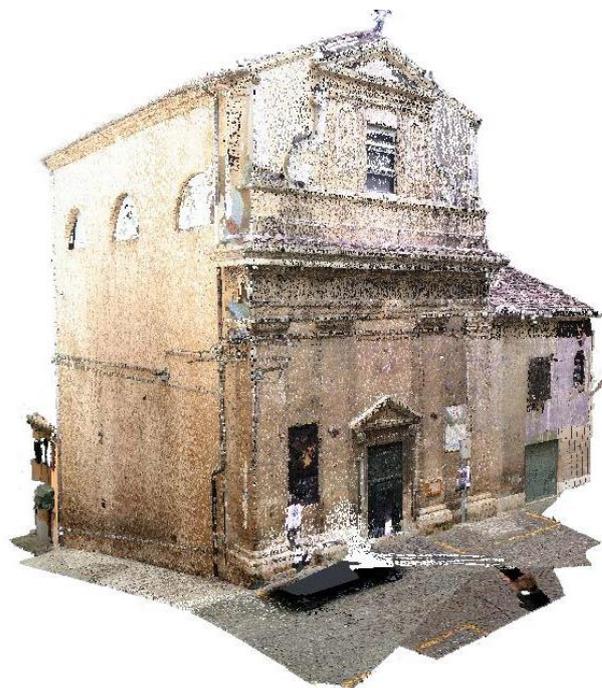
Aligning the points cloud through the software Cyclone and mapping them directly with the images from the photographic survey, and so getting a result of strong representative realism, it is possible to obtain the point cloud of the whole object for a 3D representation (Figure 5), managed with an absolute error of 0.003 mt, on Autodesk ReCap.

Figure 5. Points cloud textured by the images (by Onori F.)

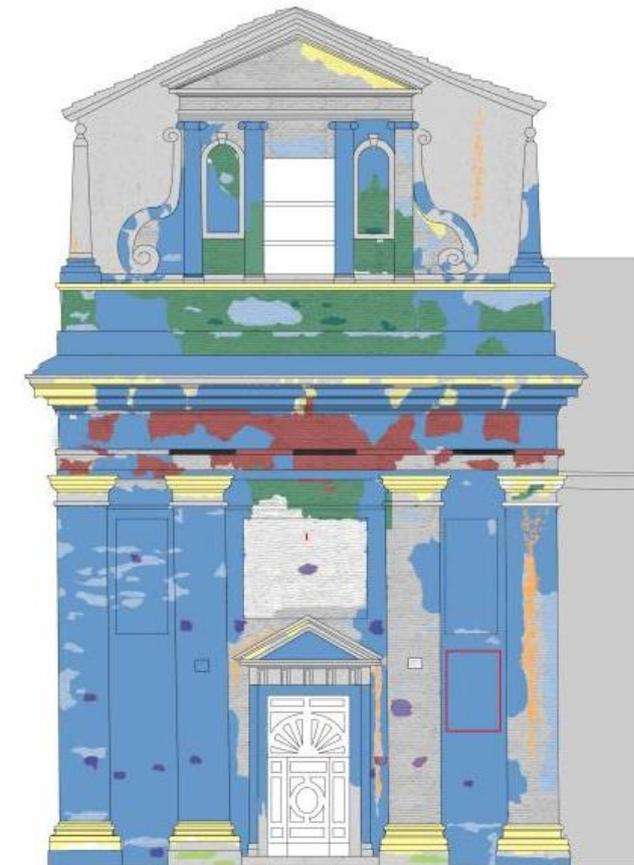
DECAY	DESCRIPTION	CAUSES
SURFACE DEPOSIT	NATURAL MODIFICATION OF THE SURFACE NOT CONNECTABLE TO DECAY PHENOMENA AND PERCEPTIBLE AS A VARIATION OF THE NATURAL COLOR.	-MECHANICAL EROSION OF RAIN -WIND EROSION -CHEMICAL AGGRESSION FROM POLLUTANTS -FORMATION OF ICE ON THE SURFACE
LAITENCE	FORMATION OF SUBSTANCE ON THE SURFACE OF THE BUILDING WITH WHITISH COLOR OF CRYSTALLINE, DUSTED AND FILAMENTOUS APPEARANCE	-MECHANICAL EROSION OF RAIN
BIOLOGICAL PATINA	COLOR LAYER SEES THIN, SOFT AND HOMOGENEOUS, ADHERENT TO THE SURFACE AND OF EVIDENT BIOLOGICAL NATURE	-ACCUMULATION OF MOISTURE -ATTACK OF AUTOTROPHIC ORGANISMS (BACTERIA, UNICELLULARS, LICHENS, HIGHER)
SURFACE WASHOUT	VARIATION OF ONE OR MORE PARAMETERS THAT DEFINE THE COLOR. IN THIS CASE IT MANIFESTS ITSELF IN THE FORM OF A LARGE DISCOLORATION ON THE BUILDING	-RAINWATER RUNOFF
DISINTEGRATION OF MALTA JOINTS	DE-COHESION CHARACTERIZED BY THE DETACHMENT OF GRANULES OR CRYSTALS FROM MORTAR STRATIGRAPHY	-MECHANICAL EROSION OF RAIN -WIND EROSION -CHEMICAL AGGRESSION FROM POLLUTANTS -FORMATION OF ICE ON THE SURFACE

STAIN	LOCALIZED CHROMATIC VARIATION OF THE SURFACE, CORRELATED TO THE PRESENCE OF FOREIGN MATERIALS (WATER, OXIDATION PRODUCTS, PAINTS, ORGANIC SUBSTANCES)	-INFILTRATION HUMIDITY
LEAKAGE	DARK STAINS WITH A VERTICAL COURSE BELOW THE PROJECTIONS	-RAINWATER RUNOFF
ABSENCE	FALL OR LOSS OF PARTS OF MATERIAL	-MECHANICAL EROSION BY ATMOSPHERIC AGENTS
CONCRETION	COMPACT DEPOSIT GENERALLY FORMED BY ELEMENTS OF LIMITED EXTENSION, DEVELOPED PREFERENTIALLY IN A SINGLE DIRECTION NOT COINCIDING WITH THE STONE SURFACE	-MECHANICAL EROSION OF RAIN -ACCUMULATIONS OF MOISTURE
INCONGRUABLE PATCH	ANTHROPIC INTERVENTION ON THE SURFACE OF THE BUILDING THAT AESTHETICALLY DETERIORATES THE BUILDING ITSELF	-ANTHROPIC INTERVENTION
INCONGRUOUS ELEMENTS	PRESENCE OF INCONGRUOUS ELEMENTS THAT AESTHETICALLY DETERIORATE THE SURFACE OF THE BUILDING	-ANTHROPIC INTERVENTION

Figure 6. Main façade: thematic map of the material decay and related descriptive legend (Onori F.)

- the South façade (or main facade) (Figure 6) is the one that presents more altered because for most of its surface are present superficial deposit phenomena mainly due to chemical attack by pollutants such as dust from combustion of the vehicles, and by the mechanical action of wind and heavy rain. For these same reasons the alteration in some parts of the façade also manifests

itself in the form of efflorescence, superficial leaching, concretion and/or dripping (developed especially at the protrusions). There are also other forms of decay such as: the disintegration of mortar joints (also caused by the action of rain, wind and pollutants), the formation of biological patina, exclusively in small parts of the base of the columns and the lack of some parts of the frieze that collapsed as a result of the mechanical action of atmospheric agents. There are signs, finally, human interventions such as repair works carried out with techniques and materials incongruous with the original state of the monument and improper insertion of elements such as hooks and/or metal boards. Particular attention in the identification of decay pathologies has been placed in the analysis of the conservation status of the entrance portal: the stone materials and the brick elements have undergone mechanical erosion by atmospheric agents and there is a clear superficial deposit due to the pollution dust deriving above all from the combustion gases of vehicles passing nearby; the metal elements, made of wrought iron, due to heavy rain and lack of maintenance, show a general state of oxidation and corrosion with the formation of rust; the doorway, made of wood with two doors, is in a slight state of deterioration mainly due to lack of maintenance. This manifests an accumulation of humidity in particular in the basal part and the cracking of the wood in some places.

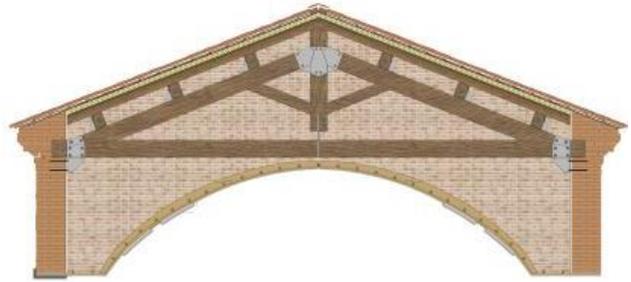
Once acquired the geometric and material survey of the artefact, a series of investigations have been carried out to assess the surfaces and material decay of the external façades and internal environments. Then, for each found pathology, a specific intervention of restoration and conservation (Franceschi, Germani, 2010) was identified in compliance with the UNI-NorMal 11182:2006 standard and the NorMal 1/88 Recommendations. Furthermore, some structural problems have been occurred, mainly due to the infiltrations of water that percolates from the roof: through some access points it has been possible to investigate and verify the presence of an advanced state of deterioration of the roof covering and of the wooden supporting structure of the roof. Given this condition, it was decided to hypothesize a complete replacement of the roof with new elements but typologically similar to the pre-existing ones. Only for the wooden trusses it is proposed, instead of the substitution, the restoration of the wood elements that compose it and the strengthening of the supports to the walls with metallic elements (Figure 7).

Figure 7. Roof construction details (by Onori F.)

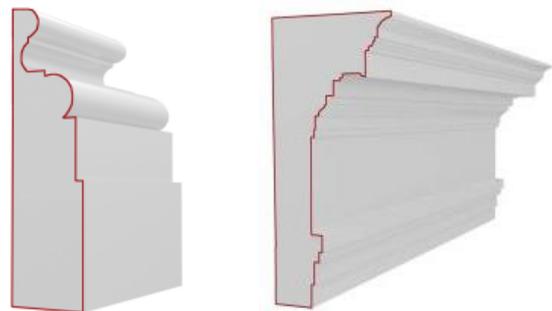
For these reasons we decided to adopt the parametric object-oriented modelling, basing on the use of pre-modelled object inserted in libraries of the HBIM software (Quattrini et al, 2015). Among software of direct modelling, we chose Rhinoceros to design 3D elements with complex shapes through operations of extrusion and revolution of composite profiles (Figure 8). These elements can be downloaded in the parametric model on software Autodesk Revit, used for the HBIM implementation.

Figure 8. Examples of direct modelling processing

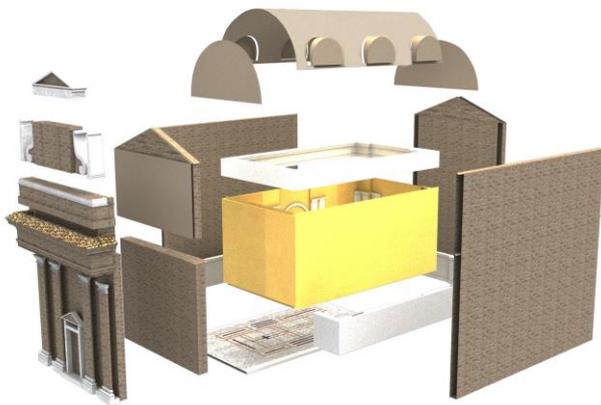
In this case it has been adopted three levels of geometry classification: the first for the representation of the building in the urban context, the second for the functional organization of the building areas, the latter one basing on the classification of architectural components. So, in deep, the level 1 coincides with the whole building. The spatial distribution allows to make a volumetric decomposition, identifying the interior areas for the functional classification of level 2. The third level is a division based on macro-elements such as: walls, floor, vault, etc. A subclass of this level describes the single components of each element, the micro-elements defining characteristics of the architectural style. (Figure 9)

Figure 9. Exploded axonometry of the 3D model showing the architectural components

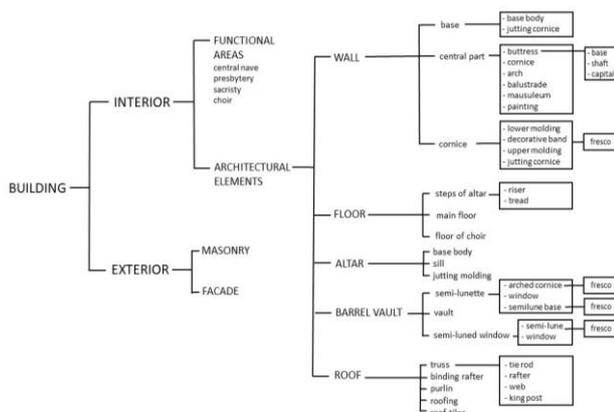
The design of the database architecture has a fundamental importance on the architecture of a HBIM, because the complexity and the usefulness of the information structure depends on it. According to the choice of LOD, the information structure of the monumental complex is built basing on the geometrical decomposition as illustrated above in the graph (Figure 10). In the same graph the classification explains better the functional logical process to the 3D modelling. This schema is useful to understand how decomposing the building and can be used as the basis of the next semantic classification.

Figure 10. Graph of the geometrical classification and the architectural elements

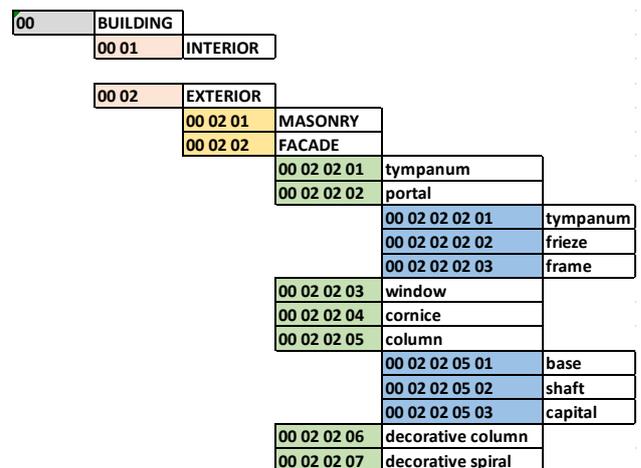
In Revit the 3D model is built with its components as separated entities attributing to them an ID-code that can be identified univocally. We tried to build a unique flexible database collecting all the components of the building and dividing them in classes and subclasses. A hierarchical structure that specifies the belonging of each entity to that part of the building. If the building has the ID-code “00”, interior environment has been assigned with a sub ID-code “00 01”, while exterior has been indicated as “00 02”. Following this hierarchy it becomes simply to continue the assignment of the ID-code to all the entities belonging to parts or areas of both interior and exterior environment of the church. As the result we generated a tree-structure database.

In Figure 11 you can see part of this classification concerning the exterior, in particular the facade element. Look also Figure 12 to understand better the labelled attribution to the elements in the facade model.

Figure 11. Tree-structure database with the ID-code assigned to each component

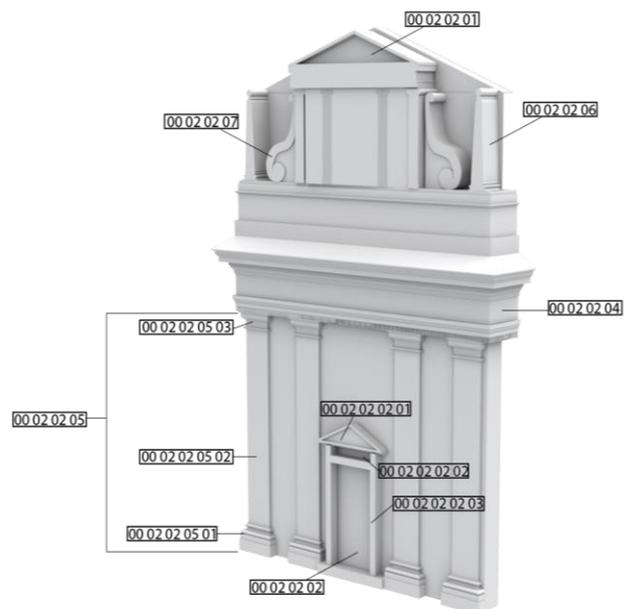
Figure 12. Labelling of the entities related to the 3D model of the facade

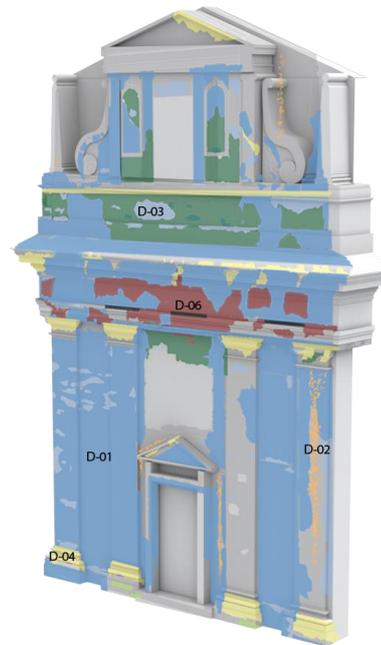
ID-code	DECAY	COLOR ATTRIBUTES
D-01	SURFACE DEPOSIT	blue
D-02	SURFACE WASHOUT	orange
D-03	LAITENCE	light blue
D-04	LEAKAGE	yellow
D-05	ABSENCE	black
D-06	CONCRETION	bordeaux
D-07	INCONGRUOUS ELEMENTS	red

Figure 13. ID-code attributing to the material decay (legend of the Figure 14)

In order to do that, the use an adaptive component was proposed: it is a particular object that can be adapted to the surface of the 3D model. In this way the thematic mapping of the material decay, analysed before, is applied, for example, to the 3D model of the façade of the church (Fig. 14).

Figure 14. 3D thematic mapping of material decay

3D modeling of decays in the HBIM platform ensures to enrich the related database with graphic and geometric data that can be effectively used to design and manage future interventions. The added value consists to associate new ID-code that identify the state of conservation of the materials and the detailed description of interventions needed to restore the building. (Figure 13).
