TLS FOR DETECTING SMALL DAMAGES ON A BUILDING FAÇADE

KEY WORDS: Laser Scanning, Damage Detection, Maintenance, Spatial Filtering

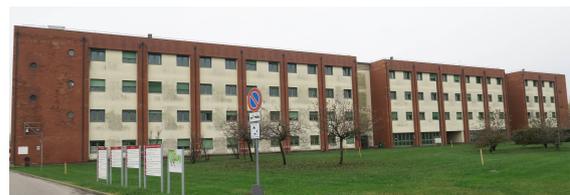
Figure 1. University building façade considered in this work.

The above considerations motivate the use of alternative, mostly automated, remote sensing tools for checking damaged areas on a building façade. To be more specific, this work considers the problem of determining damaged bricks on a building of the University of Padua (Fig. 1). Given the significant amount of damaged bricks on such façade it is very important to determine a reliable estimate of the number of those to be restored/substituted in order to limit the current maintenance costs while ensuring a satisfying result.

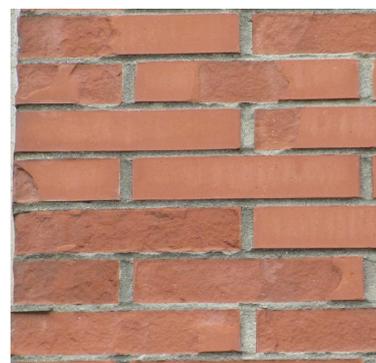
Figure 2. Close view of bricks on the façade.

Given the different aspect of damaged bricks with respect to regular ones (Fig. 2), a viable way to detect damaged bricks can

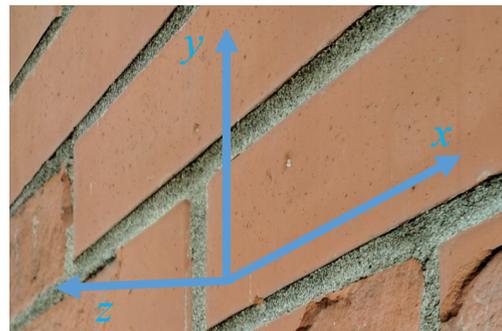
Figure 3. Reference system.

First, brick areas of the façade can be roughly determined by setting a proper threshold on the measured laser intensity. Then, the planar surface which fits best the considered brick area on the façade is computed and exploited in order to change the TLS point cloud reference system: x and y axes are set on the detected plane, with x and y axes corresponding to the horizontal and vertical direction, respectively. z axis is set orthogonal to façade surface, pointing outside of the wall (e.g. towards the laser scanner, approximately, as shown in Fig. 3).

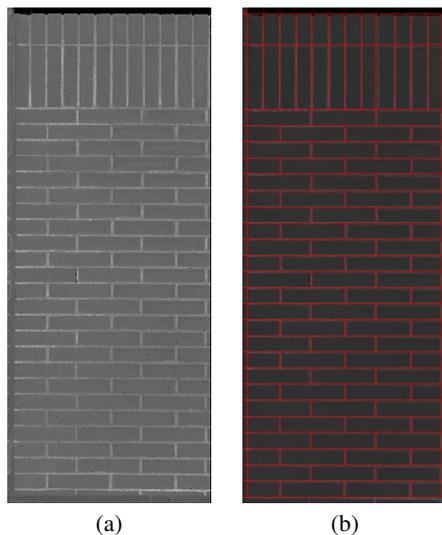
Figure 4. (a) Laser intensities (a) and (b) rough brick segmentation.

Then, similarly to (Sithole, 2008), a rough brick segmentation can be obtained by taking into account of the laser intensities and of the regular brick pattern, as shown Fig. 4.

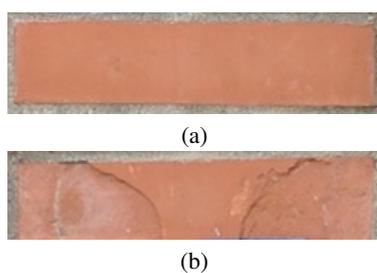
Figure 5. Example of brick in good conditions (a) and a damaged one (b).

First, assume to consider a brick in good conditions (e.g. Fig. 5(a)) and to locally fit a planar surface to its point cloud. Then, compute the distribution of the point-to-plane distances, as shown in Fig. 6(a). Since the considered brick is in good conditions, the planar surface should well describe the real geometry of the brick, hence the distribution shown in Fig. 5(a) can be considered as quite representative of the a posteriori laser scanning measurement error (standard deviation of 1.7 mm for the distribution in Fig. 5(a)), or, more precisely, it can be used to assess the measurement error statistical characteristics along the direction orthogonal to the brick surface, which actually is the direction our main interest in order to discriminate damaged bricks.

Then, the above procedure is repeated for the damaged brick shown in Fig. 5(b), obtaining the error distribution in Fig. 6(b) (standard deviation of 2.2 mm).

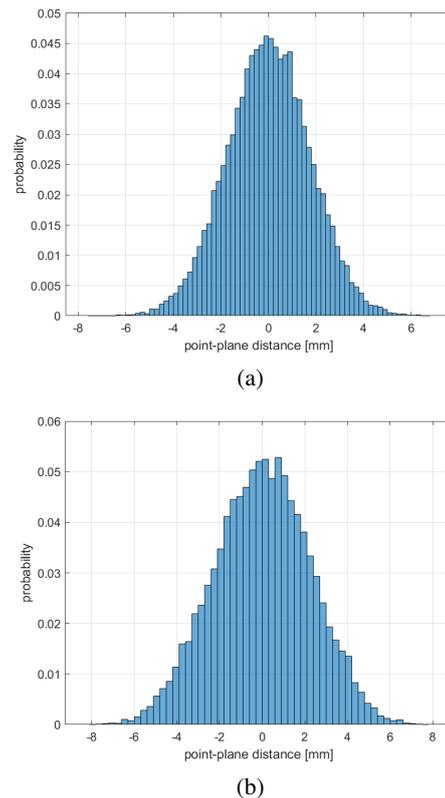
Figure 6. Histograms of point-to-plane distances for the two bricks shown in Fig. 5.

As shown in Fig. 6, roughness/geometric variations in the two considered studies are quite hardly visible by comparing the two point-to-plane distance distributions: despite a slight difference in the standard deviation, the two distributions are quite similar. Given such similarity, it is quite apparent that in both the cases the (approximately Gaussian) shape of such distributions is mostly caused by the laser scanner measurement noise: actually, in most of the considered bricks, laser scanning measurement noise is larger than the typical “depth” of the damages to be detected.

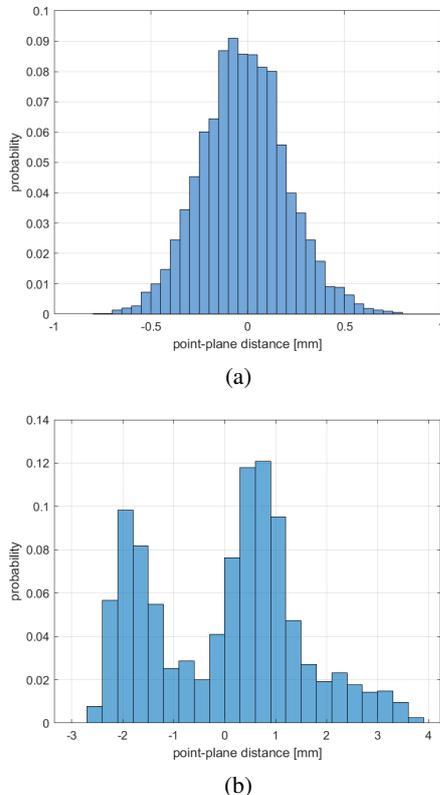
Figure 7. Histogram of point-to-plane distances for damaged brick shown in Fig. 5(b).

Furthermore, the considered error model only describes only approximately the real error. Consider for instance the case of the brick in Fig. 5(a), and assume to filter the z values averaging the measured values in a 1 cm square neighborhood (which corresponds in the considered case to an average number of considered points $n = 165$): the resulting distribution, shown in Fig. 7(a) has standard deviation 0.025 mm. Since such computation has

In order to check the effectiveness of the spatial filtering procedure for the detection of small damages on the bricks, Fig. 7(b) shows the error distribution of the filtered results obtained on the brick shown in Fig. 5(b). Differently from Fig. 7(a), it is clear that in this case most of the variation along the z axis is due to the damage: it is actually apparent that the distribution in Fig. 7(b) is multi-modal, where the two modes are associated to the central (in good conditions) and to the left and right (damaged) areas of the brick in Fig. 5(b).

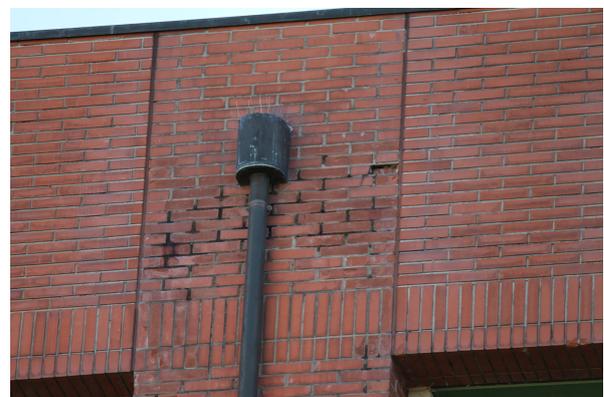
Figure 8. Test area.

The proposed procedure has been applied on a set of 523 bricks on the top part of the building façade, with the laser scanner positioned on the ground, approximately 27 m far from the façade. Most of the test area is shown in Fig. 8. TLS acquisitions have been done with a high point density, 120–130 points/cm².

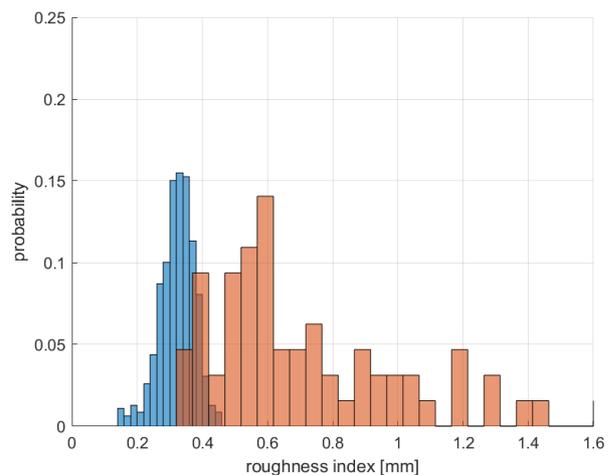
Figure 9. Comparison of roughness index distributions for bricks in good conditions (blue) and damaged ones (red).

Fig. 9 shows the roughness index of the filtered point cloud comparing the roughness of the bricks in good conditions (blue) with respect to the damaged ones (red).

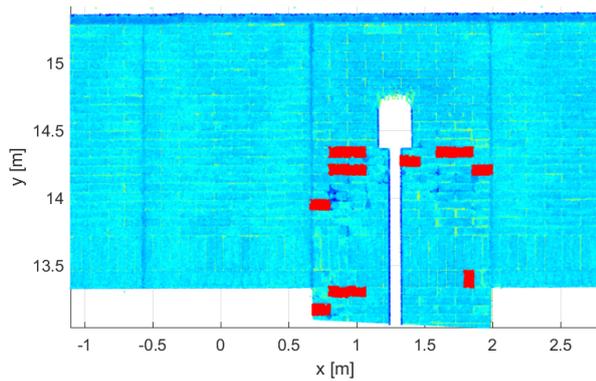
Figure 10. Misclassified bricks (red).

Fig. 10 shows the misclassified bricks (in red): 9 bricks were misclassified (1.7% error).

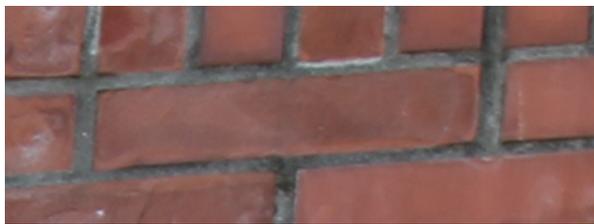
Figure 11. Example of misclassified brick.

Fig. 10 shows an example of misclassified damaged brick: despite the brick is damaged, its surface is quite close to planar, making it hard to be distinguished with respect to one in good conditions.

The proposed procedure allowed to correctly classify 98.3% of the bricks, where most of the errors were related to damaged bricks with almost planar surfaces, as shown in Fig. 11.
