GEOMATICS IN BRIDGE STRUCTURAL HEALTH MONITORING, INTEGRATING TERRESTRIAL LASER SCANNING TECHNIQUES AND GEOTECHNICAL INSPECTIONS ON A HIGH VALUE CULTURAL HERITAGE.

KEY WORDS: Terrestrial Laser Scanning (TLS), Cultural Heritage (CH), Bridge Structural Monitoring, Surface Comparison

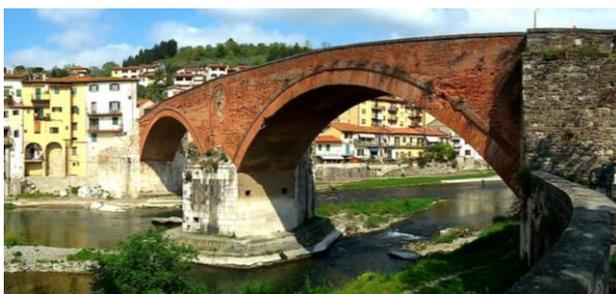
Figure 1 - View from the right side of the bridge, current state.

As a matter of facts, the Pontassieve bridge (Fig. 1) has experienced many restoration interventions during the past years, having the opportunity to build a long period monitoring would therefore permit to assess the bridge's structural health in a more comprehensive way. In detail, after a few years of inactivity, the left span bridge's has been opened to the regular flux of water. Immediately after, a maelstrom (Fig. 2) has been noticed as permanently present at the main pier's basis highlighting the presence of a fracture in the concrete base around the central pile of the bridge.

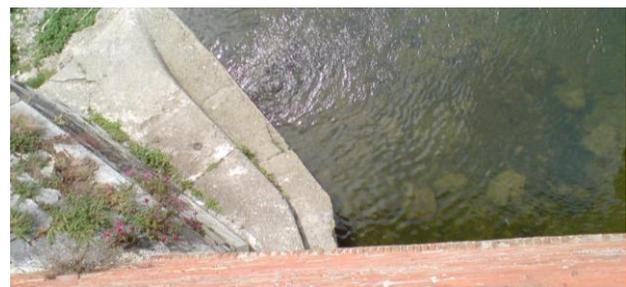
Figure 2 – View from the top of the bridge of the emerging

The flux of water is the offshoot of a current that comes out of the basement itself and that, joining the Sieve in its natural path, rises towards the surface of the water creating this turbulence effect. Over the years (local people have asserted that this phenomenon has been visible since the 1990s) the current has been dug into the basement and started a process of erosion, which could easily lead to undermine the stability of the entire bridge's structure.

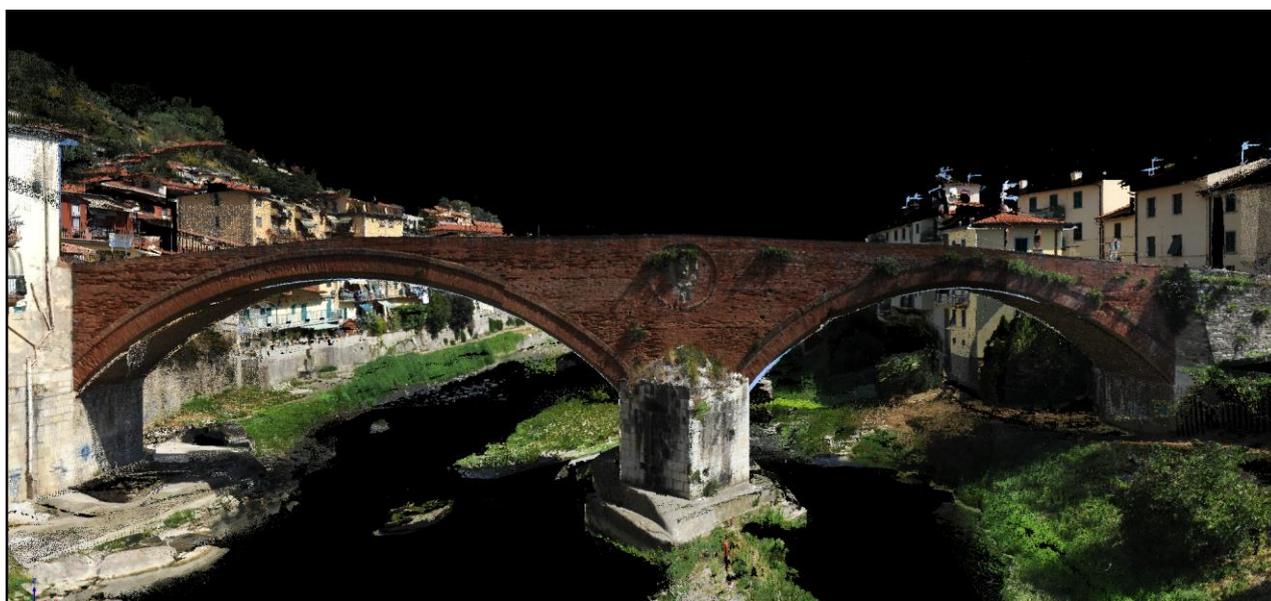
Figure 2 – Pontassieve bridge's coloured 3D point cloud. south view.

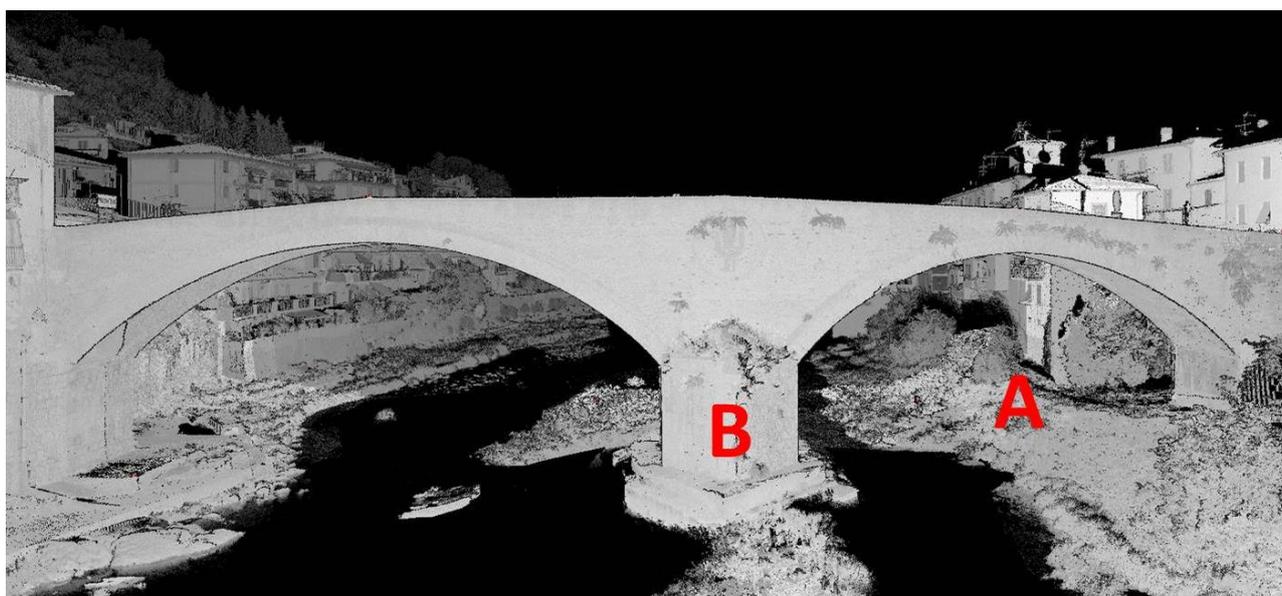
Figure 3 - Merged Point cloud from 2017 Laser Scanner campaign. A) Left span. B) Central Pillar.

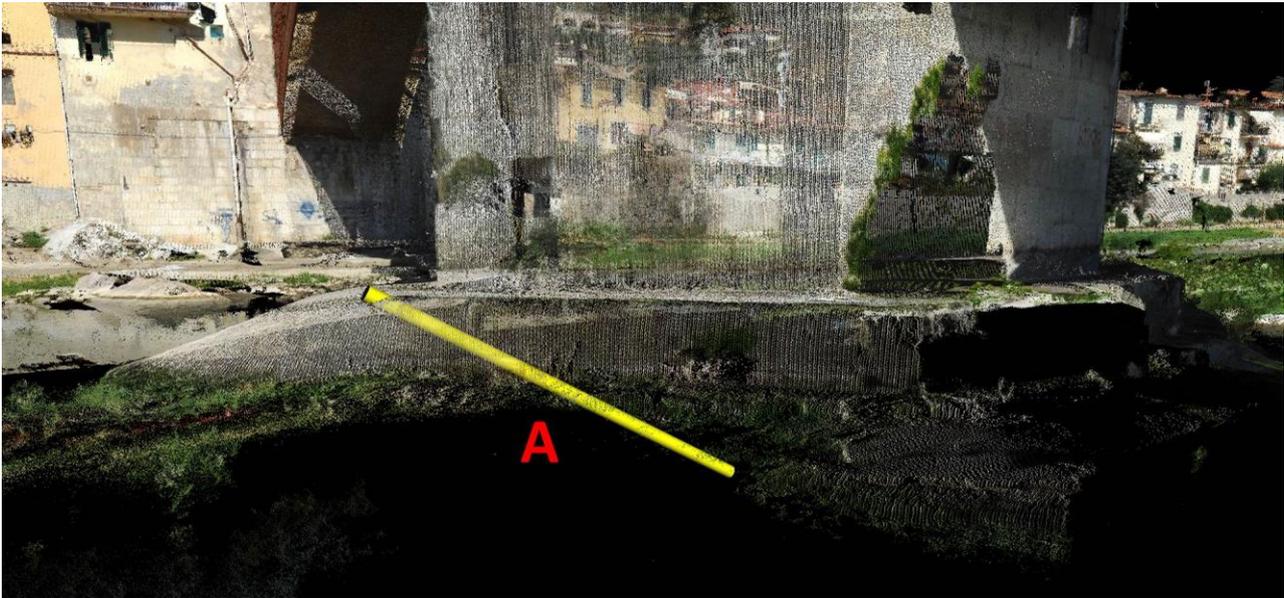
Figure 4 - Visualization of the Inclined borehole (a) on the central pillar's coloured point cloud. Inspection detected a vacuity inside the pillar structure.

The inspection campaign consisted both of a vertical borehole inspection, conducted in the bedrock underlying the main pillar, and of an inclined borehole (Fig. 3) conducted through the pillar structure.

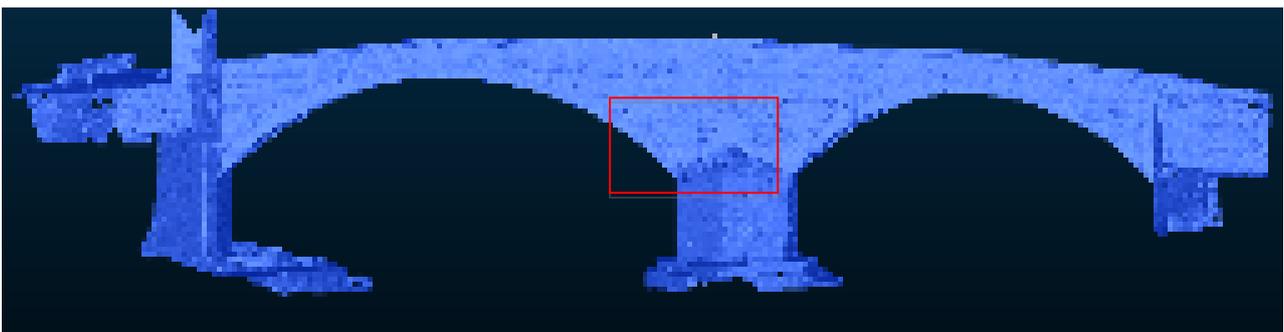
Figure 4 – 3D mesh of the bridge obtained from point cloud by applying the following parameters: Octree depth =14, Samples per node =4, Full depth =8, Point weight =12, Boundary= Dirichlet

The comparison between 2011 and 2017 points clouds have been carried out using both automatic and manual techniques. One of the two point clouds was not geo-referenced during the acquisition campaign, to superimpose the two point clouds an automatic detection algorithm has been used. However, to avoid misleading results, the automatic detection and coupling of the two point clouds has been processed on the bridgeheads only, without manipulating the central part of the bridge, that represent the core subject of the study case and has to be investigated. Figure 4 shows 3D mesh that has been generated from point clouds.

This is a well known and solid technique in TLS inspection software. Surface change is calculated by the distance between a point cloud and a reference 3D mesh (Olsen et al. 2010). To realize the mesh of the bridge CloudCompare software (EDF R&D, 2011) has been used, in particular the Poissons Surface Reconstruction plug-in (Kazhdan et al. 2006). Once the mesh has been obtained (Fig.7), it has been used as reference surface to perform surface comparison. Figure 7 shows several hotspots identified by the automatic comparison under right bridge span between 2011 and 2017 scans. A manual procedure was also carried out to verify results from automatic comparison. Carrying out comparison analysis no major deformations have been identified. Accordingly to the acquisitions' standard deviation, the comparisons have been carried out considering different displacement thresholds: lower than 2 cm, up to 4 cm, up to 6 and up to 10 cm, accordingly to the acquisitions' standard deviation < 70 mm. In the bottom surface of the bridge's span, both on the left and on the right span. To verify

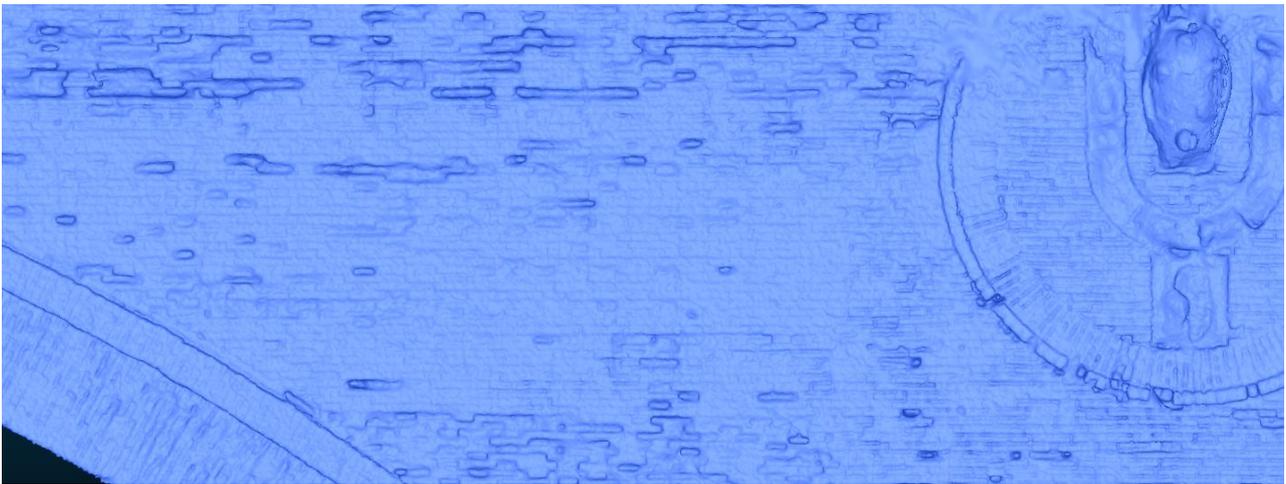
Figure 5 – Particular of the 3D mesh. Red square in figure 6.

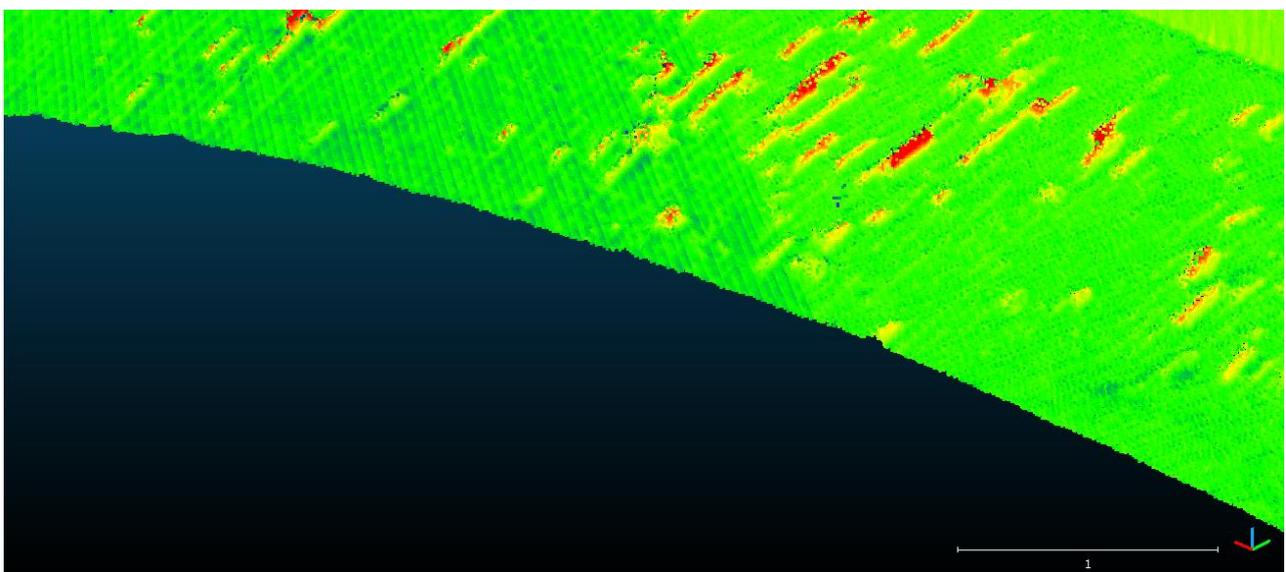
Figure 6 - Surface comparison through Cloud Compare software.

reliability of results a manual approach has also been conducted. Some discrepancies between automatic and manual one have been highlighted. The reasons of why such a false positives have been obtained, has to be identified in the different angle of view under which the scans have been performed in the two different years. As a matter of facts, the performed surface comparison analysis have been carried out by comparing the mesh from year 2011 scanning and the point cloud from year 2017 scanning. The 2011 TLS survey has been carried out using a HDS 6000 laser scanner (Leica Geosystems), while for performing the year 2017 TLS survey, a RIEGL VZ1000 has been used. Through the Geo-referencing procedure, which was made in post processing, a value of 0,067 (m) for residual standard deviation was obtained. For some reasons, mainly attributable to contract and feasibility constraints, further GPS campaigns, to improve accuracy and consequently to reduce residual standard deviation values, has not been performed. In order to mitigate residual standard deviation values obtained by Geo-referencing procedures, a set of weary parameters has been imposed to reconstruct the 2017

mesh. The final surface, especially for areas that have been scanned under certain angles of view, resulted approximate to the real object surface. Running surface comparison, the coupled effect of high residual standard deviation values and shaded areas, produced misleading results.

On the basis of a preliminary evaluation based on in field evidences, identified damages have been triggered by surficial weathering process. Nevertheless, considering the presence of the maelstrom, nurtured by the constant flux of water acting within the basement under the central pillar, periodical TLS should be planned to perform a long period monitoring.
