EXPERIENCES IN CADASTRAL RESTITUTION AT A TOWN AFFECTED BY A NATURAL DISASTER. THE CASE OF VOLCAN, JUJUY PROVINCE, ARGENTINA

KEY WORDS: UAVs, Cadaster, Surveying, Mapping, Planning, Landslides, Floods

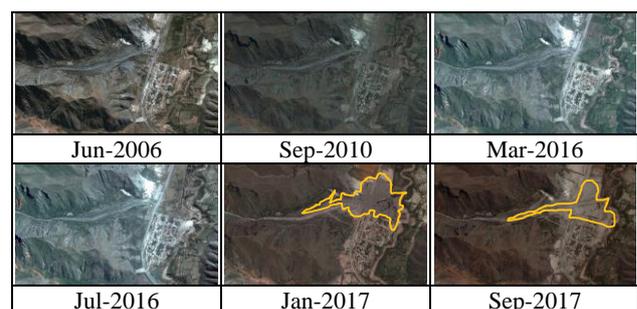
Figure 1. Evolution of Area in time

The following images (Figure 1) show the effect of the avalanche in the area and in the town of Volcán.

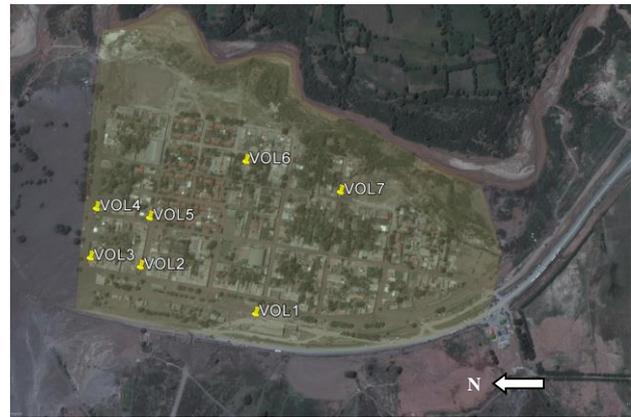
Figure 2. Area under study and GCP locations
 © 2018 DigitalGlobe (Google Earth)

The area under study for the Cadastral Registry is show in Figure 2. As natural limits, the Gral. San Martín Avenue was taken to the North, the Rio Grande to the East, the RN9 to the South and the RN9 to the West.

Ground Control Points (GCPs) were placed in different positions distributed in the urban layout (see Figure 2), which were subsequently used in the photogrammetric process and additionally some of them served as scale controls of the three-dimensional surface model (DSM).

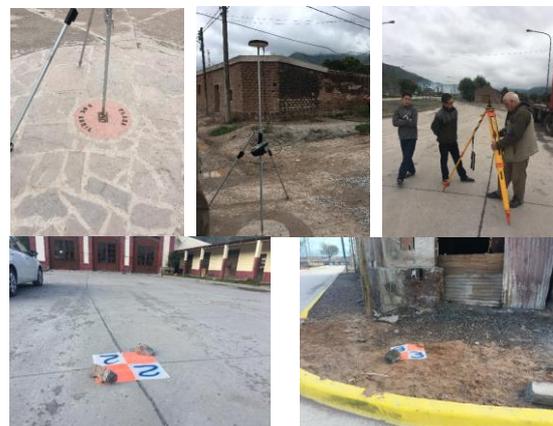
Figure 3. GCPs, Measurement and mark

In some cases, these marks were placed in easily identifiable unalterable points (Manyoky et al. 2011), in order to avoid the placing of marks in a possible fast campaign.

GCPs were geolocated in the POSGAR 94 Argentine Geodetic Positions System from the reference point of a nearby point² (7.67 km) of the Network (M. Rijsdijk et al. 2013).

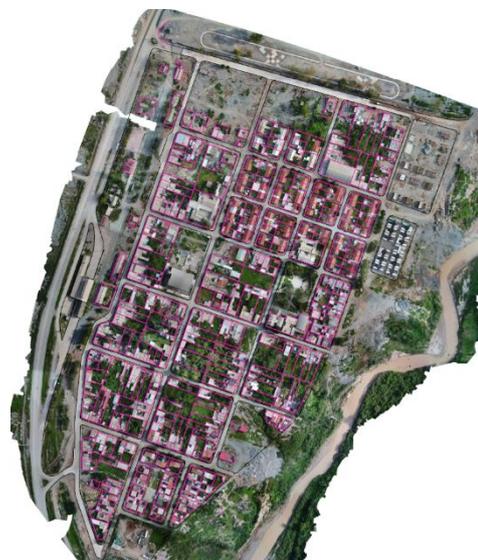
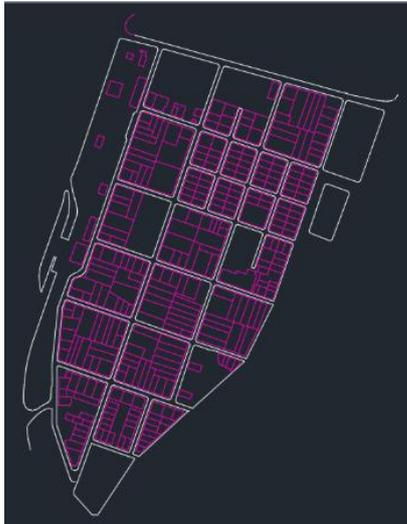
Figures 4, 5 and 6 shows the Cadastral Map perform from the Orthomosaic plotted using "existing facts" and other Cadastral elements.

Figure 4. Cadastral Map

Figure 5. Cadastral Map

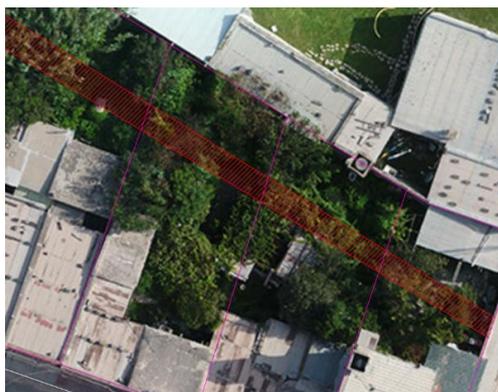
Figure 7 shows a Public Use Area (in this case a drainage area) occupied by constructions which should be corrected or removed.

Figure 7. Hatched Area is a Drainage Area badly used by privates
