THE USAGE OF TLS AND PHOTOGRAMMETRY DURING THE RESTORATION PROCESS OF SPANISH NATIONAL MONUMENT

Yolanda Spairani-Berrio^{1*}, Pascual Saura Gómez¹, J. Antonio Huesca-Tortosa¹, Silvia Spairani Berrio¹, David Torregrosa Fuentes¹

KEY WORDS: TLS, Photogrammetry, Cultural Heritage, Restoration methodology, Vaults restoration, Restoration survey.

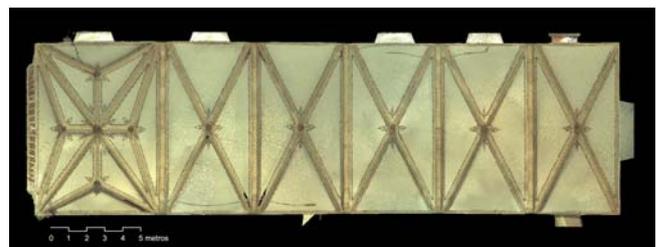
Figure 1: Zenith view of the vaults

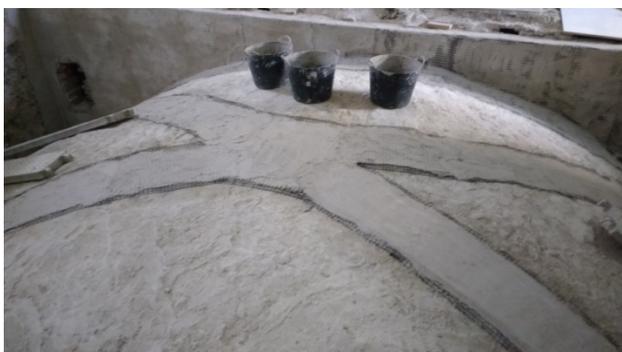
Figure 2: Reinforcement with Planitop HDM and fiberglass Mapei

2.3. The outside wall has been stabilized and consolidated by injecting fluid lime mortar. The existing cracks in vaults and arches have been sealed with special lime mortars, and some stitching with fiberglass rods has been made. For the purpose of binding the walls closing the refectory, steel braces system has been prepared. The vaults extrados has been reinforced using rendering with two-component mortar fiber-reinforced PLANITOP HDM, restoration reinforced with fiberglass mesh from the Mapei brand.

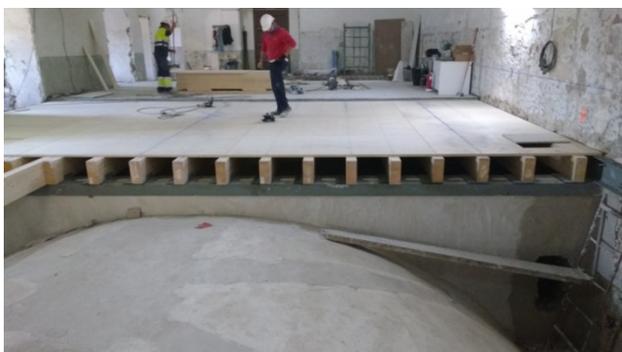
Figure 3: Reinforcement on wall ribs

2.4. Subsequently, we have followed with the placing of the new horizontal half-timbered on the second floor (forged on the refectory) with unidirectional slabs using wooden laminated beams with waterproof double board beam filling and compression layer of 80 mm thickness lightweight concrete with electrowelded lath. Slabs with beams-joists of reinforced concrete carried out in situ are made in the outer area among buttresses. All of them bound on the perimeter by means of reinforced concrete and metal framing, in order to create a lattice on the perimeter binding all the slabs on the arches and walls limits.

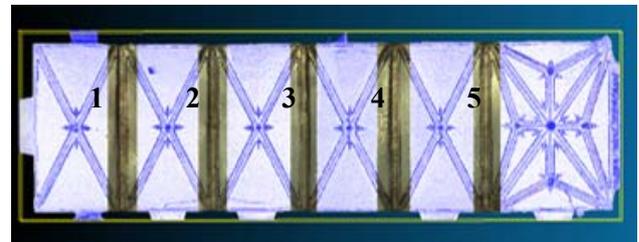
Figure 4: Part of vaulted structure: numbers of archs

sections that allow us to analyze both the dimensions of the different construction systems as deformations and displacements produced, both the arches-nerves and the vaults. Of all the results obtained and in order to generate a valid criterion to analyze the behavior of the vaulted structure of the Refectory, has been considered in each of the nerves (archs 1, 2, 3 and 4) points A, B and C in the intrados of the arch, corresponding to 1/4, 1/2 and 3/4 of the light, and that approximately concur with the kidneys and key of the archs.

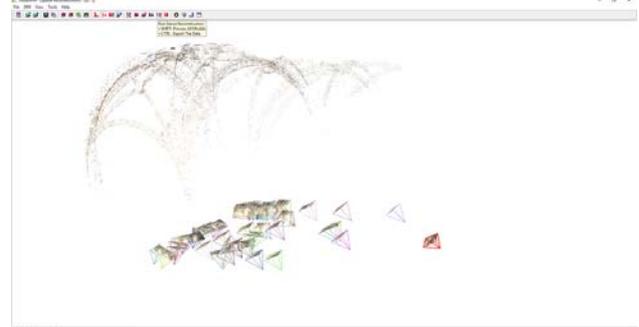
Figure 5: location of photographs in Visual SfM

On the other hand, photogrammetry by VisualSfM is used, obtaining digital photography by taking photos using a reflex camera Canon EOS 600D, with a standard lens Canon EF-S 18-55mm. The photo processing has been made with Agisoft Metashape Professional software.

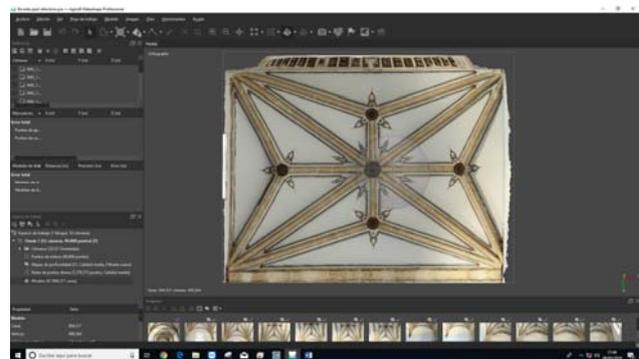
Figure 6: Model 3D in Agisoft Metashape

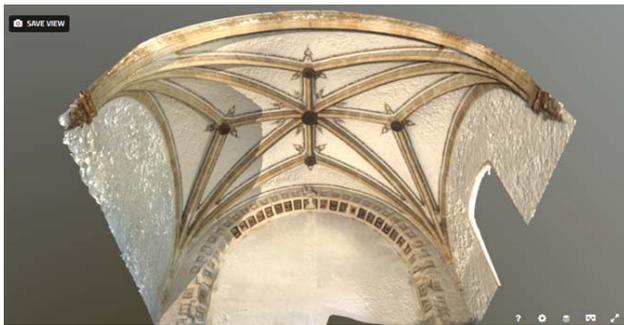
Figure 7: Model 3D with texture shared in Sketchfab

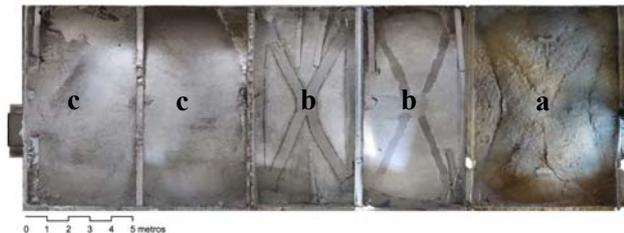
Figure 8: Vaults extrados on its different restoration stages (a): original, (b): during restoration, (c) finished. Photogrammetric study by Agisoft Metashape

It has also been a great help to document the construction phases of the walls faithfully in order to carry out archaeological studies of them, currently in the drafting phase of the final archaeological and architectural report (e.g. figure 8 and 15)

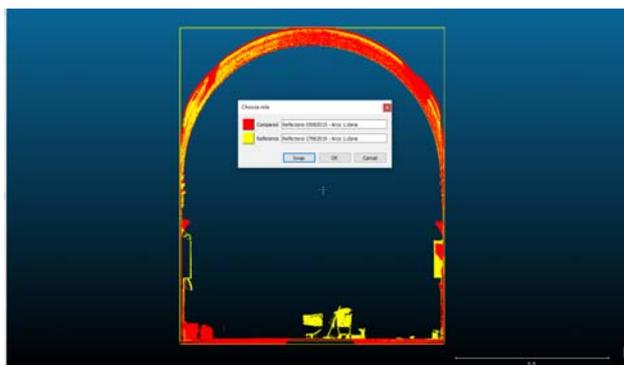
Figure 9: comparing cloud to cloud with Cloudcompare. Clouds data 2015 and 2019

The comparative studies carried out from the data collection with the techniques referred to in August 2015 and June 2019 (once the execution works of the new slabs have been completed, including the reinforcements in vaults and arches) reflect a null movement of the structures, no deformations have made compared with to the first state. The data obtained in the measurements reflect the point clouds and they contain absolute errors of the order in 1-3 mm, in such a way that the differences between the initial and final measurements are in the aforementioned interval of 1 mm.

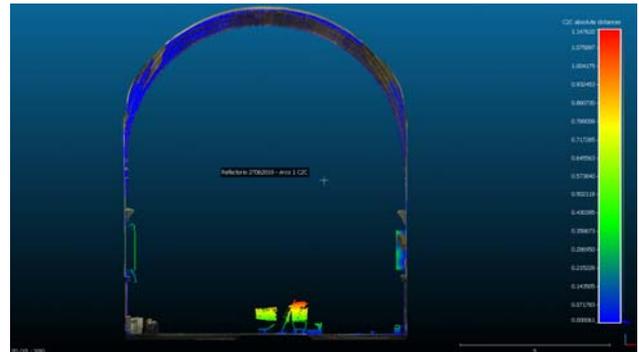
Figure 10: comparing cloud to cloud with Cloudcompare. Deformation study en arch 1

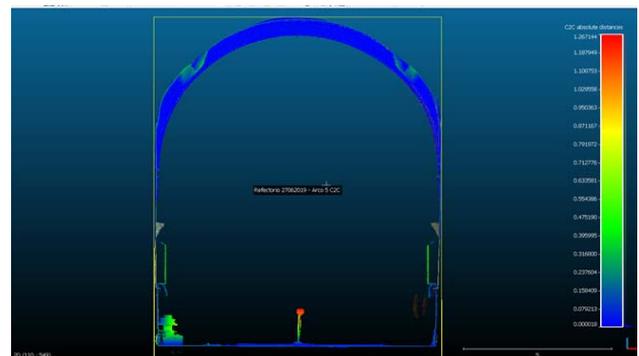
Figure 11: comparing cloud to cloud with Cloudcompare. Deformation study en arch 5

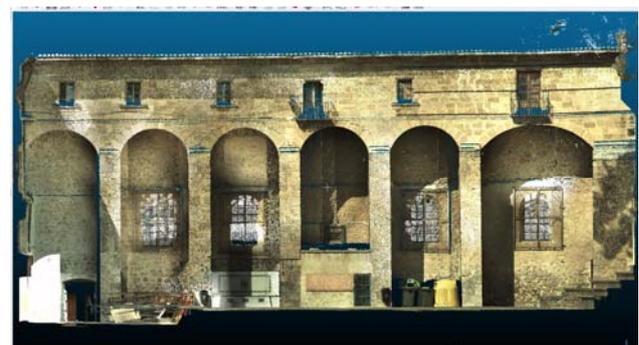
Figure 12: East facade with perceptible deformation

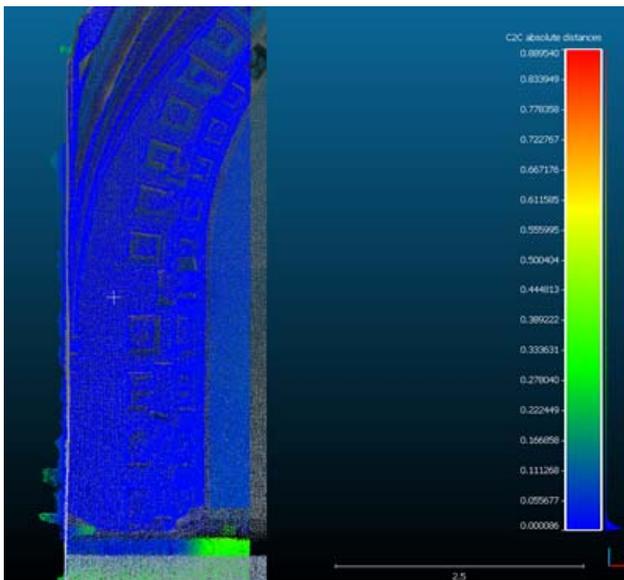
Figure 13: Crack location in wall: depth study and evaluation

With the comparison of point clouds (original-final) it has been possible to quantify the deformations of some elements, as well as their location. Specifically in relation to the areas affected by movements of the nerves of the vaults (difference of position in its initial state and its final final state, e.g. figure 13). And to quantify the depth of some of the most important cracks that the building presented (e.g. figure 12).

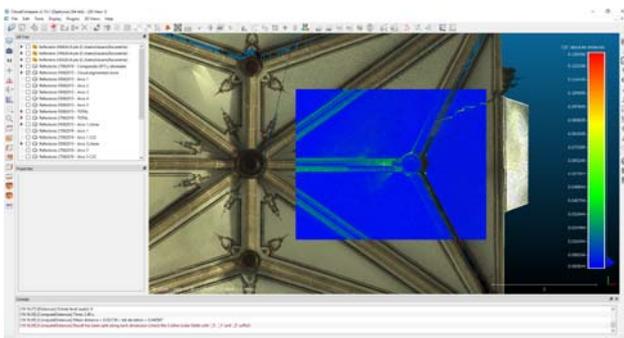
Figure 14: Deformation and descent of cross vault nerves moving evaluation

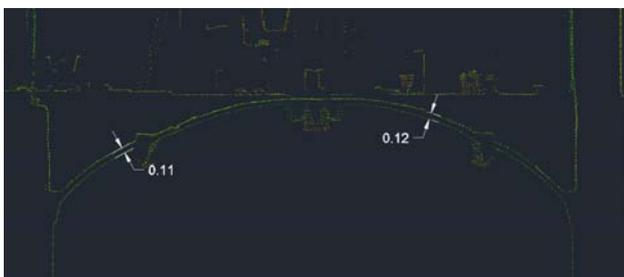
Figure 15: Point cloud section during the restoration works. The measure of the vault section can be obtained.

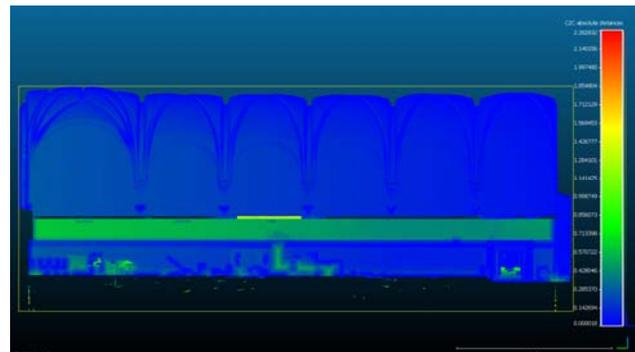
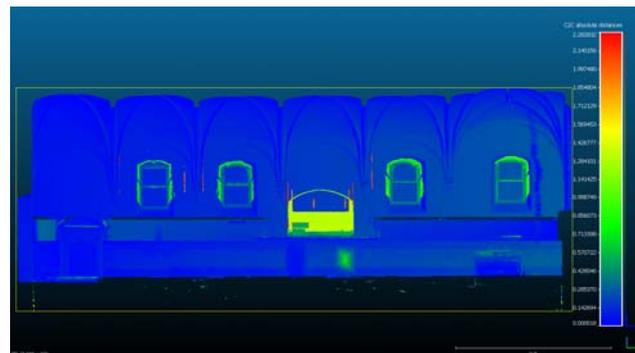
Figure 16: Cloud to cloud comparison (original state and final state) lateral east and west
