THE CHURCH OF SANT'ANDREA IN BERGAMO: AN INTEGRATED SURVEY FOR KNOWLEDGE AND CONSERVATION

A. Cardaci¹, G. Mirabella-Roberti¹, P. Azzola¹

¹ Dept. of Engineering and Applied Sciences, University of Bergamo, v.le Marconi, 5 – 24044 Dalmine, Italy
(alessio.cardaci, giulio.mirabella, pi.azzola)@unibg.it

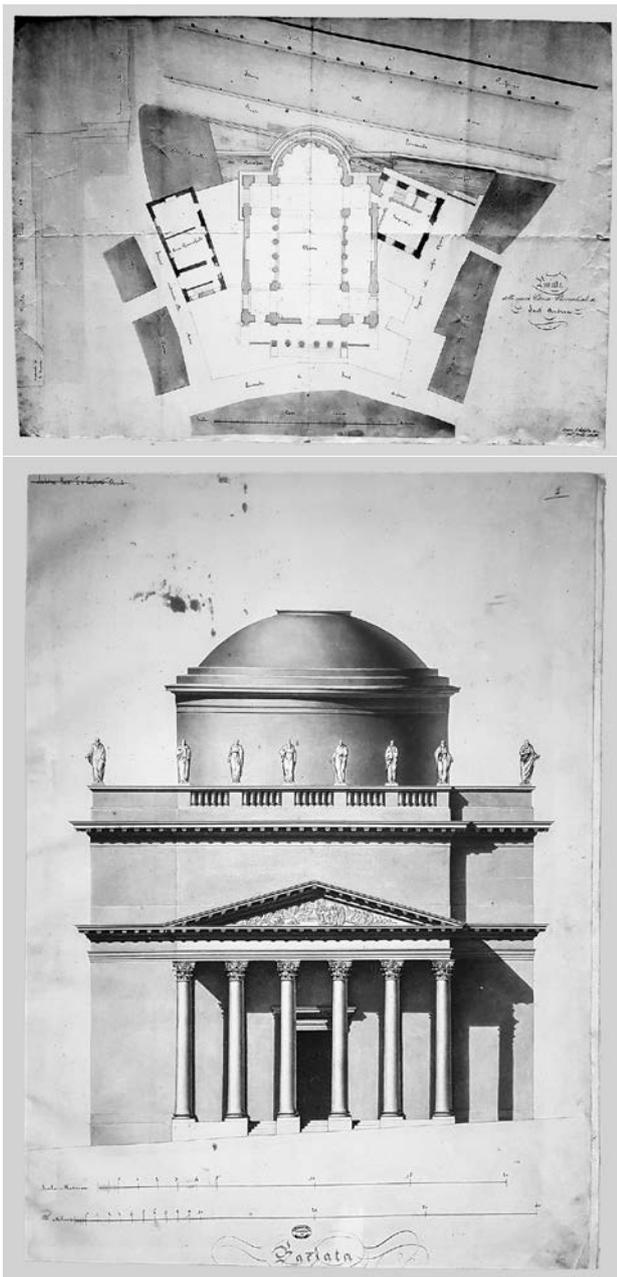
Figure 1. The second project of Ferdinando Crivelli for Sant'Andrea church.

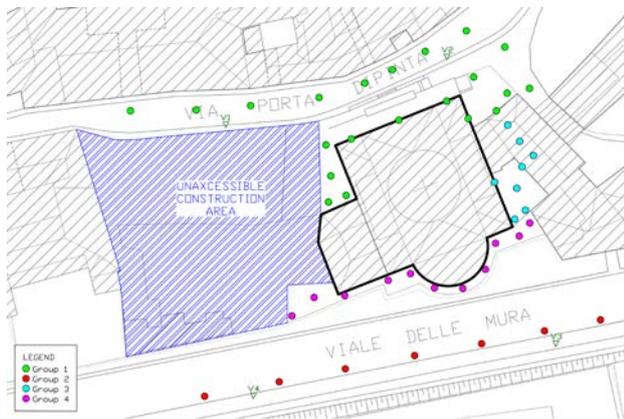
Figure 3. External positions for laser scanning acquisition.

The east façade is not visible because it is adjacent to other buildings, while an inaccessible site area to the west of the church has prevented the terrestrial acquisition with the circular method around the perimeter of the church, although there was the possibility of observing fixed points on high buildings in the area from both roads. This particular topographical situation implied to acquire the data mainly along the roads to the north (group 1, 21 scans) and to the south (group 2, 7 scans), creating connections to the west through the aforementioned fixed points and to the east by a walkway inside the rectory (group 3, 8 scans). A pedestrian passageway on the south side (group 4, 11 scans) at an intermediate level between those of via Porta Dipinta and viale delle Mura has also been used to strengthen the connection. At each entrance door to the church, a scan was performed in order to prepare the model for subsequent completion with the internal scans.

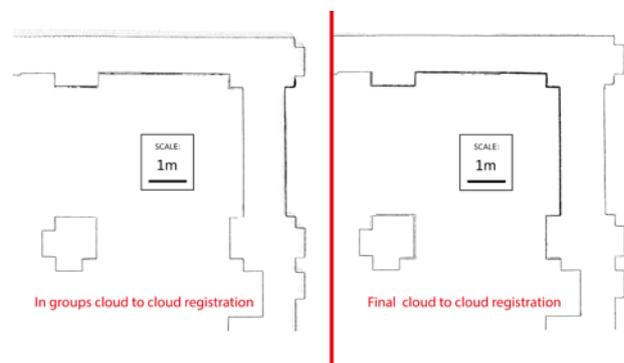
Figure 5. Alignment results before and after the final registration

The mutual alignment from cloud to cloud of the ten rigid groups constituted a rough positioning of the single scans since the model presented macroscopic alignment errors greater than the statistical values calculated in the report produced by @FARO SCENE. However, this elaboration phase was necessary to manage the large number of scans. The result of laser scanning processing has been optimized extracting all scans from the group folders and performing a final cloud-to-cloud registration making a large number of iterations. The overall improvement is confirmed by the result of the alignment report. There are still rare cases of misalignment of some scans, probably due to accidental errors during the acquisition phase.

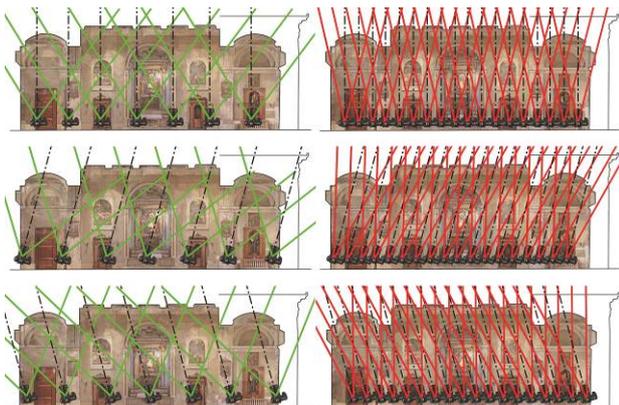
Figure 6. Camera axis direction, field of view and overlapping length in case of 24 mm lens (left) and 70 mm lens (right)

Additional images were acquired with camera axis tilted about 15° from the vertical in both directions. This value was chosen to improve the correct modelling of the existing 3D elements (overhangs, cornices, column capitals). A similar procedure was carried out for the walls setting (horizontal camera axis), as was for the floor (sub-horizontal camera axis).

An overlapping of contiguous shots varying between 60% and 80% of the length determined the acquisition step, calculated from time to time, was respected.

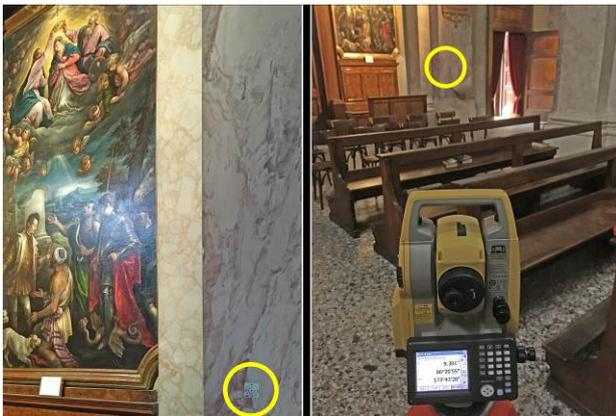
Figure 7. Internal church total-station network survey

accuracy (Wujanz et al., 2019). It makes use of the existing six reflective targets already present for photogrammetry phase, but this is based on a total-station survey, more accurate and precise compared to that was used in the previous phases which was based on four urban topographic vertices. The polar coordinates of the new local reference system, converted into Cartesian coordinates, were assigned to the targets of the laser-scanning model.

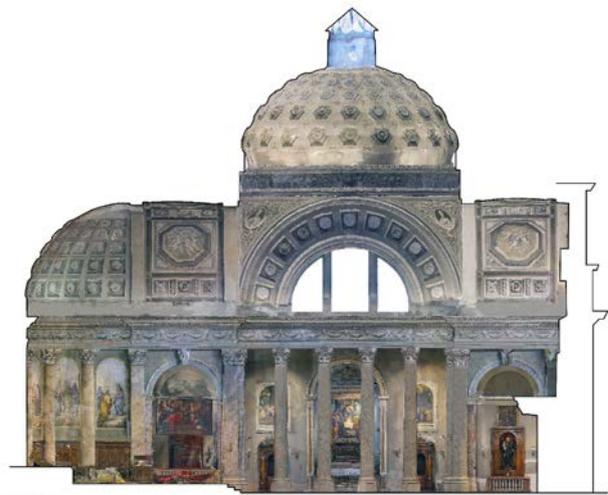
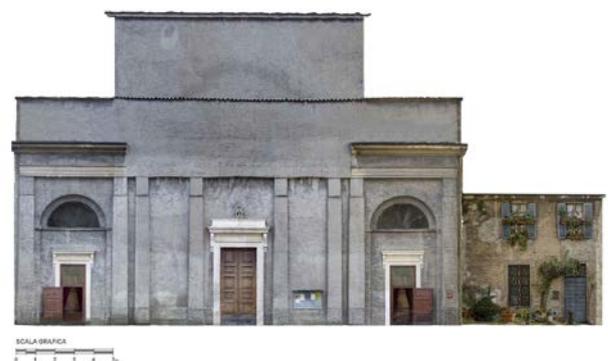
Figure 8. Orthographic projection of the longitudinal section (top) and of the façade (bottom).

The result of laser scanning processing is a project cloud with homogenized point density subsampled at 3mm in grey tones according to the reflectance value, which allowed the extraction of the typical technical drawings for the building (plans, sections and elevations).

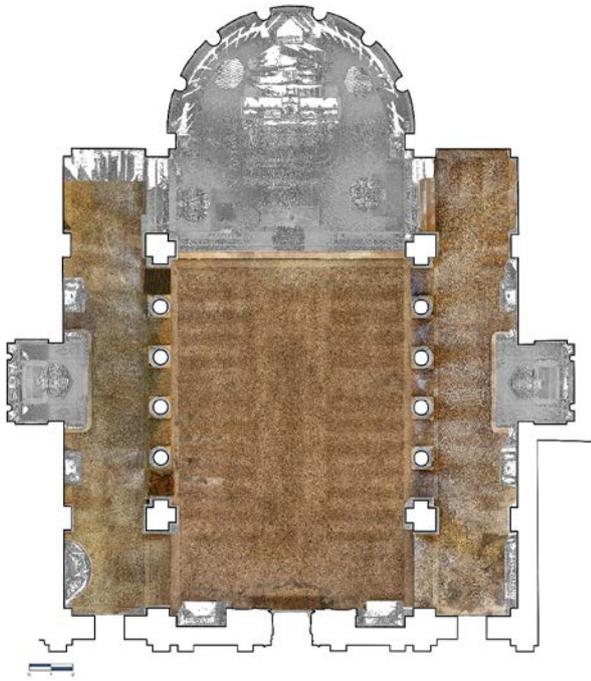
Figure 9. Internal plan with the photogrammetric floor texture

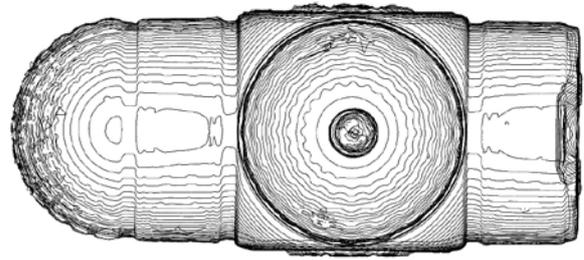
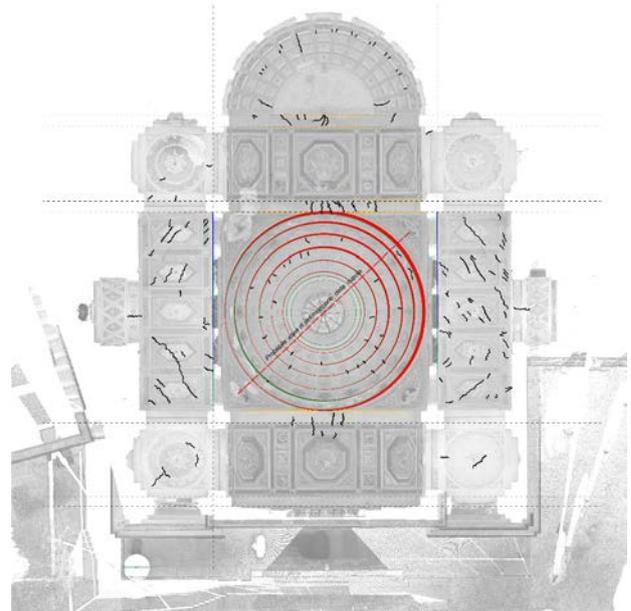
Figure 11. Geometrical analysis of the vaults and the dome: contour map of levels (top), hypsographic plan (bottom) with cracking pattern and dome deformation representation.

The point cloud of the dome was intersected with horizontal planes with constant pitch through an automated procedure with the software @3DFLOW Zephyr Aerial. The interpolation of the centres of the circumferences resulting from the intersection of horizontal planes with the hemispherical surface of the dome defined the inclination of its axis (Artese et al. 2019) that resulted equal to 0.86° in the direction of the apse (Figure 11).

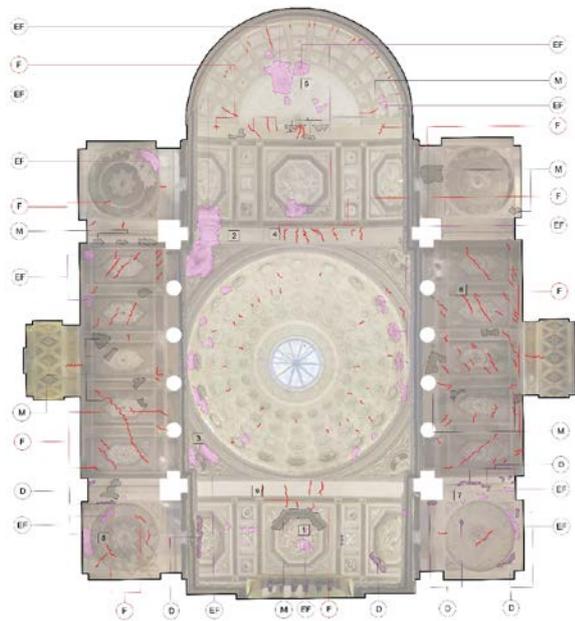
Figure 10. Hypsographic view of the ceiling with the projection of the vaults and the domes: cracking pattern and decay mapping.

The trend of the surface obtained from the points belonging to the interior floor (DSM) shows also a slight slope in South-West direction (Figure 12). The two combined observations could be a hint suggesting a possible roto-translation towards the downstream of the whole complex. Moreover, a deformation of the barrel vaults in correspondence with the arches sustaining the central dome is also evident, confirmed by the cracking pattern on the crown of this arches and a sort of 'punching effect' on the lateral naves (Figure 10).

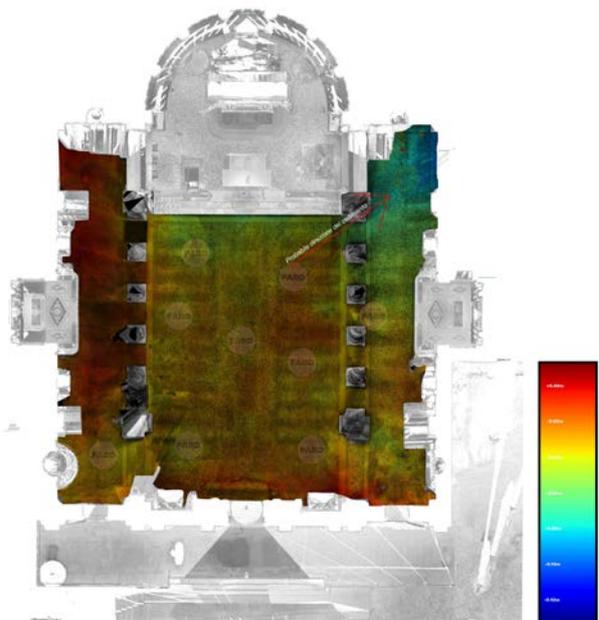
Figure 12. Digital Elevation Model of the internal floor surface
