HBIM FOR THE SEISMIC VULNERABILITY ASSESSMENT OF TRADITIONAL BELL TOWERS

A. Mondello ¹, R. Garozzo ¹, A. Salemi ¹, C. Santagati ^{1*}

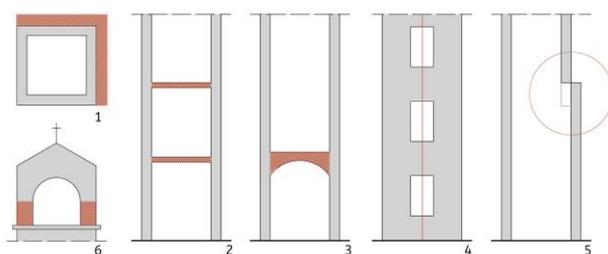
Figure 2. Explanatory schemes of geometric vulnerability indicators: 1. asymmetrical constraint; 2. empty tower; 3. vault in ground floor; 4. aligned openings; 5. discontinuous vertical wall; 6. slender piers.

In order to link the geometric vulnerability indicators to the modelled bell tower, these indicators were rearranged according with the semantic subdivision made by the chosen parametric platform and converted in shared parameters.

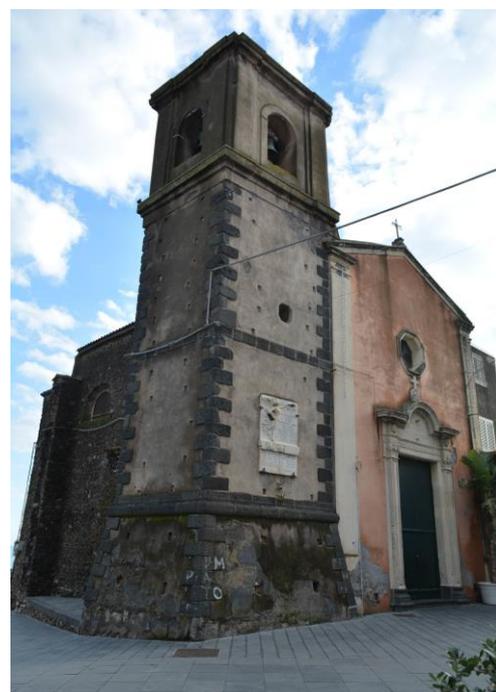
Figure 3. The church of San Giuseppe in Aci Castello (Catania).

The church of San Giuseppe is located at the eastern end of the historic centre of Aci Castello, a small town on the Ionian coast of the Etna area (Fig. 3). The church and its bell tower were built around 1740, although the lower part of the tower may be older than the bell cell, which is certainly from the 18th century. In 1908, the tower suffered the demolition of the original majolica cusp crowning the bell cell.

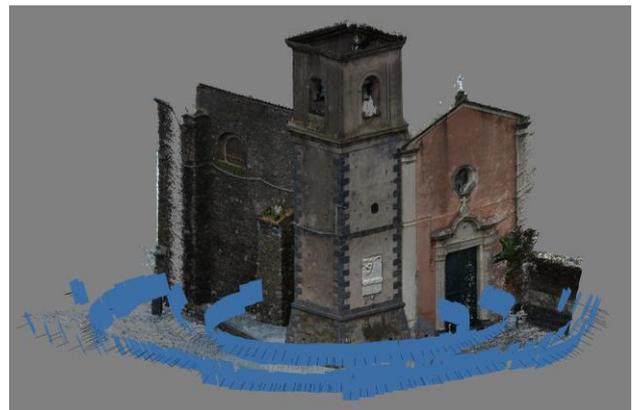
Figure 4. The point cloud obtained with a SfM photogrammetric approach.

Data collection was conducted using a Nikon D5200, focal length of 27 mm, with a resolution of 24 MP, for a total of 296 images, taken from the ground. The GDS (ground sampling distance) is 2.9 mm/pix. The photographic dataset was automatically processed with Agisoft Metashape. A first stage of cameras alignment was followed by a sparse and, then, a dense point cloud reconstruction (10.218.757 points) (Fig.4).

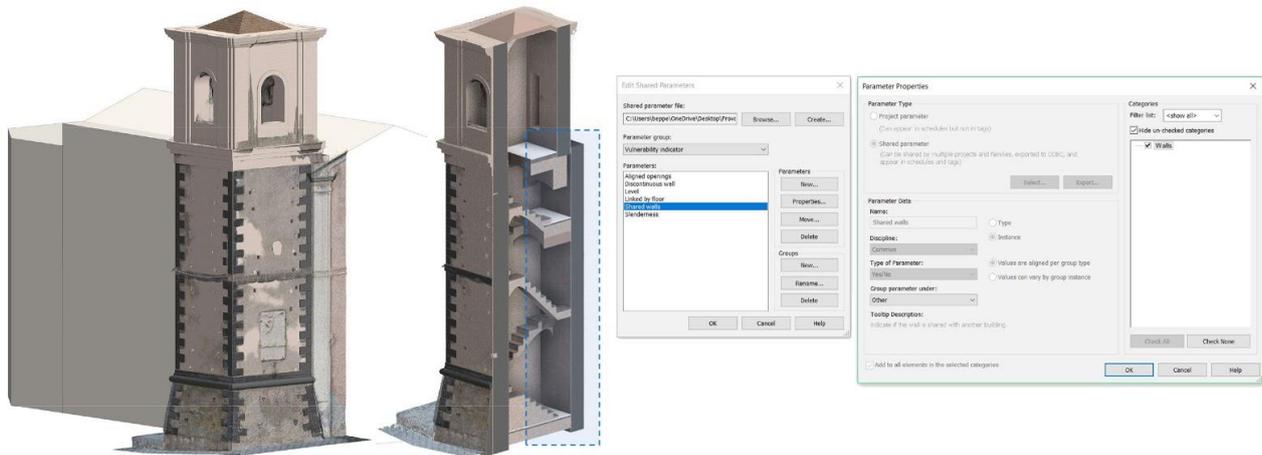
Figure 5. The HBIM of San Giuseppe bell tower superimposed on the point cloud. The shared parameters group and the parameter properties (taken as an example the “shared wall” parameter) are shown on the right.

The rampant vaults of the stairs, instead, were modelled as parametric floor-based families, that can be adjusted after performing a more reliable interior survey (Fig. 5).
