THE CONTRIBUTION OF EARTH OBSERVATION TECHNOLOGIES TO MONITORING STRATEGIES OF CULTURAL LANDSCAPES AND SITES

KEY WORDS: Cultural landscapes, Earth Observation, satellite remote sensing, GIS, Cultural Heritage policy, geo-hazards

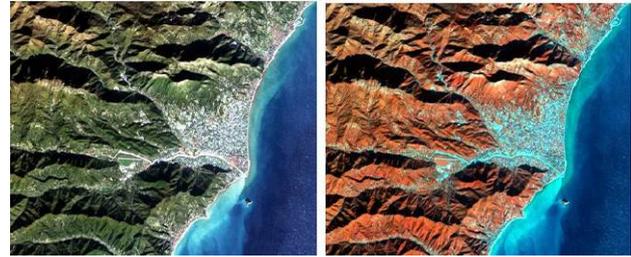
Figure 1. Town of Albenga and delta of Centa River on Nov 29th, 2016: (left) Red – Green – Blue (RGB) true colour composite i.e. the band combination that corresponds to the human vision; and (right) in NIR – green – blue pseudo colour composite that enhances the presence of vegetation (in red).

Figure 1 shows delta of Centa River and Albenga locality on Nov 29th 2016, observed in a multi-spectral image through different band combinations.

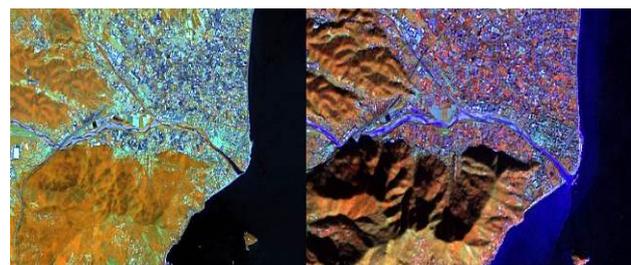
Figure 2. Town of Albenga and delta of Centa River seen in SWIR- NIR - red pseudo colour composite that enhances the difference between land and water bodies in May (left) and Nov 2016 (right).

These steps are illustrated here below confronting the images obtained. Figure 2 and Figure 3 show the area of the study in SWIR- NIR - red pseudo colour composite that offers added definition of land-water boundaries and enhances details not easily recognizable in the visible bands alone (USGS, 2016). The area depicted in the white square (Fig. 4) refers to the larger context of Albenga partially submerged archaeological site.

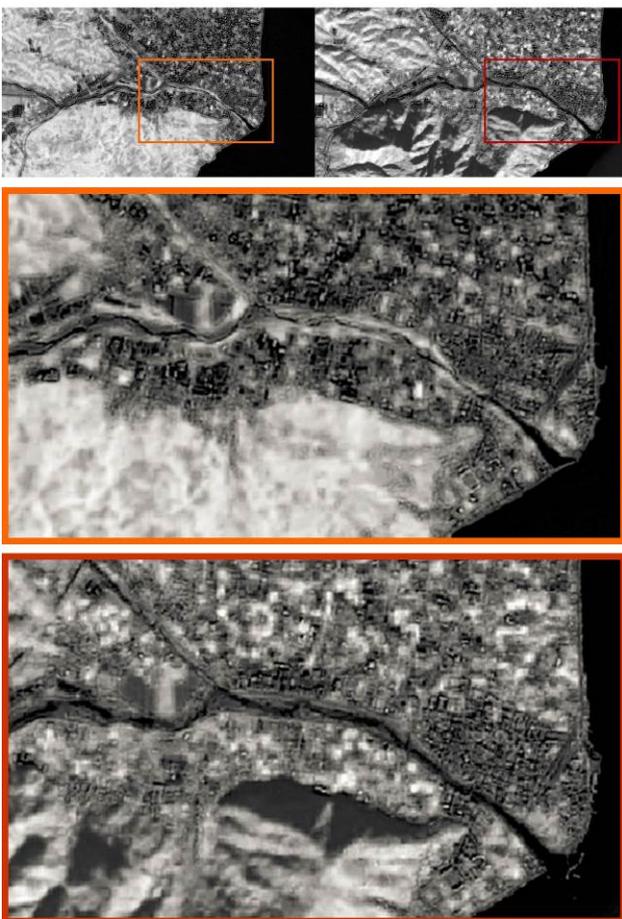
Figure 4. The calculation of NDVI on area of study in May and Nov 2016 (above); close-up on the NDVI results in May 2016 (center) and close-up on the NDVI results in Nov 2016 (below).

Successively, the two multi-spectral pan-sharpened L8 OLI image were used to calculate the NDVI values of the case study area in months of May and in November, just after the flooding event (Figure 4).

From a visual inspection, it can be easily noted that the area covered by water (black colour) has significantly increased in the width, approaching thus the shore of the riverbed and the inhabited areas around it.

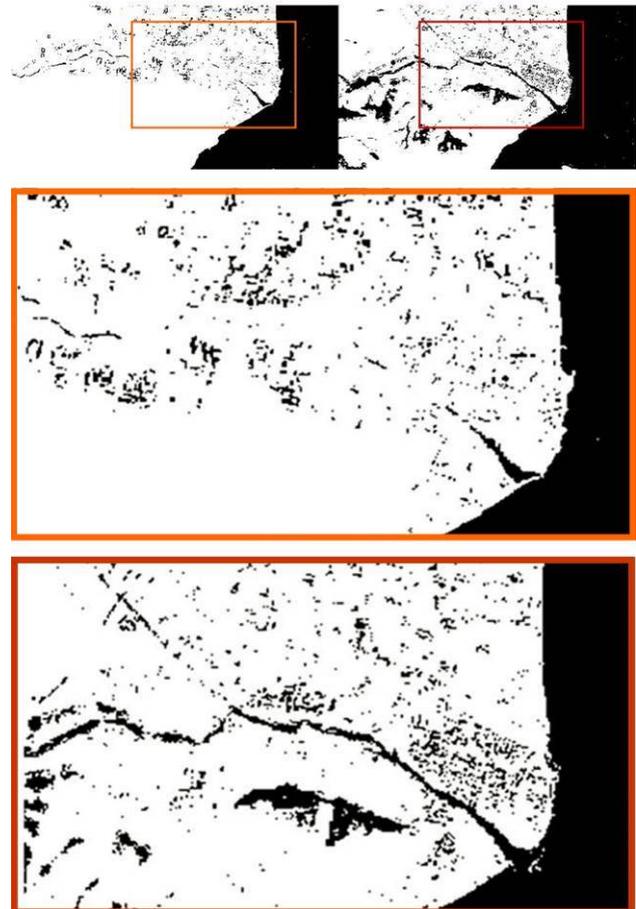
Figure 5 Normalization of significant areas for threshold of zero (0): the mage was classified for water applying the value of 0 to all negative NDVI values and the value of 1 to all positive results. The results show images of the area in May and Nov 2016 (above) and close-ups on the results in May 2016 (center) and in Nov 2016 (below).

In particular, a threshold filter of pixel value below 0 was applied in order to distinguish between areas with major water component (i.e. areas with pixel values below zero).

The result in fact show a significant change in the area covered by water (wet areas) and the it enhances the difference in the situation occurring in summer season and few days after the last major flooding event affecting the area (Figure 6).

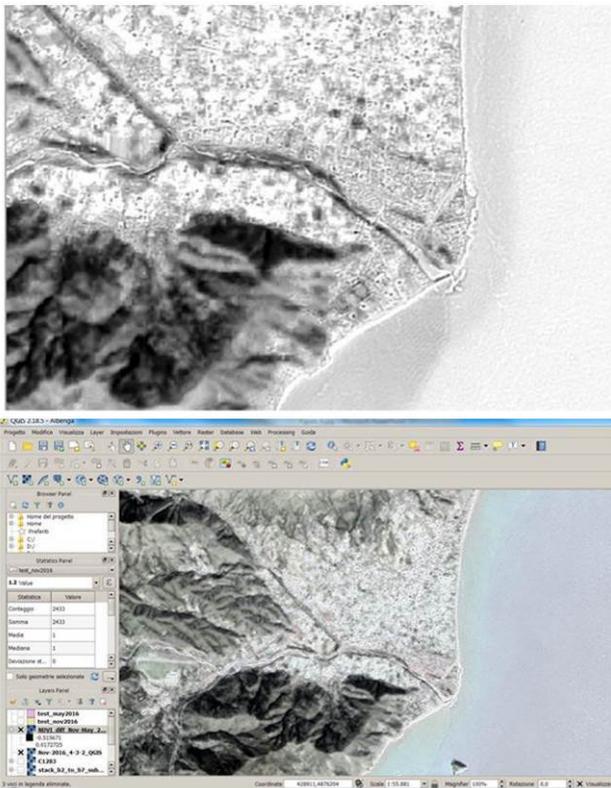
Figure 6 NDVI difference between May and Nov 2016 (above); NDVI difference superimposed to the RGB composite of the LS-8 image taken on Nov 29th 2016.

In order to explore further the difference between the two scenarios, the mathematical difference between NDVI values was calculated and observed superimposed to the RGB composite of LT-8 image taken in November 2016 (Figure 6). The visual inspection show how the difference in the two values can be well detected on the true colour composite.

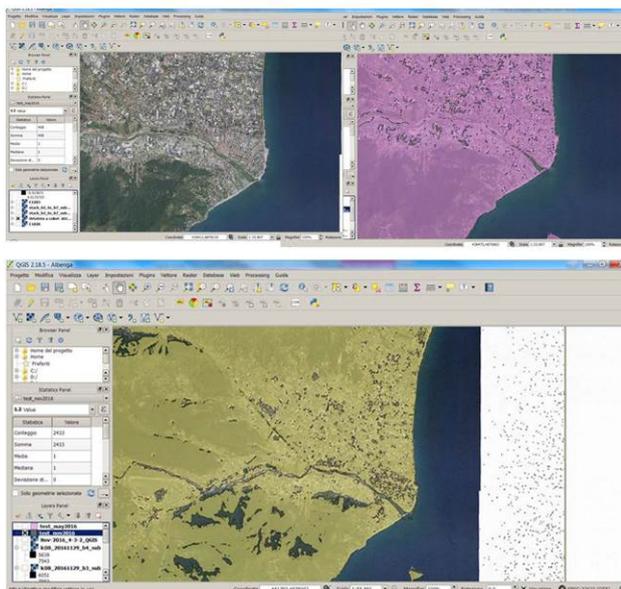
Figure 7 Orthophoto of Liguria region provided as a Web Map Service (WMS) by local authorities (above left); Vector values of NDVI results in May 2016 superimposed to orthophoto (above right); Vector values of NDVI results in Nov 2016 superimposed to orthophoto (below).

In addition, NDVI normalised results were vectorised and superimposed to an orthophoto of the Liguria Region provided as a Web Map Service (WMS), Figure 7. This procedure, done within an open source QGIS has allowed to directly connect the results deriving from complex elaborations done on satellite imagery directly with Open geospatial data provided by the

in detail giving some indications on the possible trends and magnitude of the hazard. As shown in Figure 7, the water contents in the archaeological area of Albenga has significantly changed between the two instances in 2016. Given that the site is considered to be of high cultural importance by the experts in the field, the assessment of risks due to the past hazardous flooding events and simulation of the future ones could possibly give important insight for a more sustainable management of such areas that are found within an endangered ecosystem. In case of Paphos District, the Figure 8 shows how significant changes in land cover have occurred over the past 30 years. Such changes are most probably to be connected to urban development that, if unplanned, can leave the most vulnerable areas without appropriate protection and hence more subject to threats of geo-hazards, including soil erosion.

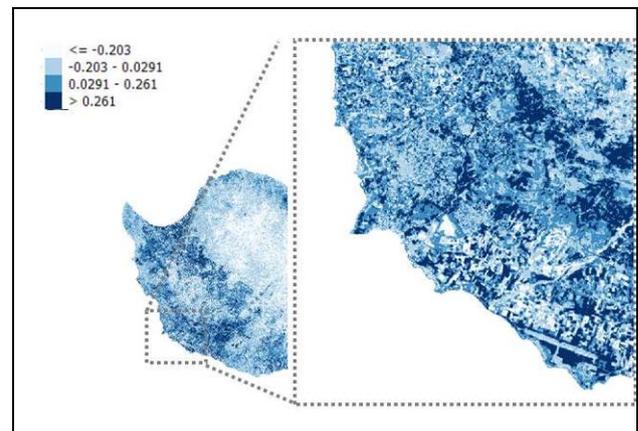
Figure 8 Difference in C-factor over nearly last 30 years observed false colour: the more significant changes potentially impacting the erosion of the soil in Paphos District are highlighted in blue and dark blue colour.

Particular attention was given to the areas sensitive to land cover change such as cultural landscape rich of archaeological remains in the District of Paphos. It is interesting to mention that for the purposes of this analysis, authors have used only freely available imagery (from US Landsat and European Copernicus missions) and mostly freely available software applications, in particular SNAP Tool provided by European Space Agency (ESA) and open source QGIS software. The main findings suggest that, as shown in Figure 8, some significant changes in the land cover did occur between 80s of the last century and today. Such alterations are probably linked with the urban expansion of the city and they have had a major impact to the C factor. It was also to be observed how these areas are situated in a very high proximity of important World Heritage Sites.
