## 3D VISUALIZATION OF A TIMBER FRAME HISTORIC BUILDING: PARTITE USAGE AND ITS IMPACT ON THE STRUCTURAL SYSTEM

**KEY WORDS:** 3D Visualization, Timber Frame Structure, Multi-Layered Building

Yorguc Pasa Mansion conservation project was prepared as a part of the Middle East Technical University (METU) Master's Program in Documentation and Conservation of Historic Monuments and Sites for the historic Yorguc Pasa Mansion. The mansion is a 19th century Ottoman Period timber frame building in Amasya, a Black Sea Region city in Turkey that has traces from different civilizations such as Hittites, Greeks, Romans and Ottomans.

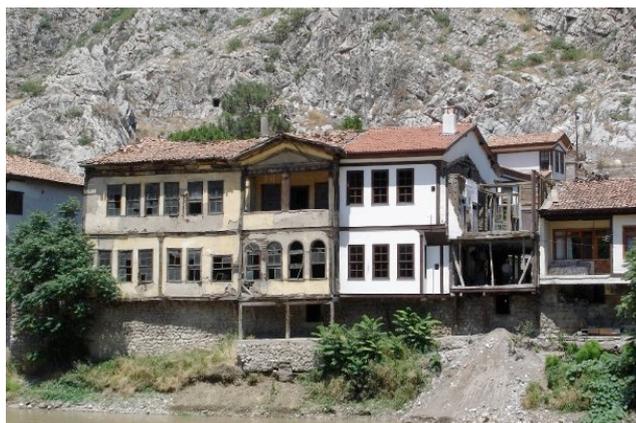
Figure 3. Yorguc Pasa Mansion before restoration

Hatuniye District consists of many historic mansions, mosques, hamams, medreses and defensive buildings. Similar to other buildings alongside the river, Yorguc Pasa Mansion is built on top of Roman period city walls and it has the longest facade amongst the other riverside mansions, which differentiates itself from the other historic buildings in the district.

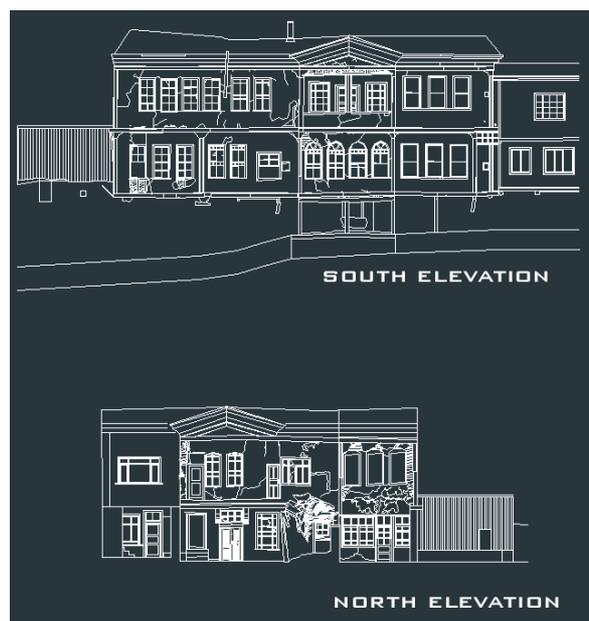
Figure 4. CAD Drawings

With Yorguc Pasa Mansion project following drawings were used as reference for the construction of the 3D model;

- Plan drawings of each floor
- Elevation and Section drawings
- RCP drawings
- Ceiling details

Documentation of Yorguc Pasa Mansion has been done by using Total Station and collecting various coordinates, in order to prepare plans, sections and elevations of the building. Additionally, photogrammetric rectification software has been used in order to prepare the different interior and exterior elevations of the building. Details for the doors, windows, wall units, fireplaces etc. has been measured by using conventional techniques.

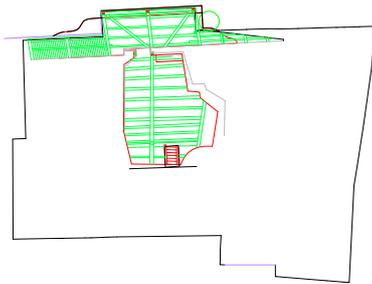
Figure 5. Basement Structural RCP

From the survey drawings several other drawings have been prepared in order to define the potentials and problems of the building. One of these drawings was reflected ceiling plan drawings with the identification of the structural elements. In addition to digital documentation, each ceiling was studied in terms of the location of the structural elements.

Visible structural elements were identified with the documentation and invisible structural elements were located with the help of the traces that were followed within the building.

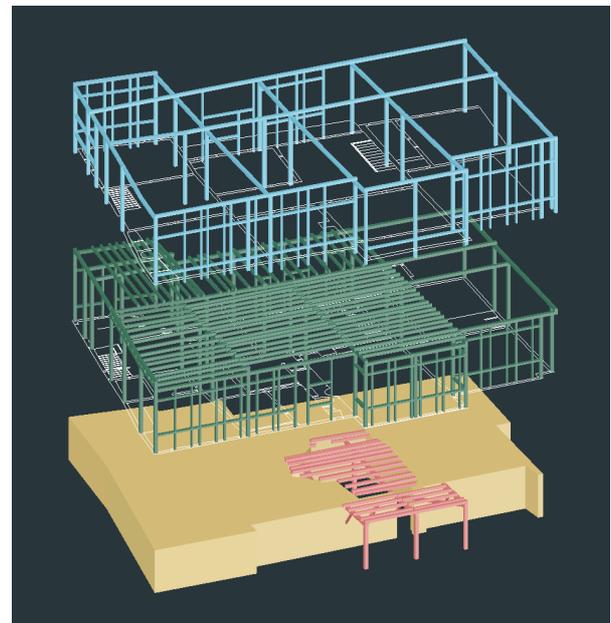
Figure 8. Timber Frame Structure

3D structural model was created by using visual documents and sketches as reference structural elements which were visible from the facades, especially in the western façade, and also from the interior of the building. For instance, girders seen from the uncovered ceilings of the interior spaces are used in the drawing.

Finding the girder axis from the nails' location on the timber floor covering was another technique to identify the structure. Due to the planks, main structural elements (both vertical and horizontal) on the exterior walls of the building were found as they were visible.

Besides the exterior ones, invisible structural elements on the interior spaces were placed by using the traces and by completing the frames. The comparison between the ground floor and the first floor helped to complete the frame construction principal of the secondary structural elements. These elements were visible from a small uncovered surface on the south façade. This information obtained from a small unit, was applied to whole model. As a result of this a legend was prepared to show the difference between the visible and invisible structural elements.

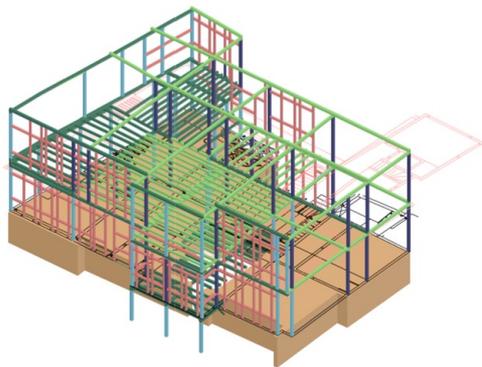
Figure 4. 3D Structural Model with Identified Visibility Status

In order to understand the impact of partite usage on structural system of the building, timber frame structural elements have been visualized in 3D environment. With the 3D model, different periods and different structural problems have been identified and analyzed. 3D model has been created in CAD environment after the site survey with the identification of the visible and hidden structural elements. With the help of point clouds that has been documented at the site by Total Station, these different type of structural elements have been generated and color coded according to the identification types. Various structural problems were identified within the timber frame structure, due to the partite usage of the historic building. These structural problems than cross checked with the identified periods of the building and areas with different levels of structural problems visualized in CAD environment.

Yorguc Pasa Mansion consists of three different structural and material conditions that have been developed through four different intervention periods that has been identified through restitution proposals. Over the years the building has been used by multiple owners by dividing the building vertically and horizontally in order to occupy maximum amount of inhabitants. At the time of the documentation, three different main partite usages have been identified according to the structural and material condition analysis of the building.

Three different partite usage of the building is described as eastern section, central section and western section. At the time of the study only the eastern section of the building was inhabited and it was in good structural condition. Although eastern section of the building was in relatively better condition, central section of the building was also in good condition except for some minor material decay. However the most critical condition of the building was the western section of the mansion, where due to the roof collapse, the structure and materials of the building were exposed to the weather conditions and severe decay was observed throughout this section of the building.
