## APPLICATION OF DIGITAL SURVEY MAPPING TECHNOLOGY IN THE INVESTIGATION OF COLORED WOOD STATUE IN THE CAO XI TEMPLE

**KEY WORDS:** the CaoXi temple, colored wood statues, digital survey mapping technology

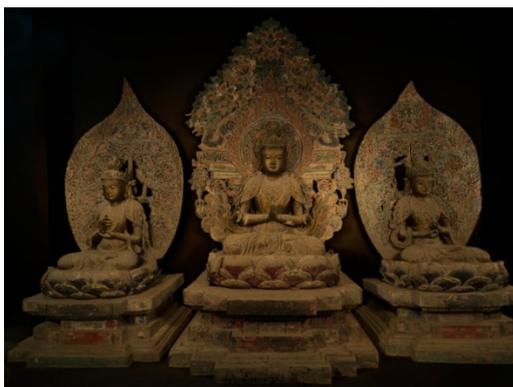
Figure 1. Color wood statues in the Caoxi Temple

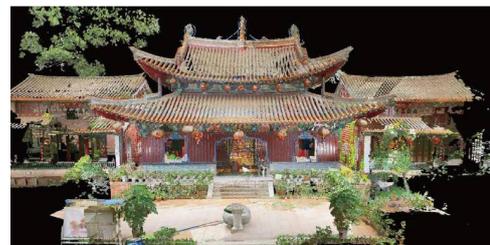
The three-dimensional scanning technique is used to record the geometry relationship between the statues, the statues and the building. The measuring error of the single point obtained is less than 2mm, and the data registration error is less than 3mm, e.g. Figure 2. After data processing, the distance of the point cloud of yard space is between 5~10mm, and the distance of the point cloud of the inside of the main shrine is between 1.5~3mm, e.g. Figure 3.

Figure 2. Point cloud of the yard

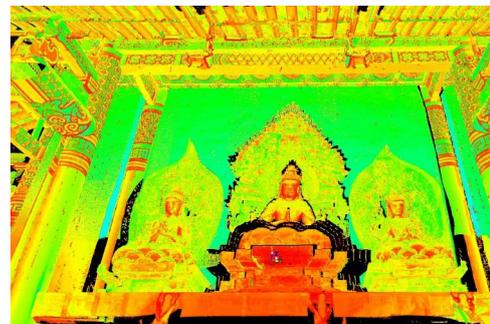
Figure 3. Point cloud of the building

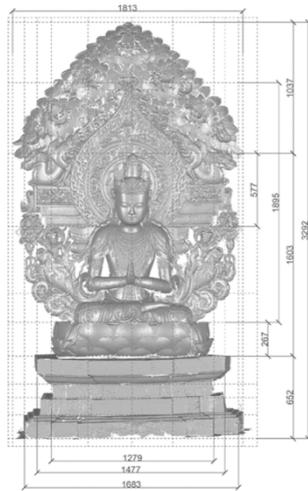
More accurate instrument for data obtaining is used to record the details of the tiny geometry and disease information of the color wood statues. This can be used for monitoring of development of extend of the disease. The measuring error of the single point obtained is less than 0.1mm, and the distance of the points in point cloud is less than 0.3mm, e.g. Figure 4.

Figure 4. 3D modal of the statue

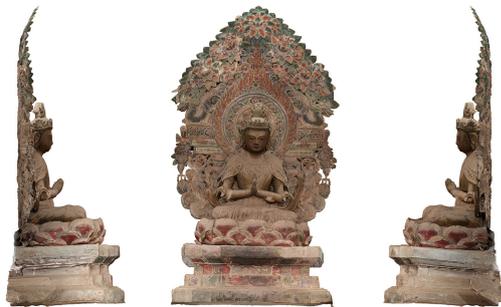
Recording the color and texture of the status objectively and actually. Color and texture of the high resolution images reflects the surface disease information, so resolution of the image obtained must be higher than 75DPI. Through these image, disease on the surface can be precisely located, e.g. Figure 5.

Figure 5. High resolution images of color and texture

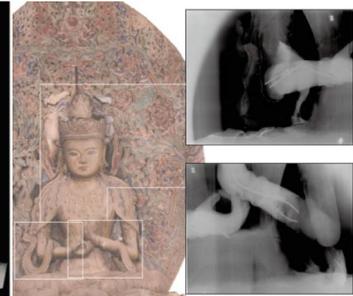
Figure 7. Components of different materials

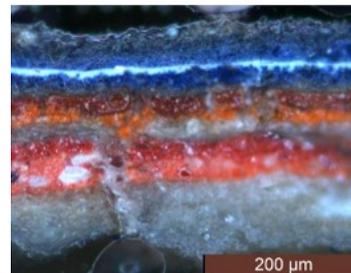
Through analysis of colored level, 2-4 layers are found on the surface of the wood statues, e.g. Figure 8. This shows that there have been at least four major repair or decoration in history.

Figure 8. 4 layers color level

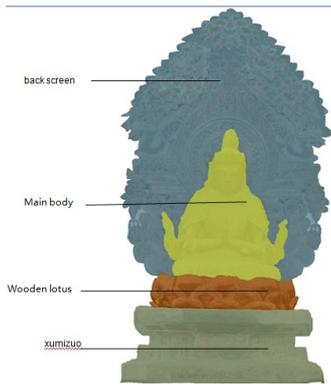
The three wood statues have the same structure, and each of them is made up of four parts from bottom to top: the xumizuo, the wooden lotus, the main body and the back screen, e.g. Figure 9. The xumizuo which is made up of pieces of wood has four layers, and these layers are connected together by the mortise and tenon joints structure. The wooden lotus is on the top of xumizuo. The main body is on the top of the wooden lotus. The back screen is connected with the wooden lotus, and it is fixed by 3 horizontal pieces of wood from the backside of the back screen, e.g. Figure 10.

Figure 9. Structure of the statues

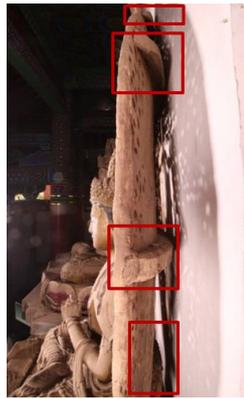
Figure 10. Horizontal pieces of wood from the backside of the back screen

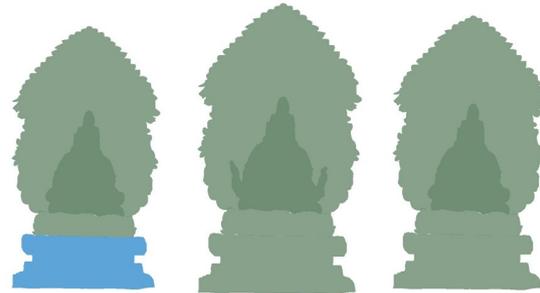
There is a difference in the type of wood used in parts of wood statue. The experimental result shows that, xumizuo of the sculpture of Samantabhadra is made of hardwood pine, but the ribbon of the sculpture of Bodhisattva is made of elm. From

observing on the spot, except for that xumizuo, all the other materials should be elm, e.g. Figure 13.

Figure 13. Material of lumber

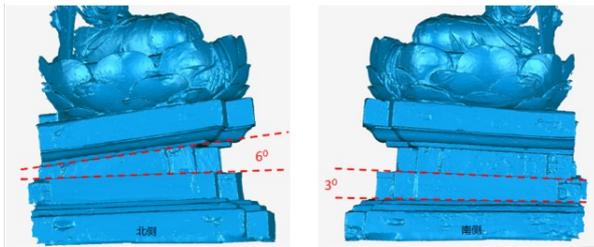
Figure 14. Angle of the slope

From outward appearance of the sculpture of Samantabhadra, it leans to the north. Measurements were made based on the three-dimensional model. The sculpture is tilted backwards  $6^\circ$  and  $3^\circ$  from the north and the south respectively, e.g. Figure 14. And inclines to west in an angle of  $3^\circ$ , e.g. Figure 15. It is assumed that the sculpture xumizuo was splitting or rotten at the rear of the third floor of the north side and the second floor of the south side of the supporting members, and the north side is much worse.

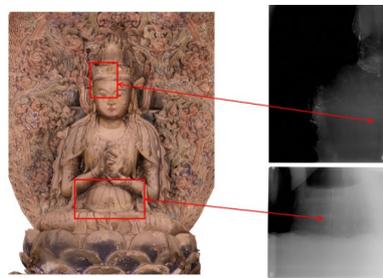
Figure 16. Crack in the statue

Cracking is also one of the main diseases of the statues. This basically has two reasons: Aging of the fittings causes cracks in the joints of the components. Another reason is that swell-shrinking causes the wood to crack. A 0.7 meters long connected crack from head to abdomen is found inside of the statue of Samantabhadra through the X-ray images, e.g. Figure 16.
