## HBIM CHALLENGE AMONG THE PARADIGM OF COMPLEXITY, TOOLS AND PRESERVATION: THE BASILICA DI COLLEMAGGIO 8 YEARS AFTER THE EARTHQUAKE (L'AQUILA)

R. Brumana<sup>a</sup>, S. Della Torre<sup>a</sup>, D. Oreni<sup>a</sup>, M. Previtali<sup>a</sup>, L. Cantini<sup>a</sup>, L. Barazzetti<sup>a</sup>, A. Franchi<sup>a</sup>, F. Banfi<sup>a,b</sup>,

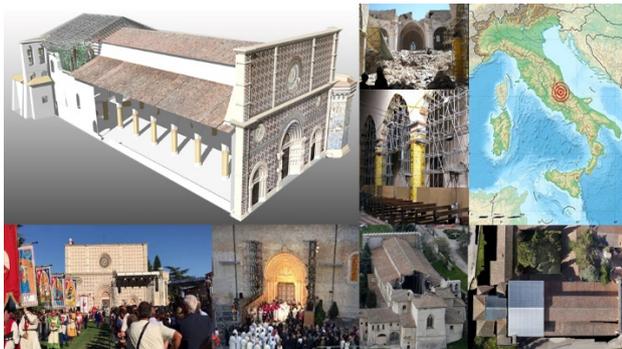
Figure 1. Earthquake damages, the Holy Door during the Jubilee Forgiveness procession, and 3D textured models

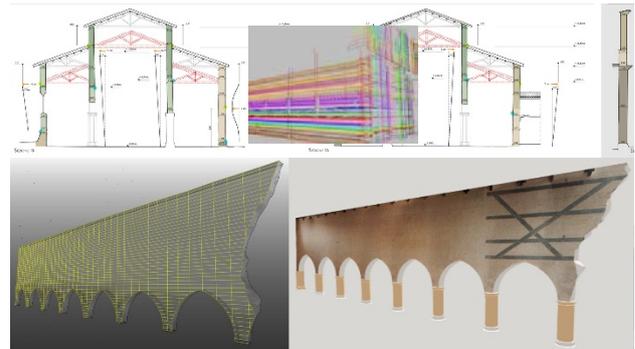
Figure 2. From multi-sliced wireframe to the NURBS-based complex modeling followed for each 3D parametric object

In the following picture, the generative process from the first phase of processing is represented by the creation of accurate 3D parametric objects (Figure 2).

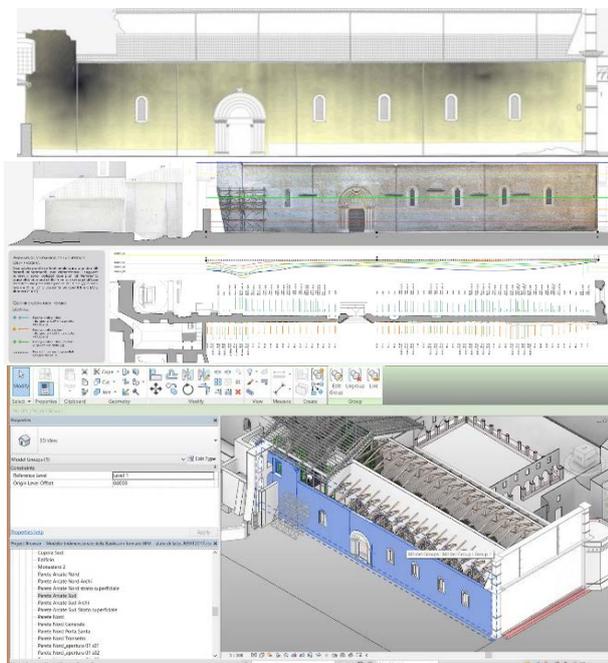
Figure 3. The example of the NURBS-based BIM modelling of the damaged north front with the Holy Door

The method applied to the generative process of the H-BIM provided the integration of Non-Uniform Rational Basis-Spline (NURBS) modelling (Piegl,1997) with the parametric logic of the BIM application. The NURBS model of the basilica is a mathematical representation able to achieve complex three-dimensional architectural and structural objects, transmitting the accuracy level of the data sources (point - clouds) collected by laser scanning and photogrammetry. In recent years, drawing the profiles in 3D was mandatory for defining the wire frame models. The models were defined from their physical edges (Figure 3).

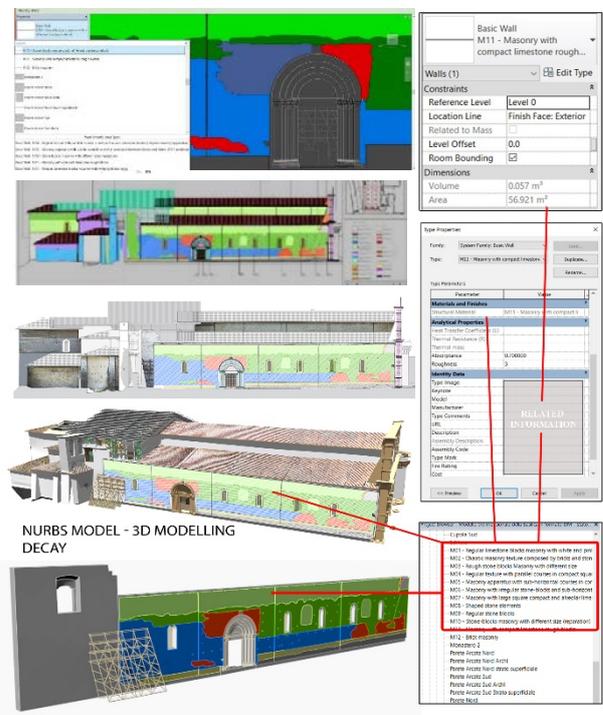
Figure 4. From CAD mapping drawings of Materials and Decay to 3D BIM management. The decay analysis is incorporated into the NURBS-based model

The following picture depicts the generative process from the first phase of processing, through the modelling phase, to the creation of accurate 3D parametric objects. (Figure 4). The main reason for generating 3D BIM mapping of materials was that 2D drawings do not show real permanent deformations, specific structural deterioration, suffered damage and accurate quantification in one overall visualisation.

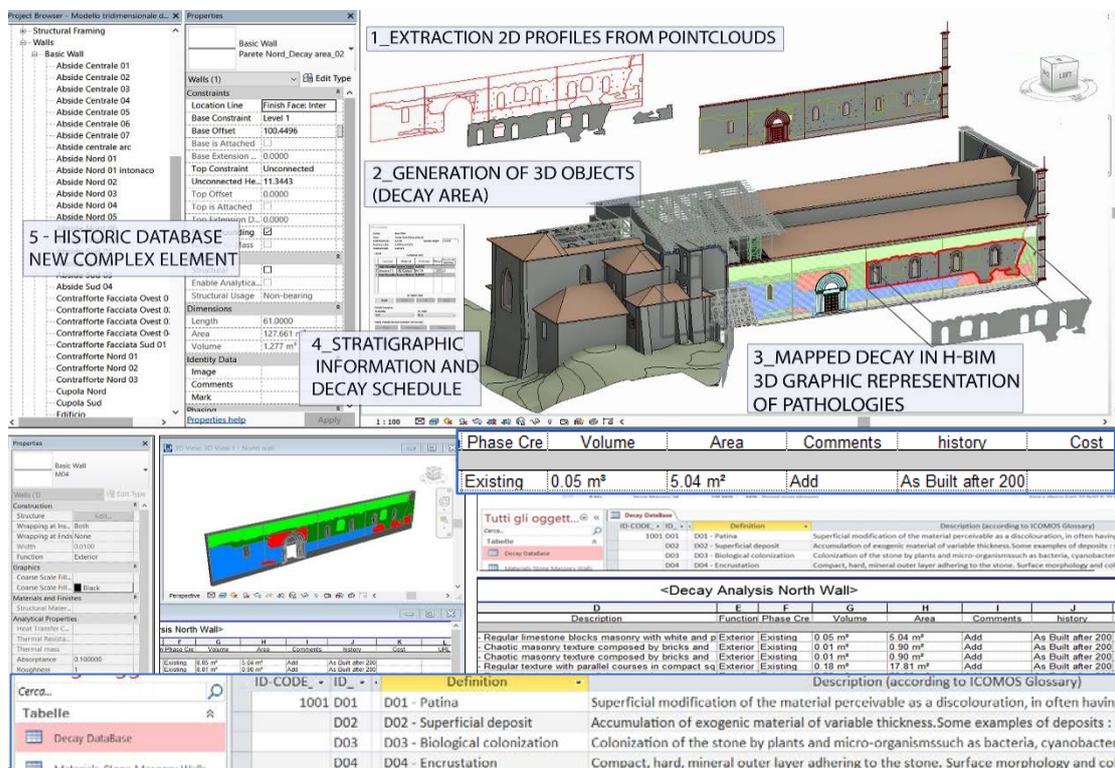
Figure 5. HBIM Material and Decay Mapping DB data management. From 2D to 3D HBIM NURBS model. Each material area is a parametric Object in the BIM DB with the 3D shape of the Objects (i.e. walls, vaults) belonging to the different Families

The creation of specific objects made it possible to go beyond the simple correlation between drawing, 3D model and data. Each 3D element was associated with the following list of information: identification number, stratigraphic information on the wall such as materials, thickness, length, area, volume, resistance, thermal mass, type of decay, the reason for decay. The historic database has been created in order to improve the BIM interoperability toward the different actors (i.e. cost estimations). All these types of information allowed a high level of sharing during the process of the restoration project of the Basilica for each parametric object and after the restoration updating the as-built (Figure 5).

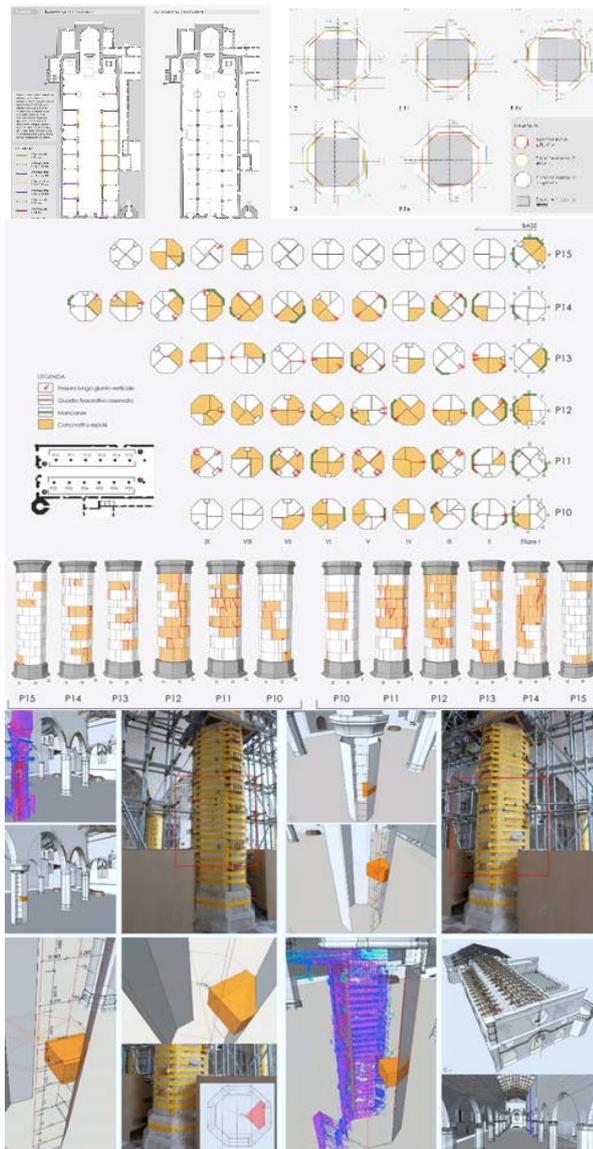
Figure 6. From the scan profiles to the 3D models of the left nave's columns and their stone ashlars. In yellow, the broken ashlars (diagnostic analysis)

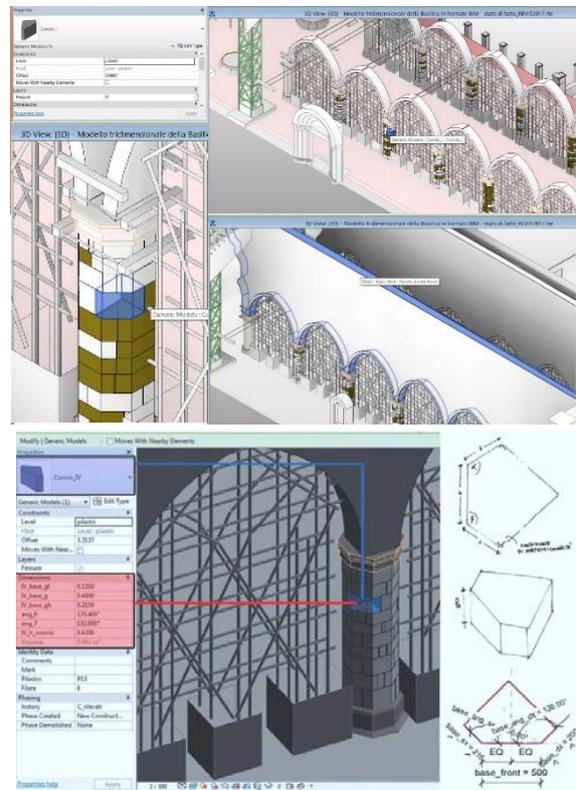
Figure 7. HBIM model of the arches and the octagonal stone pillars (above). Pillar n. 6 of the nave (bottom): on the right the hands-on survey of the only completely visible ashlar element.

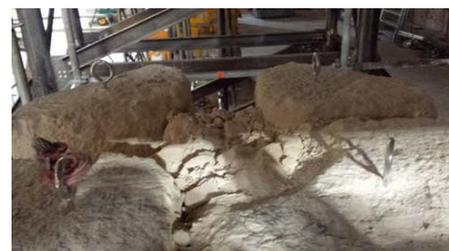
Figure 8. Top images of a pillar during disassembly; in the centre, the irregular mortar core of the column

The first phase of column restoration consisted in the removal of the vertical loads, by progressively inserting temporary metal structures under the two relevant arches (Figure 8).. This operation made it possible to continue with the on-site intervention of stone ashlar replacement or with the complete disassembly of the columns.

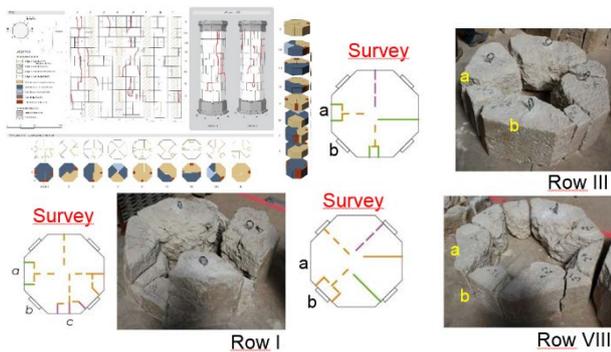
Figure 9. Pillar n. 12. The drawings made during diagnostic phase without inspections. State of the art of the ashlars before and after disassembly: rows I, III, VIII, the external deterioration of the stone in good condition in the inner part

First, starting from the upper part, the ashlars of the central pillars (P04-05-06-12-13-14), the most stressed by the seismic actions and extremely degraded (Crespi, 2016), were disassembled, numbered and reassembled on the floor. This operation made it possible to verify the exact geometry of the stone elements, to evaluate the material and thickness of the central core (Figure 8), to recognize the broken elements (not visible from the outside) and to refine and rectify the drawings made during the diagnostic phase (Figure 9).

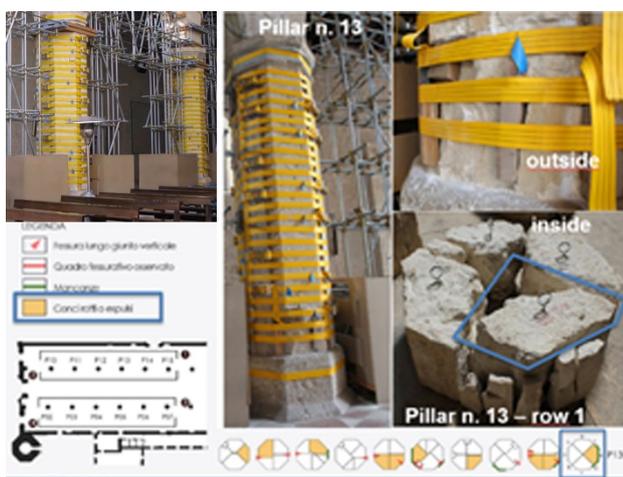
Figure 10. Pillar n. 13. A case of better ashlar stone conservation with respect to the hypothesized state of the art of the inner before disassembly and after reassembly. The external deterioration of the stone, in good condition in the inner part, is evident.

Comparing all the information gathered made it possible to validate the survey method used in the diagnostic phase and the results obtained, both in terms of geometric analysis and of the volume stone to be replaced (approximately 50% of the total volume of the columns). All in all, in fact, a good correspondence was registered between the geometry of the detected blocks and the real ones, albeit with some expected, and in some cases also important, differences. The major differences are linked to the failed detection of the broken stone elements in the inner part, along with fracture lines not visible from the outside, or covered by temporary wooden structures. As assumed in the diagnostic phase, the substantially limited thickness of the patch stone elements, mostly due to restoration work performed by the Superintendent Moretti in the 1970s, was recorded. In fact, the restoration phase gave back a multiplicity of thicknesses. In the case of Pillar n. 12 the disassembly of the central columns of the nave has shown a big difference between the shapes of the core of each row, depending on the stone ashlar dimension and disposition (Figure 10).

In some rows, the central core occupies up to 50% of the total area, compromising the mechanical characteristics of all the elements. The material filling the core is the so-called

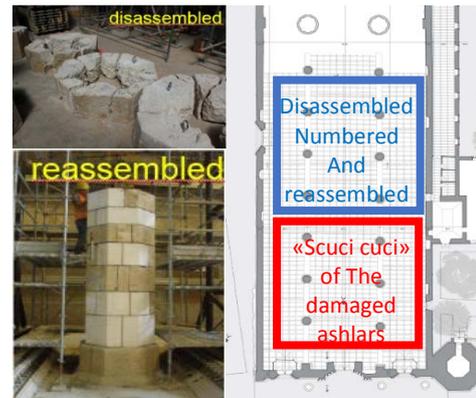
Figure 11. The two different conservation activities planned on the pillars in the design project: global disassembly & reassembly of the stone ashlars with approximately 50% of the stone volume saved and 50% replaced (red); «scuci cuci» proposal with punctual replacement of the single damaged stone ashlars (blue)

“incoherent mortar”, poor in aggregates, similar to the mortar analysed in pillar n. 6 during the diagnostic phase. Throughout the restoration activities, it was possible to recover some stone elements, in some cases using metal connections or paste, which was considered seriously damaged in the diagnostic step; in that case, their external condition did not reflect the inner one. Therefore it was possible to recover them (Figure 11).

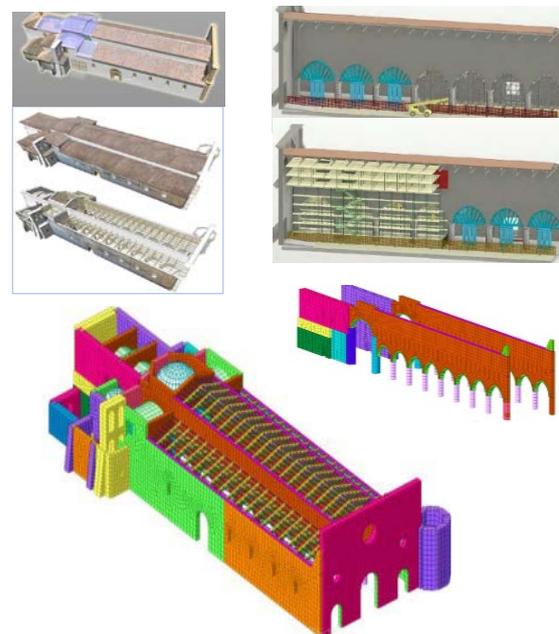
Figure 13. HBIM interoperability. The HBIM of the Basilica is fully interoperable with design project simulation, construction site management (COSIM) and structural analysis (BIM to FEA Revit © Midas ©)

After obtaining the HBIM of each INSTANCE as described, the overall sum of elements was tested to support a full interoperable HBIM for many purposes: a. the design project simulation; b. the Construction Site data Management (COSIM); c. the structural analysis: the HBIM was converted from the parametric BIM platform, with the possibility of managing the Finite Element Analysis (BIM to FEA) using specific exchange formats and new modelling tools to support the structural choices. An overall model of the basilica managed by MIDAS© was obtained (Barazzetti, 2015), entailing all the morphological complexity of each element without any simplification (Figure 13).

After this experience still, on course, we could say that the most HBIM challenging issue is represented by the structural analysis. In theory, this result certainly represents an important step in the process linking HBIM complexity to the structural analysis domain. In the case of single elements data management (i.e. the case of the Pillars preservation), we could say that HBIM heavily contributed to support the preservation challenge, given that the demolition and reconstruction of all the pillars was one of the starting option and also one of the main arguing among specialists, restorers and structural engineers, between regulations on seismic risk reduction, the safety framework, and preservation ones. On the other side a contribution of the HBIM model to the whole dynamic behaviour, and its simulation to enhance the preservation, is still lacking under different points of view. As for the BIM/FEA results, we can’t say that it was achieved a tangible difference with respect to the traditional
