## A MULTIDISCIPLINARY LANDSLIDE CASE STUDY: DEVREK LANDSLIDE

**KEY WORDS:** Landslide, Terrestrial Laser Scanning, Land-based SAR, Geotechnical

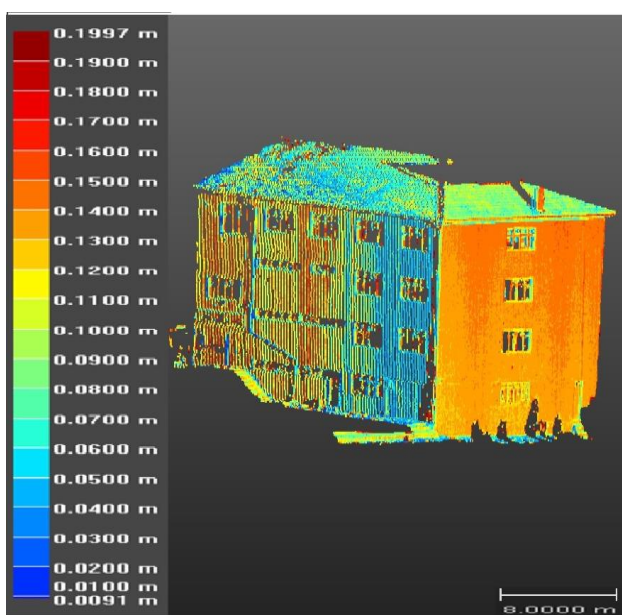
Figure 1. Terrestrial Laser Scanning Difference View, Devrek Imam Hatip High School

Figure 1 shows the difference image of this building on the 27/07/2015, produced from two measurements conducted two hours period. According to these scanning results, deformations varying from 1 cm to 20 cm have been found on the building over a period of 2 hours. When the results posed a serious threat to the safety of the building, the danger was immediately conveyed to the relevant units. With safety measures taken around the building, the building collapses itself the next day.

At the point where active landslides remain, one of the other important issues is that some buildings can stay under risk in the vicinity of the landslide. With this approach, it has been possible to trace the structural deformations by using the terrestrial laser scanning method on some buildings within the possibilities. The most striking results among the studies performed with the Terrestrial Laser Scanning technique from 27<sup>th</sup> July to 1<sup>st</sup> August, were obtained at observations in Devrek Imam Hatip High School.

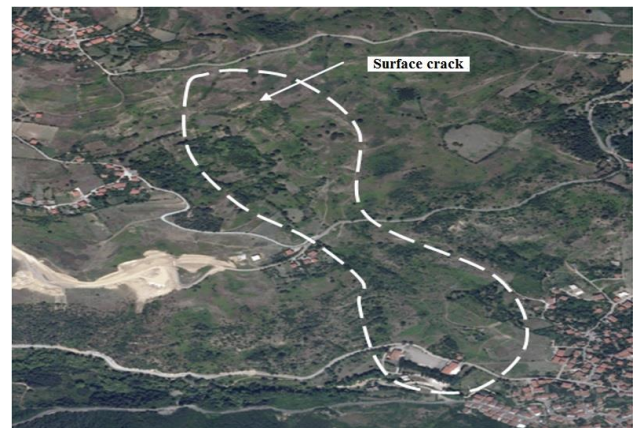
Figure 2. 2011 Stereo view of orthophoto image obtained from General Command of Mapping

In the landslide area in Devrek, on July 23, 2015, 17 aerial photographs were taken with Ultracam Eagle Digital Aerial Camera at 10 cm ground sampling interval with 80% forward and 60% side overlap rates. The 6 geodetic points selected and measured from the region was used as ground control points. Subsequently, a digital surface model with a resolution of 70 cm was produced by intensive mapping technique. The orthophotos and digital surface model produced from 45 cm resolution photos taken in 2011 belonging to the same region as well as the updated data for the analysis of the change in the region were obtained from the General Command of Mapping. Figure 2 shows the state of the landslide area in 2011, Figure 3 shows the state after the landslide on July 23, 2015.

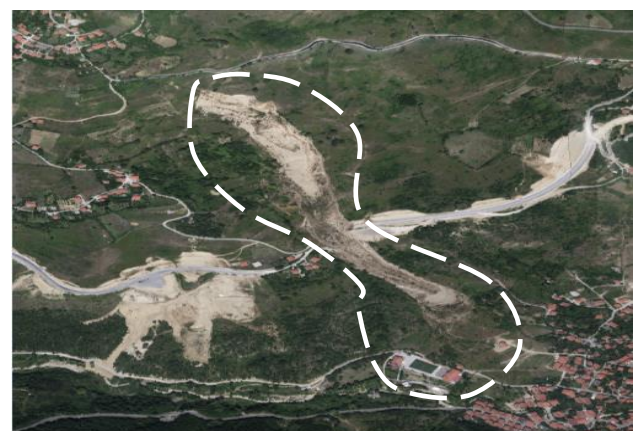
Figure 3. 2015 Stereo view of orthophoto image obtained from General Command of Mapping

The mass loss in the upper right corner of the motion boundary in Figure 3 is due to a planned operation caused by the road construction. The changes in the other regions are due to landslide. As it seen from Fig. 3, the landslide follows a path

like "S" along a distance of about 1300 meters and changes direction 4 times.

Four individual landslides were recognized by examining deformation features. As seen in Figure 3. Approximately the landslide is about 1300 m long(S shape) and ranges from 80-140 m wide. Since the direction of landslip changed 4 times, it was very complex landslide. First, the depth of the landslip was determined as 15-20 m and the second plane was 5 meters deep. The third and the fourth the depth of the slip planes were 7-8 and 4 meters respectively.

As a result of the analysis performed on the deformation map produced by comparing the 2011-2015 orthophoto images, it was determined that the landslide route is approximately 1300 meters and the area is 38.9 hectares. Moreover, it has been determined that the disaster is not a single landslide, at least four successive landslides trigger each other. The depth of slip plane of these landslides is determined as 15-20 meters, 5 meters, 7-8 meters and 4 meters respectively from top to bottom.

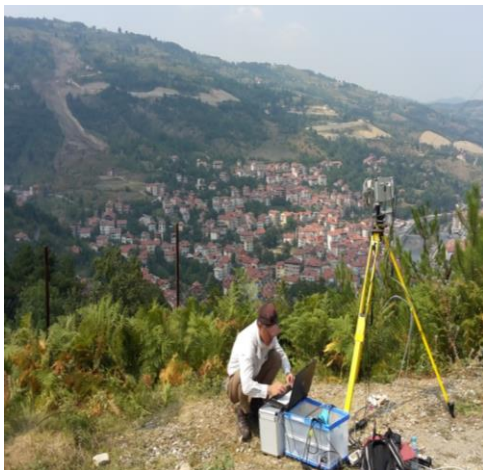
After the device transition completed, ground based SAR observations started on 02/08/2015 and continued until 05/08/2015 (Figure 4).

Figure 4. Ground based SAR observations

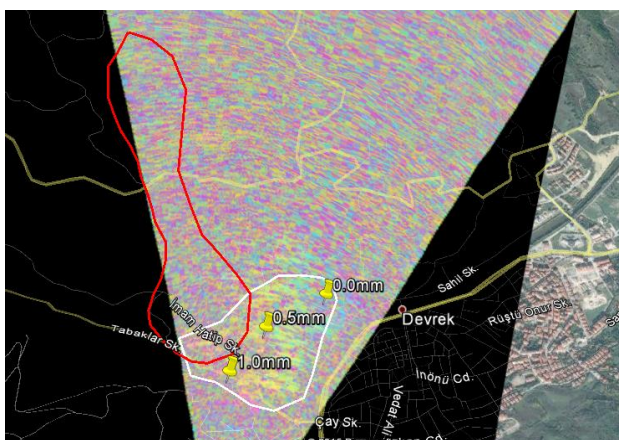
Figure 5. Analysis of ground based SAR observations

Figure 5 shows the phase interferogram obtained by SAR observations conducted on 03/08/2015. According to the interferogram, the colorings pointing to the ground motion in the area surrounded by a white line surrounding a part of the landslide area defined by the red line but not the majority, are projected. This movement, which is on the order of 0.5 to 1 mm on an hourly basis, is around 1.2-2.4 cm on a daily basis.

The area in which the current landslide is located remains within the risky area defined by the risk map prepared in the past. Moreover, the area in which the motion is detected by the ground based SAR is within the bounds of the designated risky area in this map.
