USING REMOTE SENSING DATA FOR CALCULATING THE COASTAL EROSION IN SOUTHERN THAILAND

W. Pantanahiran¹

¹ Dept. of Geography, Faculty of Social Sciences, Srinakharinwirot University, Bangkok, Thailand, - wichaip@swu.ac.th,
pwichai@yahoo.com

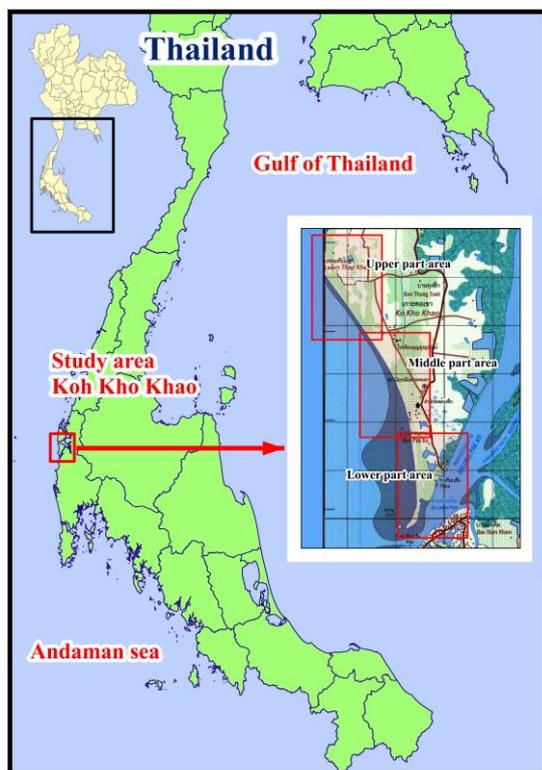
Figure 1. Study area

The study area was located in Koh Kho Khoa (island), Ban Nam Khem sub-district, Takua Pa district, Phang Nga province, in the Andaman sea in southwest Thailand. The area is nearly flat, and the elevation is about two meters above mean sea level (MSL). The area of the island is approximately 6,328.33 ha (Figure 1). The land use has been classified as coastal zone (22.32 ha), upland crops (271.41 ha), orchards (605.78 ha), paddy rice (33.68 ha), upland forests (1,968.14 ha), shrubs (697.76), mangrove forests (2,341.19 ha), wetlands (199.18 ha), and unclassified (83.26 ha). Additionally, the climate has been classified as tropical monsoon. Takua Pa District is fully influenced by the northeast monsoons from January to April during the summer season and the southwest monsoons from May to December during the rainy season. The island is also well-known as a touristic area (Figure 1).

The objective of the research was to identify the coastal changes to the island, Koh Kho Khao in Takua Pa District, Phang Nga Province. The study area was divided into 3 parts: the upper area, the middle area, and the lower area (Figure 1).

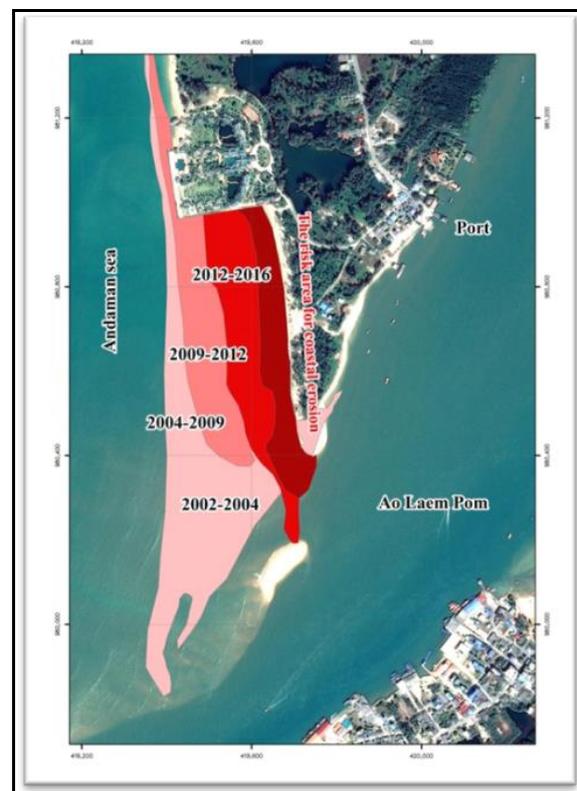
Figure 5. The severe erosion of Koh Kho Khao and the special monitoring area

year. However, the present study showed that some areas still remained as severe erosion was still active. This indicated that natural adaption plays a major role in this area; however, these areas are still in critical condition (Figure 5).

The results showed that the tsunami in 2004 caused coastal erosion in the area, as coastal changes during those years were found. However, natural adaptation was found after 14 years in the middle and upper parts of the island. Aerial photographs, IKONOS imagery, QuickBird imagery the Worldview-2 imagery, and Pleiades imagery were used. These remote sensing data were very useful tool for the coastal change. Severe coastal erosion in the lower part of the island has been continuously found, and it was also found that the seawall might be the main factor in the coastal erosion after tsunami occurrence. It is recommended that the lower part of the island be declared a special observation area in order to prevent further coastal erosion.
