Applicability Assessment of UAV Mapping for Disaster Damage Investigation in Korea

KEY WORDS: UAVs, Rapid Drone Mapping, Natural Disaster, Damage Investigation

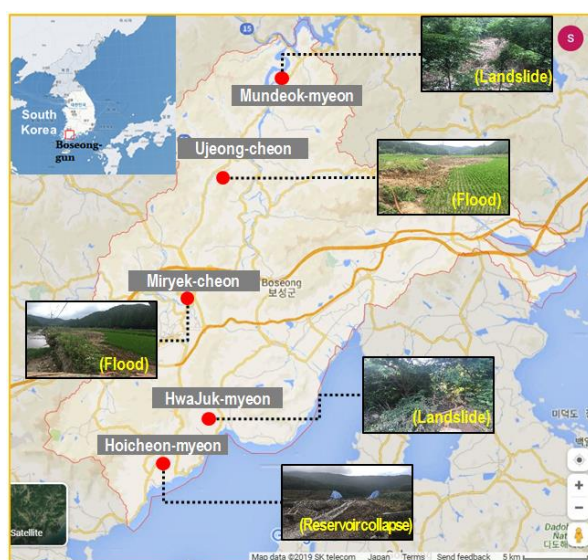
Figure 1. Study area

From late June to early July 2018, there were heavy rainfalls around southern area of Korean peninsula. In this paper, the study sites were selected on considerable damaged areas where landslides, river floods, and reservoir collapses have occurred due to heavy rains and a typhoon at that time (Figure 1).

During this period, due to the heavy and continuous rainfall in Boseong-gun, more than 15ha of agricultural area was flooded and the landslides occurred in 17 steep mountainous areas in national and private forests. Cumulative precipitation during this period was 236 mm ~ 327.5 mm around Jellanam-do.

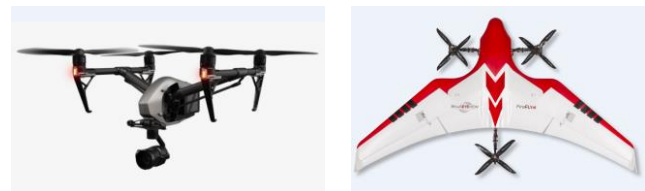
Figure 2. Small UAVs of this study

DJI's Inspire2 is a commercial drone with a relatively stable flight performance and has a battery capacity of about 25 minutes with longer endurance flight than the Inspire1. Zenmuse X5S camera is mounted with a 3-axis gimbal which is suitable for taking aerial photography for drone mapping.

A fixed-wing FireFly6 being capable of a vertical take-off and landing, is a rotor-tilling type drone on a flight mission, so it does not need a plenty of runway space for take-off and landing, which is advantageous for disaster field operation. A fixed wing drone enable users to carry out mapping mission with relatively stable and efficient flight performance, so it has advantages for long flight mapping in wide area disaster area.

Sony A6000 optical camera mounted on FireFly6TM has a built-in 24.3MP APS-C sensor that allows users to collect high-

(a) Inspire2

(b) FireFly6

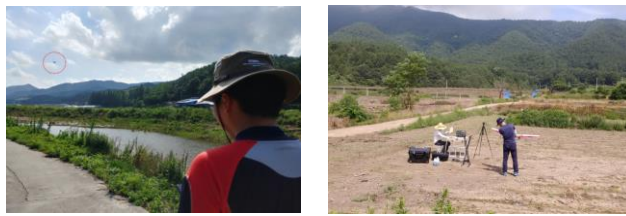
(a) Imaging by Inspire2 (b) Pre-test of FireFly6
Figure 5. Small UAVs operation in disaster field

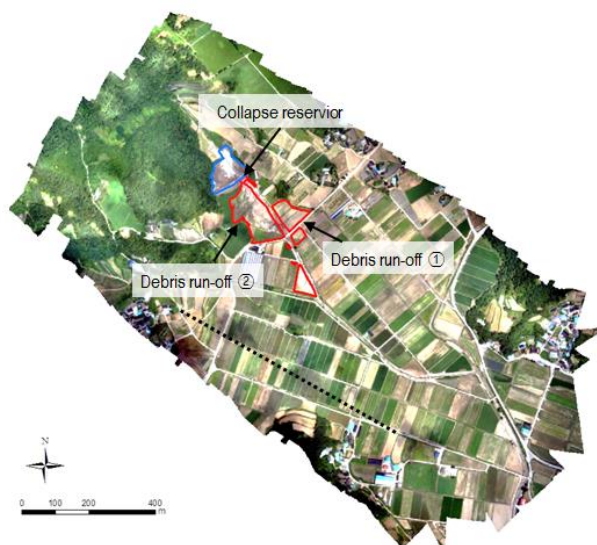
Figure. 7. Flood damage analysis by reservoir collapse

The total 267 drones aerial photographs were taken into the area where debris outflow occurred as a result of the collapse of reservoir due to strong heavy rain, and an ortho-image map of about 4cm level with spatial resolution was generated.

The total drone aerial mapping area was is about 1.5 km², and the soil leak area of the river bank on the generated 3D terrain model and ortho-image map is about 1.3km, and the damaged area estimated based on the runoff trace on the ortho-image map is about 24,248.8 m².

The decay length between the top of the reservoir was about 23.9m and the whole bank distance was about 129m on the 3D terrain model. As the damaged area due to disasters is wide and mapping coverage increases, the fixed wing with the longer
