## THE TRANSMISSION CHANNEL TOWER IDENTIFICATION AND LANDSLIDE DISASTER MONITORING BASED ON INSAR

**KEY WORDS:** Transmission Channel, Transmission Tower Identification, InSAR, Time Series, D-InSAR, Landslide Monitoring

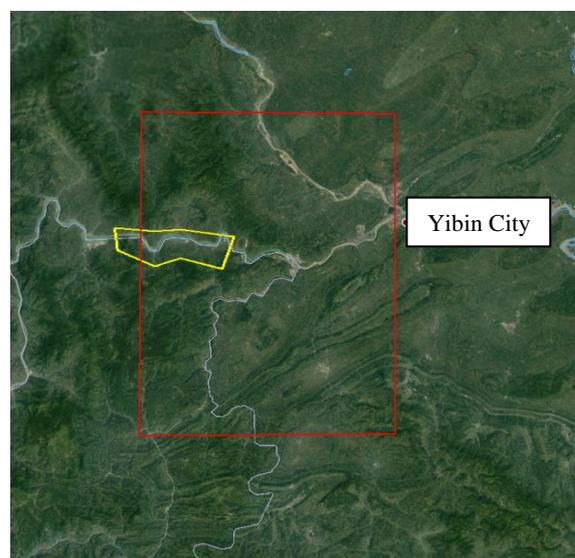
Figure 1. Data coverage (Red rectangle is the data coverage area, yellow area is the transmission channel)

The study area uses ALOS-2 PALSAR image data. The data coverage area is shown in Figure 1 below. The details are shown in Table 2. A total of 11 scenes were used.

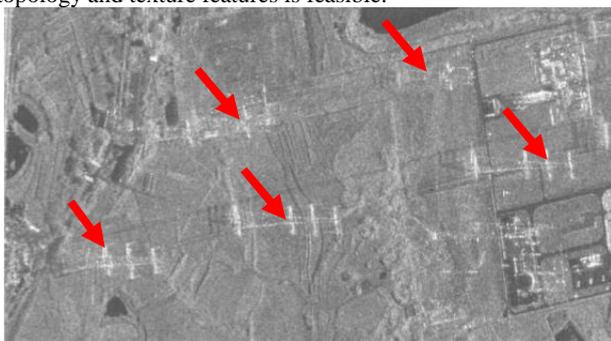
Figure 2. Transmission line tower in SAR image

SAR imaging systems compared to other imaging systems, in particular optical imaging systems, the two-dimension images with generated have many distinct differences. The SAR image mainly reflects two kinds of characteristics of the target: electromagnetic scattering characteristics and structural characteristics. Its target characteristics large extent depend to radar system parameters and geographical parameters, such as: working wavelength, angle of incidence of the electric wave, polarization direction of the incident angle, regional surface roughness, shape and direction of the regional target, and restoration of regional materials, dielectric constants and so on. Compared with optical images, SAR images have poor visual readability and are affected by speckle noise and geometric distortions such as shadows, overlap, and perspective shrinkage, making SAR image information processing more difficult. Therefore, it is necessary to study the imaging characteristics of ground objects according to the characteristics of SAR imaging. Taking the UHV transmission tower as an example, the characteristics of the UHV tower are studied for SAR images. The characteristics of the tower in the radar image can be summarized as the following two points: The material of the tower is generally a metal material, and there is a strong backscattering characteristic in the SAR image, which appears as a brighter region in the image; The direction of the tower is the same as that of the SAR platform, which makes the structure of the tower target very clear in the image, especially the brightness of the cross-section is extremely high. The tower is shown in Figure 1 below on the SAR image. In short, the UHV transmission tower on high-resolution SAR images is represented by structural information and is no longer a point target. Therefore, the damage status is analyzed through the extraction of information such as its geometric structure, spatial topology and texture features is feasible.

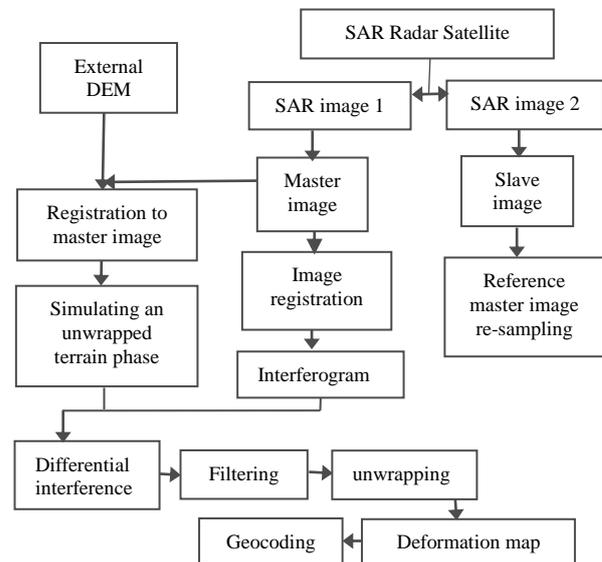
Figure 3. Flowchart of Two-pass DInSAR Technique

In this study, the external DEM used the SRTM-1 DEM data with a resolution of 30m to construct a simulated topographic phase interference fringe map based on the image parameters of the two imaging steps, and then subtracted this information from the overall interference map to obtain ground change information. The data processing flow is shown in Figure 3 below.

By DInSAR technical monitoring of surface deformation, the need to eliminate the delayed impact of the atmosphere, affecting the ground effect, noise, undulating terrain. The phase delay caused by atmospheric fluctuations during the transmission of radar electromagnetic waves can be applied to increase the signal-to-noise ratio between the deformation information and atmospheric interference signals by using the method of superposition of interferograms, and to reduce the phase component; the phase of the ground can be removed by accurately calibrated to the baseline; error noise, which can be used to suppress noise in the interferogram based on adaptive filtering; terrain phase can be removed by introducing external DEM data. Considering the selection of radar data and the actual situation of the monitored area, the "two-pass" differential interferometry technology is adopted, ie, the external high-precision DEM and the two-view radar complex image data are adopted, and the topographic phase is achieved on the basis of radar conformation equation by high-precision DEM, and then removed from the radar interferogram to obtain the surface deformation phase.

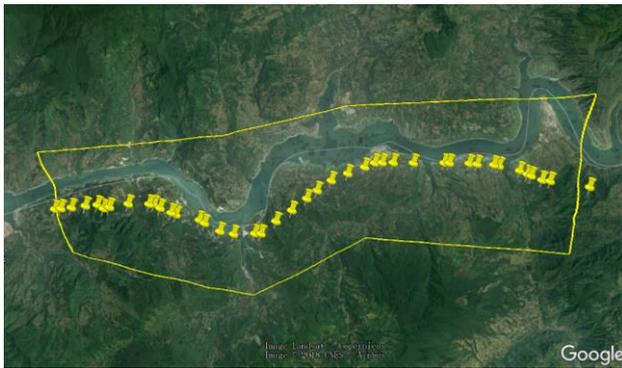
Figure 4. Research area

The No. 550 transmission line of Jin Su line in Sichuan passed through Yunnan and Sichuan province, and the topography is undulating and typical of the karst landscape. The latitude and longitude range is (28.570950°N~28.658069°E 104.007497°E~104.267392°E). The area is approximately 350 square kilometers across the cities of Zhao tong in Yunnan Province and Yibin City in Sichuan Province. The scope of the study area is shown in Figure 2 below.

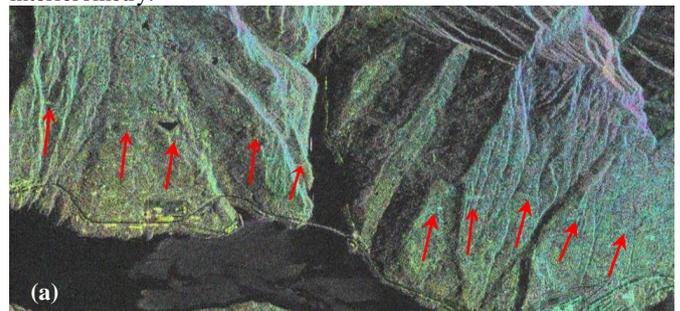
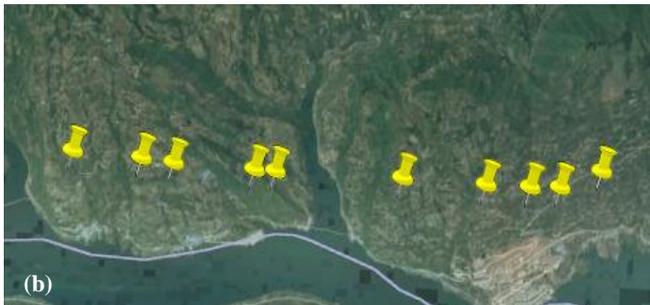
Figure 5. Identification of SAR UHV Transmission Towers

Figure.5(a) is a differential interferogram along the transmission channel of the study area. The tower appears as a bright fringe in the interferogram. As indicated by the red arrow in the figure, the transmission tower can be identified in the differential interferogram and can be clearly distinguish the basic form of the tower. Figure.5 (b) is the google earth image in the same location, which validated the accuracy of the tower identified by using SAR interferometer. Based on the above analysis, it can be found that it is feasible to identify the tower in the differential interferogram of SAR. In addition, if a large-scale deformation or collapse accident occurs during the operation of the transmission tower, the deformation of the tower can also be monitored by using differential interferometry.

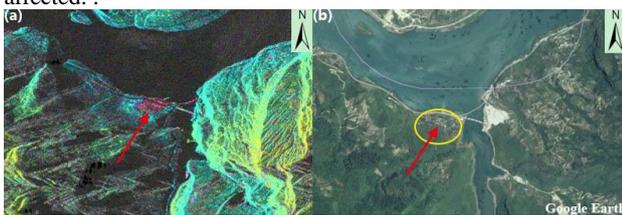
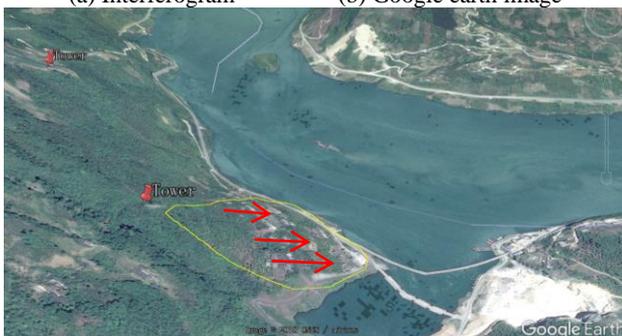
Figure 6. The result of the DInSAR Xintan Town

(a) Interferogram (b) Google earth image

(c) Landslide area in google earth ( The yellow polygon is a landslide body, the red arrow is the development trend of the

landslide body, and the red landmark is the power transmission tower)

InSAR interferometry was performed using ALOS-2 PALSAR data from 11 scenes from August 21, 2016 to August 20, 2017. A total of 26 differential interferograms were generated. The hidden point of landslide in the interferogram was found in Xintan Town of Xintan Village Qijiang County Zhaotong, Yunnan Province. The topography of the area is undulating, there are numerous ravines and rivers, mountains and hills. Controlled by structure, lithology, and the Jinsha River water system, it exhibits a variety of landforms such as peaks, mountains, valleys and river valleys. The area is a typical karst landscape, and it is easy to form shadows on radar images. The incident angle of  $36.1^\circ$  can largely avoid the appearance of shadows. Figure.6 (a) shows the differential interference fringe map of Xintan Town. The corresponding geographical location is shown in Figure.6 (b). The monitored geographical position of the landslide area is  $28^\circ 36'3.99''N, 104^\circ 5' 41.25''E$ , Figure.6 (a) can calculate the deformation is 6.4cm. The lower color scale represents the phase cycle corresponding to 11.5 centimeters (ie, half the wavelength (23 centimeters)) at the ground. Note that we can be observed that several white pixels in all interferograms, which indicate no data values. This is due to the geometric distortion, perspective and shadow effects of radar signals. Figure.6(c) is a magnified view showing that there is a tower in directly above of the mountain and there are villages below the landslide. The trend of the landslide is shown in the red arrow. If a landslide occurs, the tower above the landslide and the village on the landslide will be directly affected. .

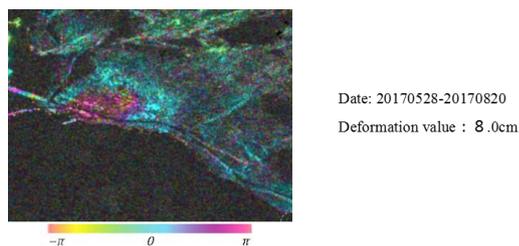
Figure 9. Rainy season in 2017

**4.2.3 Rainy season in 2017:** During the period from May 28th, 2017 to August 20th, 2017, obvious deformation occurred in the area during the local rainy season, with a deformation of 8.0cm; Furthermore there was a clear acceleration of deformation.

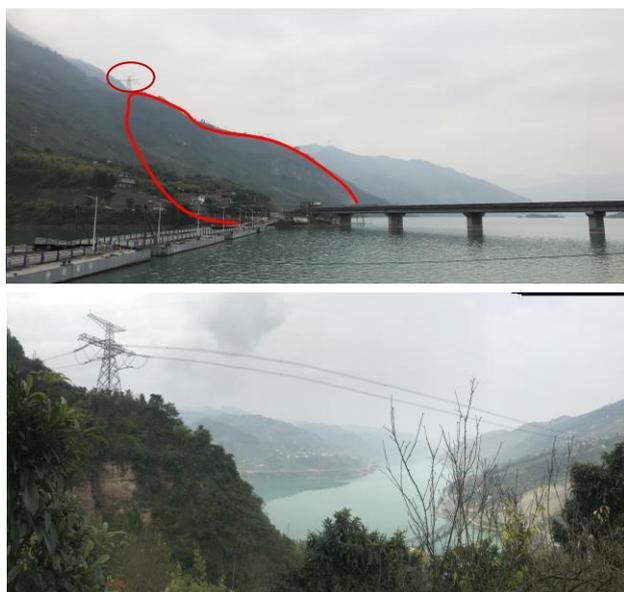
Figure 10. Landslide body and tower

On December 16, 2017, we conducted a field survey of Xintan Town. The verification results are shown in Figures 8, 9 and 10. The dormant landslide area is located near Xintan Village of Qijiang Zhaotong in Yunnan Province. From the on-site inspection photos and local hydrogeological data, it is known that the vegetation cover is thick and the soil layer is thick. The characteristics of the rock mass are the Late Permian-early Triassic siliceous terrigenous clastic and siliceous rocks. The characteristics of soil is yellow clay and its loose structure, develops shrinkage cracks, and has poor stability. It has caused small-scale slippage. The accompanying landslides are yellow mud and some clastic rocks. The average slope of the monitored landslide area is 40 degrees. It can be found that there is a tower located directly above the landslide body in on-site photograph. The bridge below the landslide body has partial landslide debris and the bridge bridge body is 4-5 cm. In the crack, the bridge was forbidden to pass on March 3, 2017. In addition, in the village below the landslide, some cracks occurred in houses, floors, and steps. Once the rainfall increases or heavy rains strike, the soil is loose and landslides may occur at any time.

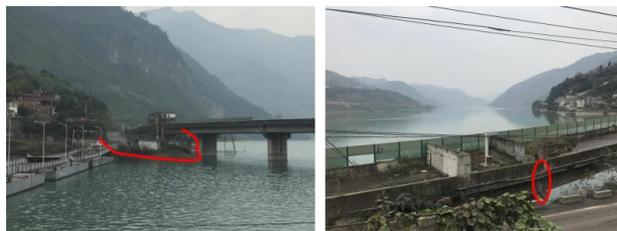
Figure 11. Deformation of bridge below landslide body(The bridge was banned from traffic on March 3, 2017 due to security risks)

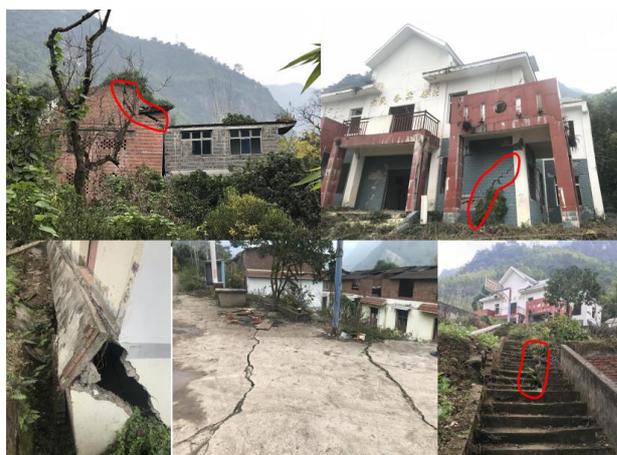
Figure 12. House cracks and ground cracks
