# THE COMPLEX POINT CLOUD FOR THE KNOWLEDGE OF THE ARCHITECTURAL HERITAGE. SOME EXPERIENCES.

C. Aveta<sup>a</sup>, M. Salvatori<sup>b</sup>, G. P. Vitelli<sup>c</sup>

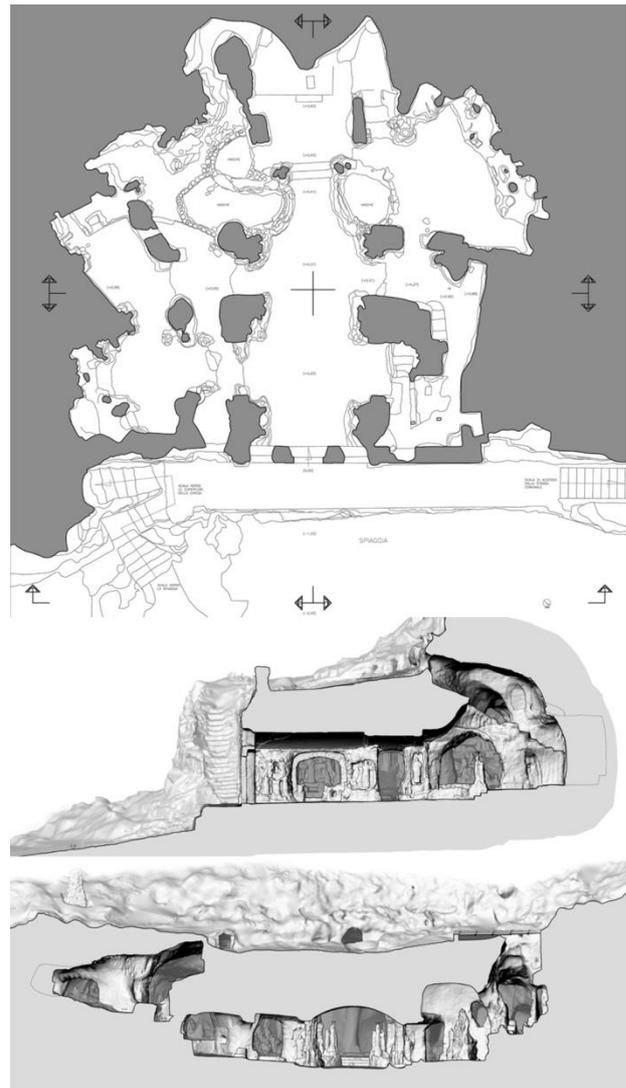
Figure 1. Two-dimensional representations of the model

The resulting point cloud was then segmented into four parts and transformed into a polygonal mesh surface which, appropriately sectioned by secant planes, allowed to generate, in addition to an accurate 3D model, numerous maps and sections capable of showing the space complexity of the church also through two-dimensional representations. (Figure 1)

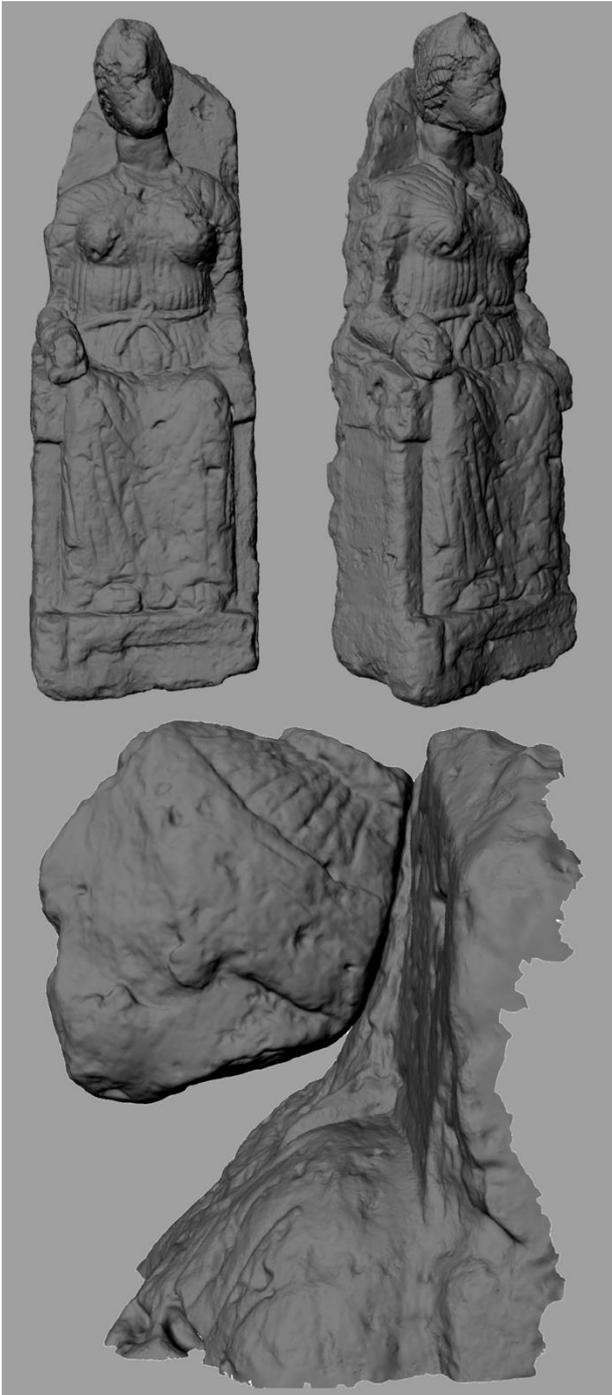
Figure 2. The virtual model of the statue "A" before and after the de-restoration.

To accomplish these operations, it was necessary to acquire approximately 180 scans with a Konica Minolta Optical Triangular Scanner and build models with polygonal meshes of high resolution, intentionally colorless, to permit the recognition of matches and connections useful for the correct positioning of the parts. (Figure 2)

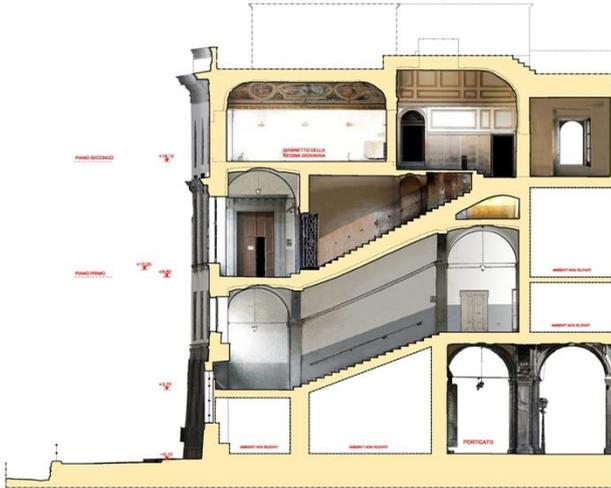
Figure 3. Section of the staircase

From high resolution captured point clouds, colored with the RGB data of a photographic sensor, were extracted plants, sections and precision statements used for the analysis of the degradation and for the restoration project. (Figure 3)

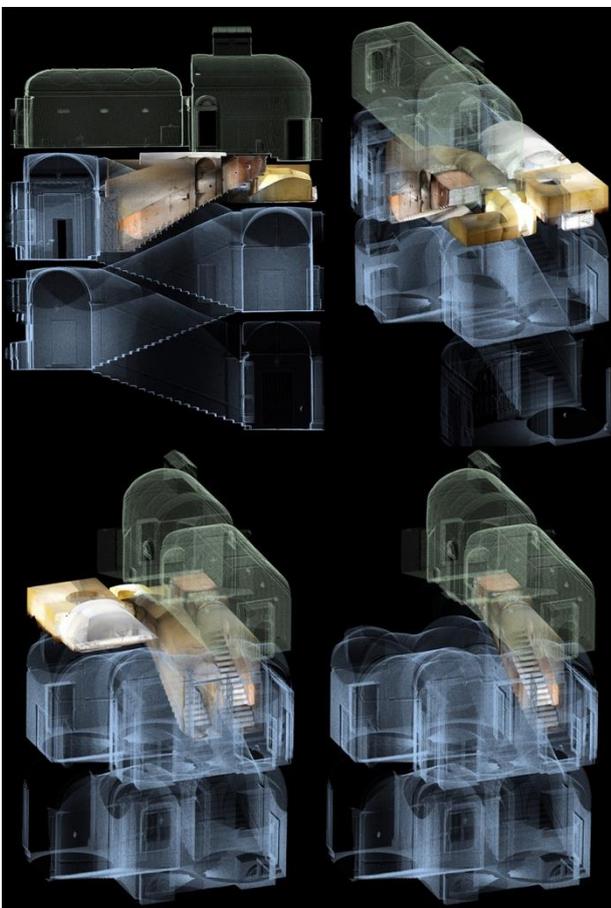
Figure 4. The point cloud treated with different colors and densities to build a special three-dimensional model.

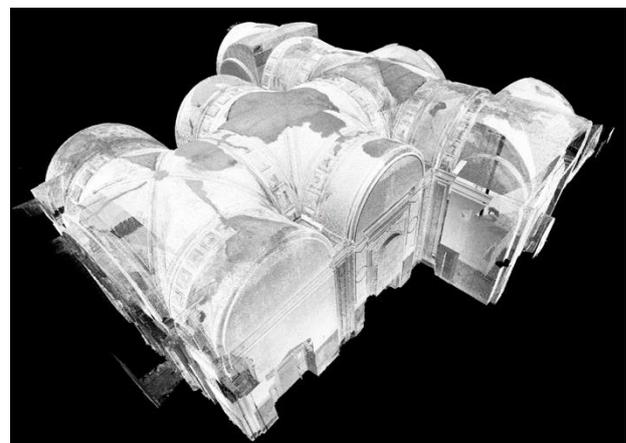
Figure 5. The point cloud of the inner volume of the church.

The survey, thus, permitted not only to obtain a three-dimensional model of the church (Figure 4), useful for any kind of evaluation - particularly with regard to geometry and genesis of the vaults, indispensable support for historical investigation - but also to create classical representations: maps, prospects, and sections, with geometric precision to allow assessments both on the lesion-structural framework and on surface degradation, directly interrogating the model.

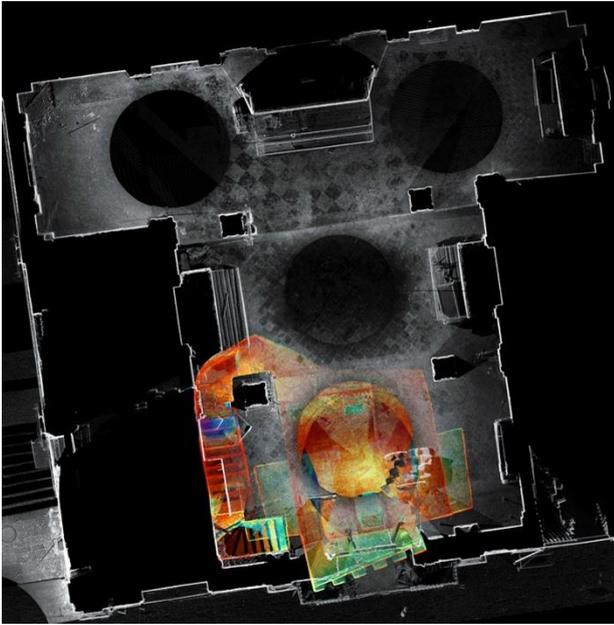
Figure 6. The point cloud treated with different colors and densities to build a special three-dimensional model

Similarly to what was done for the Castel Capuano staircase, then, by modulating the density and color of the point cloud, a representation was done to visualize, through a play of transparency, the spacial relationship between the underground crypt, the interior of the upper church and the placement of the original pillars. (Figure 6)

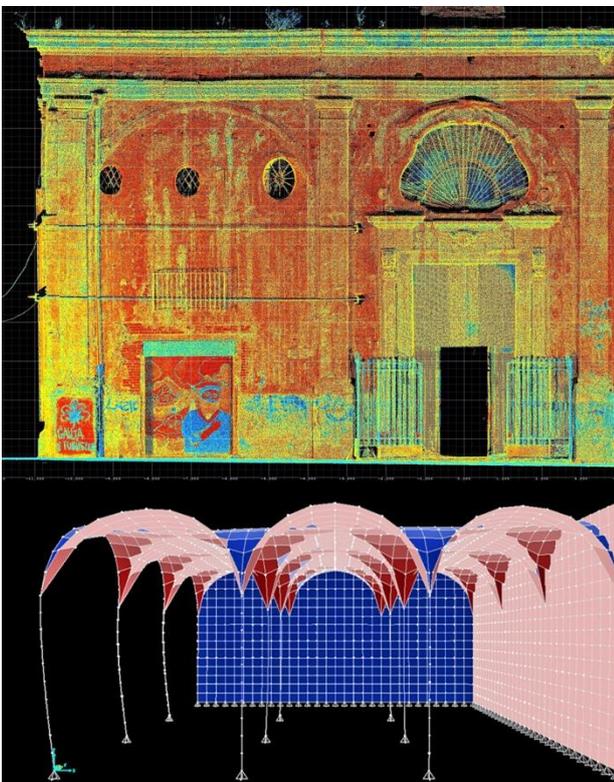
Figure 7. The point cloud of the façade and the structural behavior model.

Outside, the acquired cloud allowed for detailed analysis of the deformation state of the façades: it was possible to highlight and quantify a lateral facade rotation and estroflexion mechanism, which is associated with a flexion on the front facade cornice. The analysis allowed engineers to choose between structural behavior models, built into structural analysis software, those who had returned the same deformations. (Figure 7)

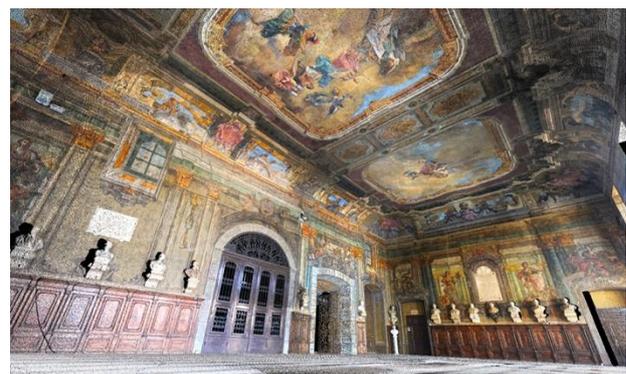
Figure 8. The complex point cloud of the Hall of Busts

In the Hall of the Busts, one of the biggest hall in the south of Italy entirely covered by frescoes, it has been realized an accurate reading of the painted surfaces reflectance's variations, looking for anomalies due to previous restorations, specific decay processes and washout caused by the previous crumbling roof covering.

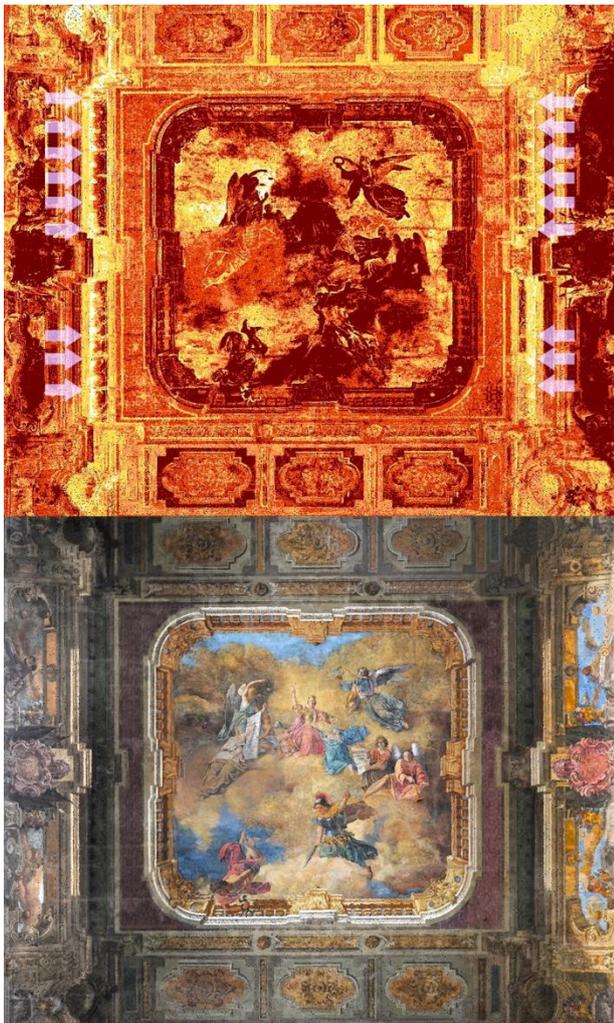
Figure 9. Comparison between colored point cloud with reflection data and RGB data.

These lines have been related to the wooden rib groove that supports the thin masonry shell, especially in the flat central part. The highlighting of these traces through the reflectance, in fact, suggests that they correspond to points of greater humidity transmission coming from the wooden ribs in direct contact with the extrados of the shell. (Figure 9)

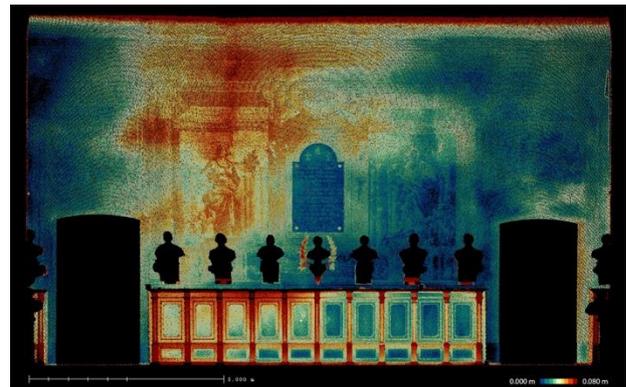
Figure 10.

For example, in the southern wall of the Hall of the Busts, a slight discontinuity was found in the fresco plaster that vertically slides the wall to a third, approximately, from the left corner. To analyze and even quantify this alteration, the acquired point cloud is colored in false color, depending on the deviation of each point from a reference interpolator flat surface. In this way it was possible to point out a marked swelling that affects a fairly extensive area around the above mentioned discontinuity, whose maximum arrow from the reference area was approximately 8 cm. (Figure 10)

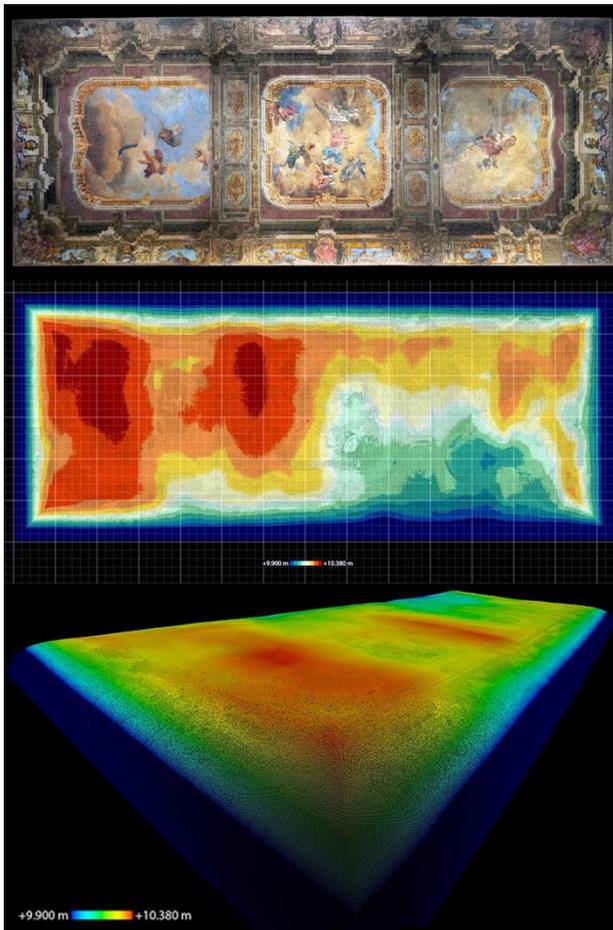
Figure 11.

Finally, in extracting the longitudinal section of the point cloud in the Hall, an unexpected noticeable irregularity in the horizontal level of the false masonry pavilion vault covering the large hall has been highlighted. This irregularity is also invisible to the naked eye, mainly due to visual disturbance consisting of the continuous presence of perspective / architectural decorations present in the intrados, which make it difficult to distinguish real shadows from painted shadows. Even in this case, the acquired point cloud was colored in a false color as a function of the deviation of each point from a horizontal reference level (not interpolator) placed at a height of 9.90 meters from the floor.

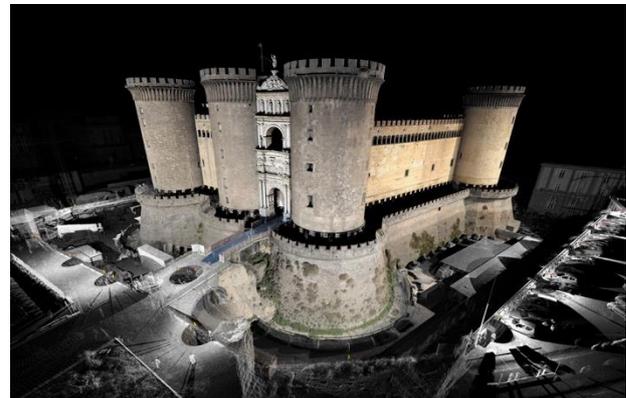
Figure 12. South-west view of the acquired dot cloud, indicating the scanning points.

To obtain a sufficiently dense and homogeneous point cloud with such a scanner to provide a reading of the actual geometry and state of degradation of the artifact, up to the scale of the single ashlar stone, the scanning positions were distributed with some regularity along the perimeter of the facades, spaced in such a way as to guarantee the covering of the geometry of all the protruding and receded parts, and to compensate, with the overlapping of contiguous scans, the inevitable density variations of the each point cloud which gradually degrade towards the farthest parts of the scanner. (Figure 12)

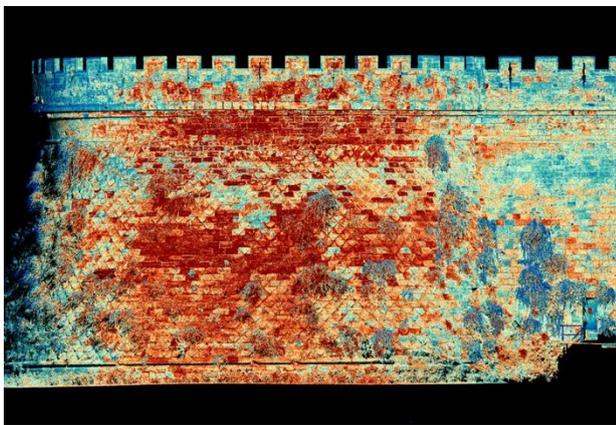
Figure 13. Orthoprojection of the tower tower stand points cloud, colored in false color depending on the variation of luminance.

For this purpose, for each facade of the castle, different orthoprojections of the point clouds were elaborated in false color, depending on the variation of luminance values recorded by the instrument. These have been used to identify and highlight areas with widespread surface alterations or punctual abnormalities related to the material differences or the conservation status of each ashlar stones.

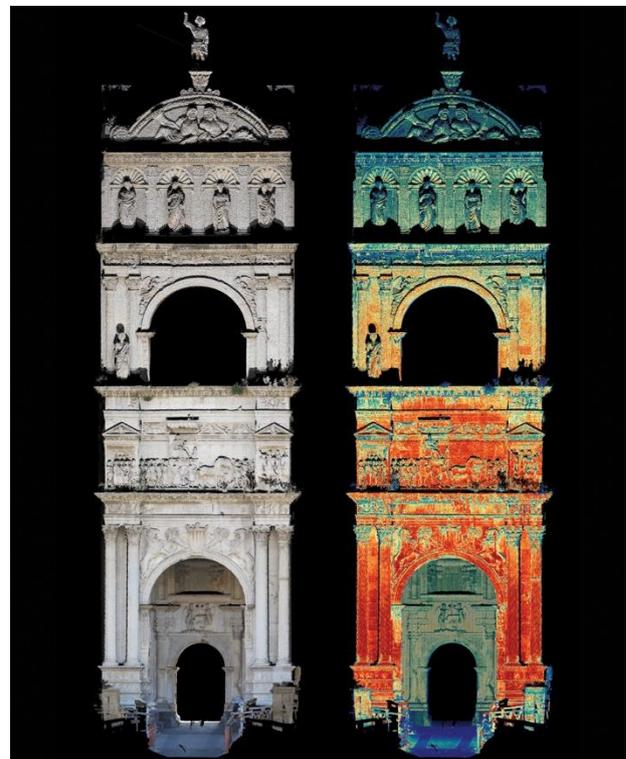
Figure 14. Orthoprojection of the Aragonese arc dot cloud with actual RGB data and false color depending on the luminance variation.

Thanks to this method, it was possible to highlight how the articulated transformations of the product, which have involved considerable material integration, have resulted in the formation of a heterogeneous degradative state characterized in particular by a diffused phenomenon of erosion and chromatic alteration caused by environmental pollution and disruptive action from soluble salts produced by marine aerosols.

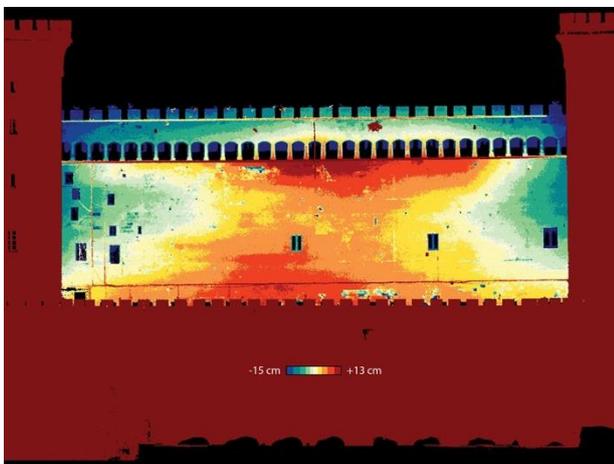
Figure 15. False color chart of the geometric deformation of the flat wall between the Guard and the Golden towers.

and geometric alterations often, but not always, are symptomatic of a lesioning condition. (Figure 15)

The result, which must necessarily be compared with historical information, the lesioning framework and the structural model for its correct interpretation, visually returns the wall deformation geometry with respect to its ideal plan and locates and quantifies precisely the points of maximum and minimum deviation.

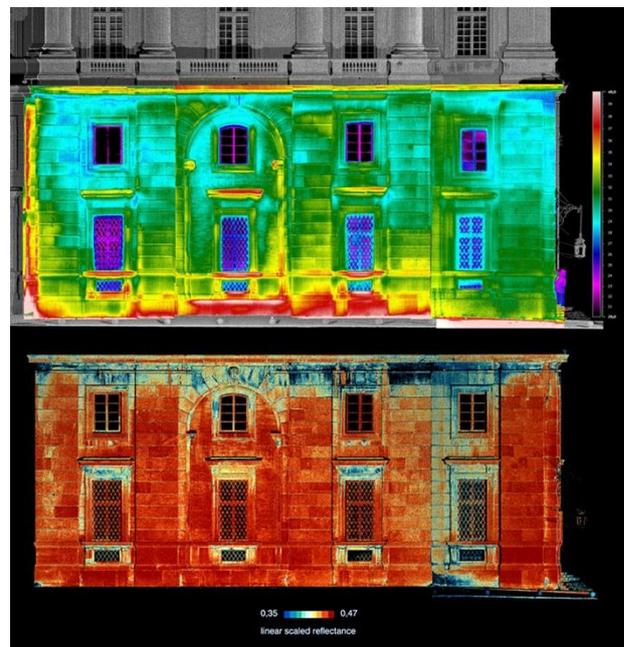
Figure 16. Comparison between colored point cloud with thermographic data and reflection data.

These thermographic maps, in which the color bands correspond to the isothermic lines, are designed to analyze a number of related issues, in particular, the pathologies of degradation and the difference in the materials. For this purpose, further thermographic images were elaborated, four for the low part of the facade, four for the upper one, which were then compared with the laser scanner data. (Figure 16)
