SURVEY METHODS FOR SEISMIC VULNERABILITY ASSESSMENT OF HISTORICAL MASONRY BUILDINGS

M. Ballarin^a, C. Balletti^a, P. Faccio^a, F. Guerra^a, A. Saetta^a, P. Vernier^b

KEY WORDS: Earthquake, Laser scanner, Cultural Heritage, Camera degli Sposi, Mantegna

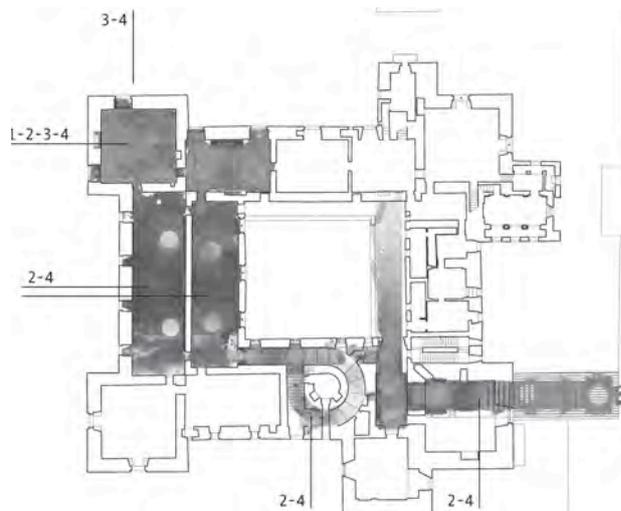
Figure 1. Plan of the documented rooms in the emergency survey

The second and the third team worked on the survey of the exterior and interior (figure 1-2) of the tower and the visitors' path, with two laser sensors based on the measurement of distance. Those instruments can be considered as automated total stations that measure horizontal and vertical angles and the distance between tool and surface, allowing the calculation of 3D coordinates of all points detected by the laser on the surface of the object to be scanned.

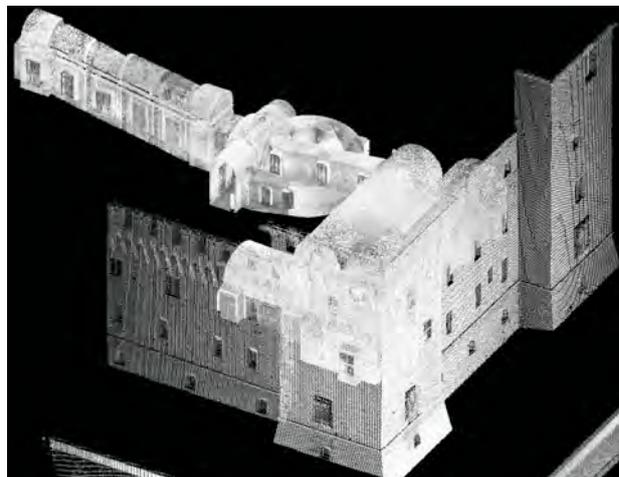
Figure 2. View of the dense point cloud

The second team, with the Riegl LMS-Z 390i (www.riegl.co.at), TOF technology based, focused on the acquisition of three-dimensional data on the external walls of the north tower: 4 coloured scans were performed, in order to define the digital shape in the space of the external surfaces of the tower. With the same laser scanner point clouds for the entire Camera degli Sposi were also acquired.

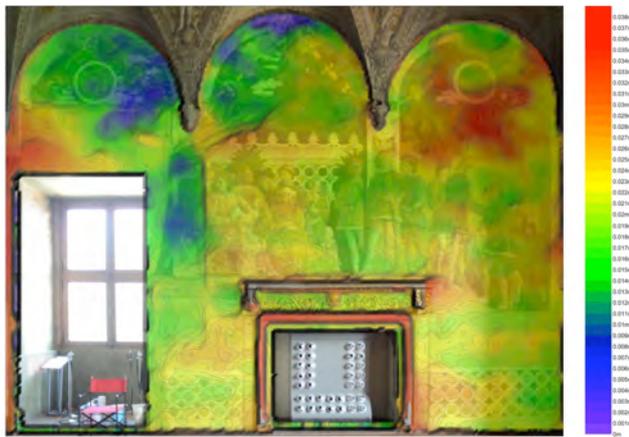
Detailed scans (figure 3) of the damage in the Camera degli Sposi were acquired with the range camera Minolta Vivid 9i, a non-contact tool measurement system based on triangulation (www.konicaminolta.eu).

Figure 3. Range map in false colour of the north wall of the Camera degli Sposi

40 detailed scans of the crack on the wall called "della Corte", were acquired, in order to obtain the complete shape of the damage along the wall and to have a measurement of any deviation from the mean plane of the surface of the area affected by the crack.

Actually, the preliminary analyses carried out for this element showed the high vulnerability of the curtain wall in correspondence of the chimney, figure 5, also demonstrated by the results of the survey, which have shown the deviations from the mean plane of the surface of such wall (i.e. see figure 3).

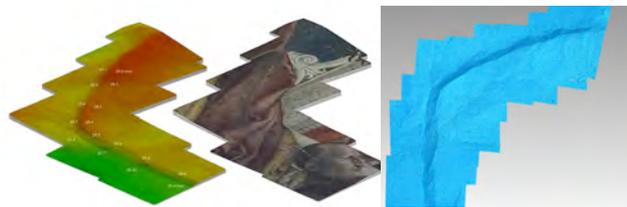
Figure 4. Detailed DSM of the crack

However, the observations derived from this first analysis did not give a complete picture of the situation. Other representations were then obtained with the false colour depth mapping of the damage. As we did for the orthophotos, the two images were overlapped and compared. The operations just described have shown that the external wall did not present considerable discontinuities and therefore that the earthquake had not caused harmful effects. On the other hand, the internal wall, in correspondence to the damage, presented deviations of up to 5 cm between the body of the tower and the infill.

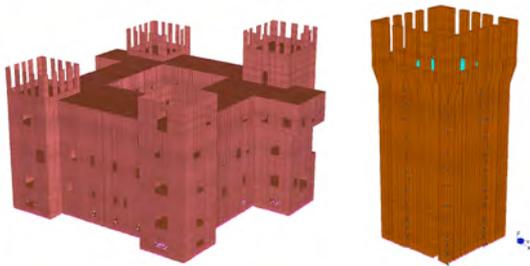
The chance of giving back the Camera degli Sposi to the city of Mantova, with the reopening of Palazzo Ducale to the tourists, required the preliminary assessment of seismic vulnerability of the North-East Tower, hosting this famous Camera degli Sposi. Thanks to the accurate survey of both the geometry and damage state (i.e. crack pattern and out-of-plumbs), the FEM models of the North-East Tower and of the entire San Giorgio Castle have been realized (figure 5).

Figure 5. (a) FE model of San Giorgio Castle and (b) of the North East Tower

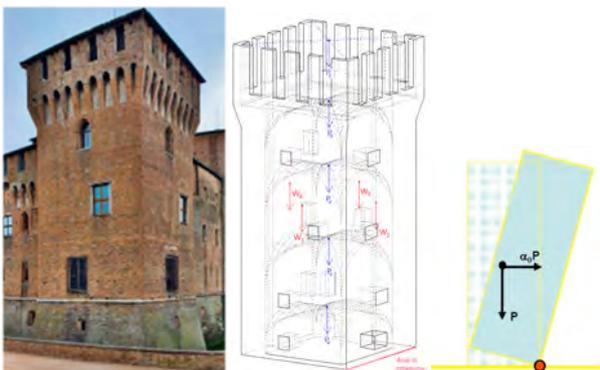
As an example, figure 6 shows the scheme of the local mechanism which involve the rotation of the whole North-East Tower around a side at the base. The load multiplier results:

$$\alpha = \frac{\sum_{i=1}^n W_i \cdot \frac{S_i}{2} + \sum_{i=1}^n F_{Vi} \cdot d_{Vi} + \sum_{i=1}^n P_{Si} \cdot d_i + \sum_{i=1}^n T_i \cdot h_i - \sum_{i=1}^n F_{Hi} \cdot h_{Vi} - P_H \cdot h_i}{\sum_{i=1}^n W_i \cdot y_{Gi} + \sum_{i=1}^n F_{Vi} \cdot h_{Vi} + \sum_{i=1}^n P_{Si} \cdot h_i}$$

and, in this case, the capacity / demand ratio resulted greater than 1.00, so demonstrating that this particular mechanism is satisfied.

Figure 6. (a)The North-East tower; (b) The loads involved in the local mechanism; (c) the scheme of the local mechanism

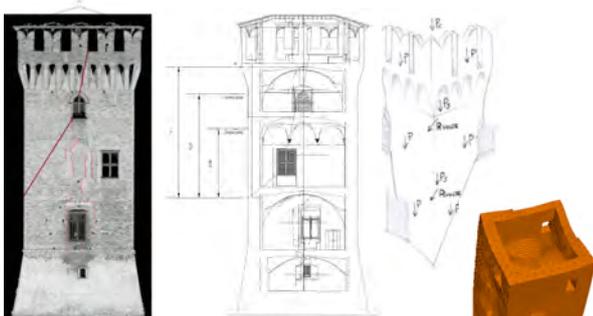
In figure 7, it is shown the mechanism which involves the upper corner part of the tower, whose identification has been possible thanks to the accurate analysis of the crack survey and by performing a modal analysis which allowed to identify the proper vibration mode.

The capacity/demand ratio in this case resulted equal to 0.27, underlining a high vulnerability of the tower with respect to such a mechanism. Similarly, the local mechanism involving the overturning of the single facades around their bases, does not result satisfied.

Figure 7. (a)The North-East tower; (b) The section; (c) the scheme of the local mechanism; (d) the corresponding vibration mode

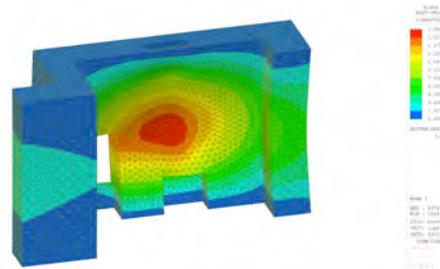
Figure 8. Preliminary results of FE analyses of "della Corte" wall

The outcomes of these analyses evidenced the need of specific restoration interventions, mainly aimed to reduce the vulnerability of local mechanisms. Therefore a restoration project, prescribing the adoption of steel hoops and ties at the floor levels of the tower was developed by prof. Paolo Faccio. Finally, a FE model of the north wall of the Camera degli Sposi, i.e. the "della Corte" wall, was developed. The main aim was to investigate the vulnerability of this wall, where the famous Mantegna's fresco is located, caused by the presence of the previously cited chimney.

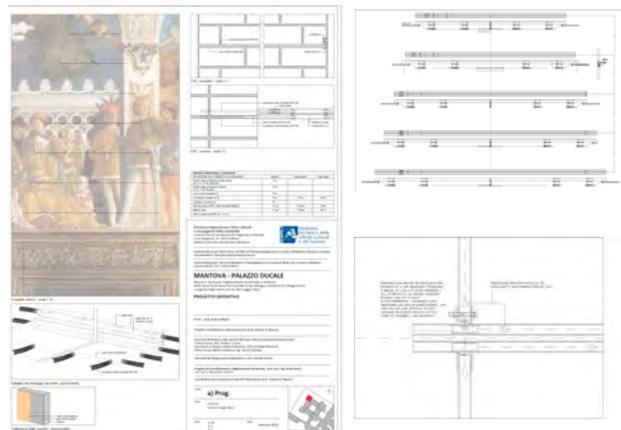
Figure 9. Restoration project

Based on the results of the numerical analyses, a restoration project for the chimney internal wall was developed by prof. Paolo Faccio (figure 9).

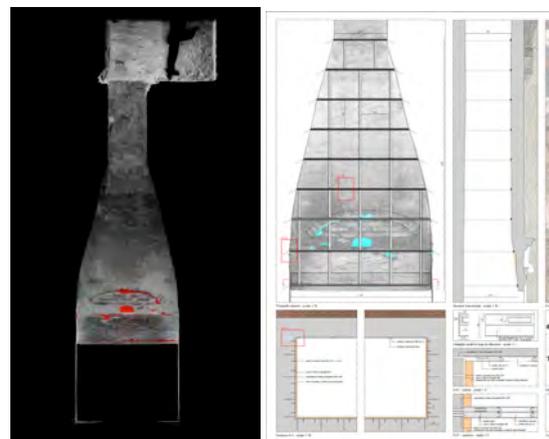
Figure 10. (a) laser scanner survey of the internal side of the chimney; (b) view of the restoration project

This project prescribed the use of steel and basalt elements positioned in correspondence of the internal side of the chimney, by using the existing discontinuities evidenced by the laser scanning survey, figure 10. In this way the realization of the intervention minimized the actions on the curtain wall where the famous painting is located.
