MULTITEMPORAL 3D MODELLING FOR CULTURAL HERITAGE EMERGENCY DURING SEISMIC EVENTS: DAMAGE ASSESMENT OF S. AGOSTINO CHURCH IN AMATRICE (RI)

KEY WORDS: UAV photogrammetry, multi-temporal model, structural assessment, seismic emergency, Cultural Heritage

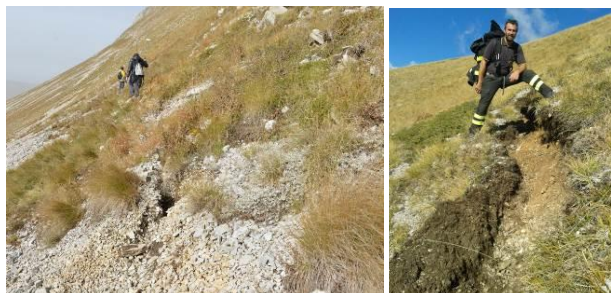
Figure 1. The Fault of Mt. Vettore before the earthquake of Norcia (Left) and after (right)

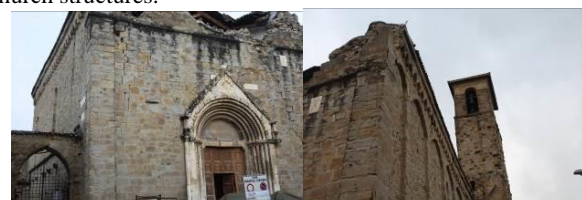
Figure 3. Two terrestrial images acquired in the first campaign

The first reconnaissance (5th- 9th of September) performed after the earthquake of Amatrice (24th of August) allowed to acquire a terrain dataset of the S. Agostino church with some topographic measurements as well. The images were acquired by a Nikon D800E reflex digital camera equipped with a 24x36mm frame. The camera has a 36 Mpx full-frame CMOS sensor with a pixel size of 4.89µm. The images (7360 x 4912 pixel) have been acquired from almost 8 m, then were post processed for balancing light and colours and masked for the next processing steps. The access to the area was, during this first campaign, very short since the area was in the red zone. Only images of the main façade (south), west and bell tower were recorded since in the other parts the entrance was forbidden according to the instability of the church structures.

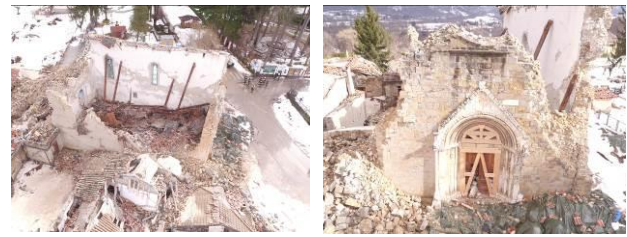
Figure 5. Oblique image of the Sant'Agostino Church; the top of the bell tower and the collapse after the Norcia earthquake; the structure after the January seismic events

After the first event, the church was shored up using the traditional provisional structures realized by the firefighters in emergency areas. As many other structures in the area the building was declared unsafe and controlled with ad hoc analysis and surveys. The new main event of the 30 October 2016 (6.5 M) increase the damages of the church especially in the belt tower (the top collapsed), in the main façade and in the east part. After this event a new reconnaissance was realized for the 29th of November up to the 4th of December and new data were collected (terrestrial and aerial). For the terrestrial acquisition the afore mentioned camera was used again while for the aerial one in this case the Phantom 4 was employed. The Phantom 4 is equipped with a 4K video camera that has a 1/2.3" CMOS sensor, 94-degree field of view, 12.4 MP images. The flight was performed again in manual mode according to the shape of the church in order to acquire sufficient number of images for a correct realization of a complete documentation of the area for photogrammetric purposes.

As one can clearly deduce from the previous paragraph, the extremely poor balance situation was definitively exceeded after the sequence of three earthquakes occurred at 9:25 (M5.1), 10:14 (M5.5) and 10:25 (M5.4) on the 18th of January 2017. This new seismic swarm produced the collapse of the belt tower, the east and south façades and an important increasing of the damages on the main façade. The west part of the church is still preserve although very important damages are clearly recognizable on the structure.

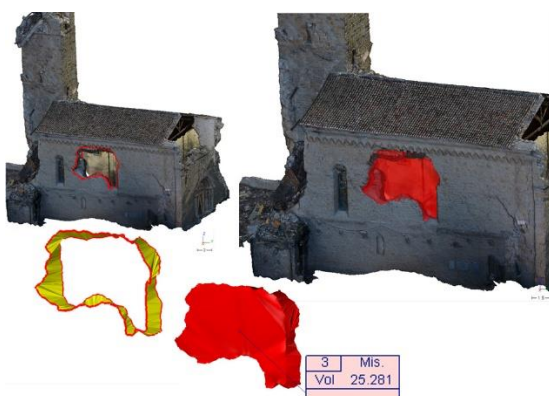
Figure 12. Analysis on West wall where the damage mechanisms caused the collapse of the central part of the masonry by shear failures.

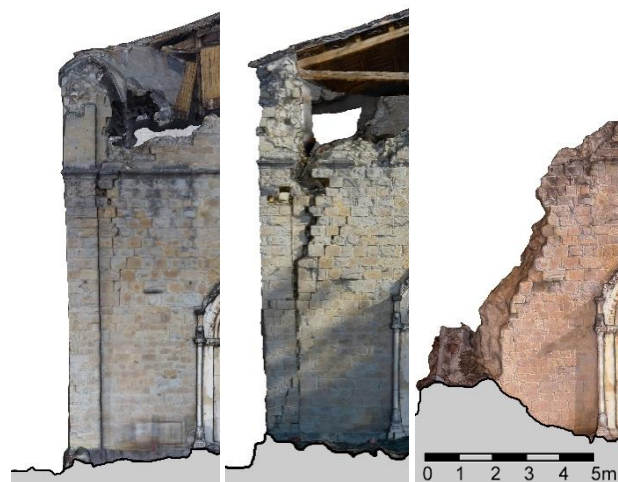
In this specific focus on the left connection with the West wall (Figure 14) the progressive evolution of collapse a series of break lines traces were detected in t1 in relation to the ones identified in t2 before the decisive collapse.

Figure 14. Orthoimages of the main façade in t1, t2, t3.

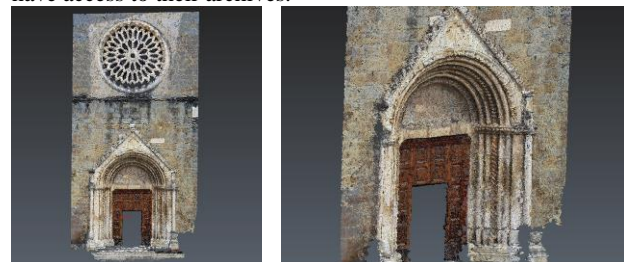
Figure 17. First test of point cloud generation of the portal before the earthquakes

In March 2017, we started a new project to evaluate if it would be possible to create a 3D model of the church of S. Agostino through an online campaign of crowdsourcing. In the first phase of the project we wanted to evaluate the type of images that were online available for the church and the quality of the results we can expect. We performed some researches on the major online platforms for the storage and sharing of images and we selected a set of around 20 images. The images were selected depending on size, quality and presence of metadata and were all focussed on the decorated portal of the church. The same solution for SfM (Agisoft Photoscan) was used in this first phase and some encouraging results have been reached (Figure 17).
