LOW-COST UAS PHOTOGRAMMETRY FOR ROAD INFRASTRUCTURES' INSPECTION

L.Pinto^{1*}, F. Bianchini², V. Nova¹, D. Passoni¹

^{1,2}Department of Civil and Environmental Engineering, Politecnico di Milano, Milan, Italy

Commission II, WG II/10

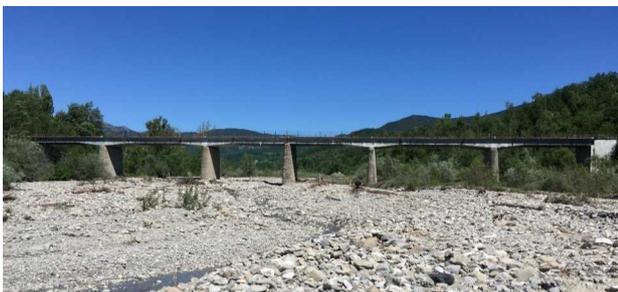
Figure 1. The Lavaiana Bridge

The first field test was carried out on June 13th, 2019 during a typical spring-like weather that allowed to take advantage of the sunlight for several hours, for a test total duration of about seven hours. The surveyed structure (Figure 1) is a 140m x 11m x 8m RC bridge that crosses the Lavaiana creek along the SP8 road, made of six spans, five piers and two abutments.

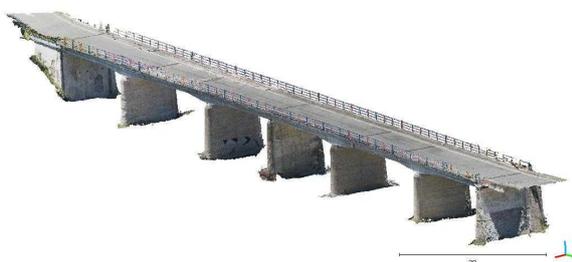
Figure 2. Dense cloud of the Lavaiana bridge

The successive step was the creation of the sparse cloud. It was automatically computed by Metashape through an operation called *Photo alignment*, and the only user's task was to select the output quality on a five levels scale (from "lowest" to "ultrahigh"): in this case, the sparse cloud was computed selecting a "medium" quality. The output was computed in about 30 minutes and it was made of 66.011 points. Based on the sparse cloud quality and before computing the dense cloud, namely the final 3D model, it was possible to improve the total accuracy by using the "Optimize camera alignment" tool, which allowed to correct possible estimation errors of the parameters, leading to deformations in the final model. Finally, choosing once again a "medium" quality, the dense cloud could be computed through a Metashape command called "Build dense cloud" based on a computation of the collinearity equations system. With a computational time of about five hours, the final output was a 6.042.252 points dense cloud (Figure 2) with an 9mm accuracy; the "medium" quality represents a compromise between a good quality of the model and a reasonable time of computation (Gagliolo et al., 2018; Pagliari, Pinto, 2018).

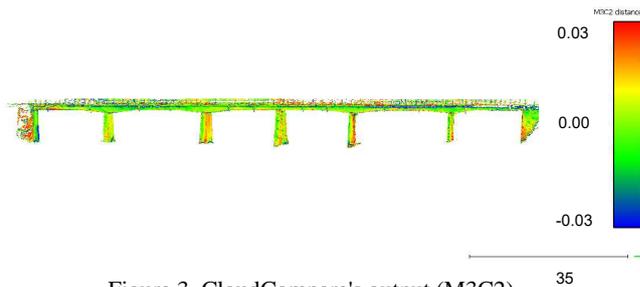
Figure 3. CloudCompare's output (M3C2)

It was possible to verify the consistency of the survey by comparing the two clouds of points obtained using the two methods (the photogrammetric and the laser ones). To do this, the M3C2 (Lague et al., 2013) tool of CloudCompare was used to calculate the metric distance between groups of points of each cloud. As inputs, the tool requires a "reference cloud" (the most precise one, generally) and a "compared" one, a "sampling rate" (m) and three additional parameters ("normal", "projection", "max depth"). The laser scanner cloud and the photogrammetric one were respectively selected as "reference" and "compared cloud"; the sampling procedure allowed to reduce the high numerosity of the reference cloud, making the software computation easier. A 0.025m sampling rate was selected: the higher this parameter, the less numerous the output's cloud. A 0.025m sampling rate meant that the new reference cloud could be made by taking one point every 25mm from the original cloud. The subsampled reference cloud was made by about one million points, around 1/6 of the original cloud: they are called "core points" and represent the reference points to calculate the distance between the two models. The "normal" and "projection" parameters generate a sort of cylinder around each core point; their best fit values are generally recommended by the software itself. The last parameter is called "max depth" and establishes the maximum searching distance. As outcomes of this comparison, CloudCompare generated an overall image of the bridge and two histograms: each of them confirmed the good quality of the photogrammetric cloud. In particular, as can be seen in Figure 3 and in Figure 4, along most of the structure, the distance between the two clouds is less than 7mm (light green and yellow colours); the major distances, that are around 3cm and highlighted in blue and red, are less numerous and appear along the bridge's abutments, central pillars and intrados external portions.

Considering that the MS60 model precision is greater than the photogrammetric one, these differences can be especially ascribed to three factors: the presence of outliers (or "noisy" points) that were not removed correctly from the sparse cloud; the greater difficulty of reconstruct sharp edges through photogrammetry; or an intrinsic error of the model. As said before, MetaShape's dense cloud is characterized by a 9mm accuracy: this means that each point of the 3D model can differ from the real structure by no more than 2.7cm (with a 99.7% probability).

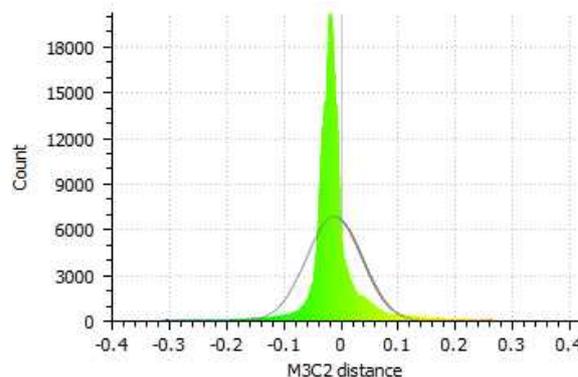
Figure 5. Points' distribution around the average value

Therefore, portions of bridge with a distance lower than this can be considered satisfying; on the contrary, portions characterized by a distance greater than 2.6cm from the MS model represent points that do not belong to the structure or structural elements that were not correctly reconstructed. Figure 5 represents the Gaussian statistical distribution of the point, centered around its average value ($\mu = 0,010m$) and with a standard deviation $\sigma = 0.051m$.

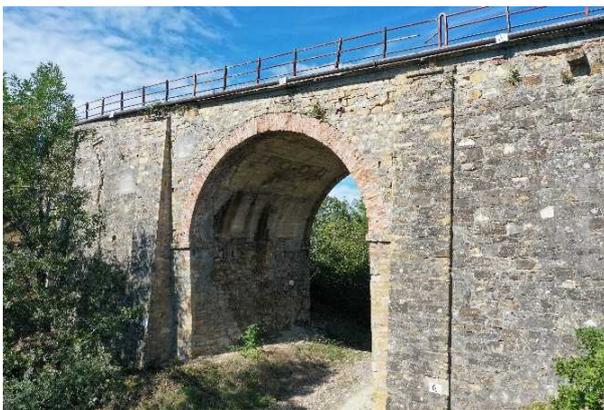
Figure 6. The Lanzone Bridge

The second test was conducted on September 24th, 2019 during a sunny day, a perfect weather condition for a drone survey. The surveyed structure (Figure 6) is a 30m x 9.5m x 8m one arch masonry bridge called Lanzone Bridge located in Dignini, a small town in the Vernasca municipality (Piacenza -Italy).

Both the equipment and the procedures were the same as the survey for the Lavaiana bridge, except for the fact that this time, because of the small dimension of the bridge, visual data were acquired by taking pictures instead of recording videos. This choice was made during an inspection conducted a couple of months before the survey, during which it was decided to remove some dense vegetation very close to the structure. Besides being a physical obstacle for the flight of the drone, it did not allow to properly reconstruct the covered portions of the bridge. Again, thanks to the size of the bridge, the MS60 computed the 3D model of the bridge by scanning only its east and west side, for a total of two clouds to be merged instead of the seven computed for the Lavaiana bridge. A total of 12 GCPs were positioned on the structure, five on each side and two on the internal walls of the masonry arch. A total of four drone flights were performed, during which 146 pictures were taken. The visual inspection of the bridge highlighted several structural damages, such as deep and extended cracks, humidity spots and vegetation grown between the walls stones.

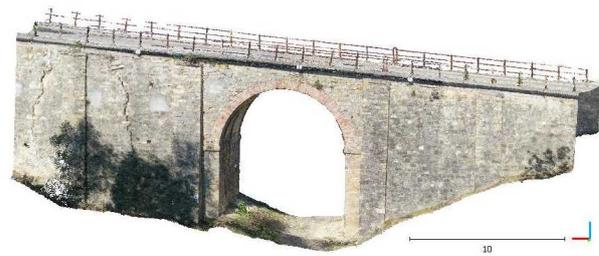
Figure 7. Dense cloud of the Lanzone bridge

The laboratory test followed the very same procedure of the first one, apart from extraction phase of the frame. All the 146 pictures were given as input to Metashape, which computed a "medium" quality sparse cloud made of 108.904 points with a 20 minutes computational time by using the same PC as before. The dense cloud was computed in about five hours and was made of 5.912.527 points, with a 7mm accuracy (Figure 7).

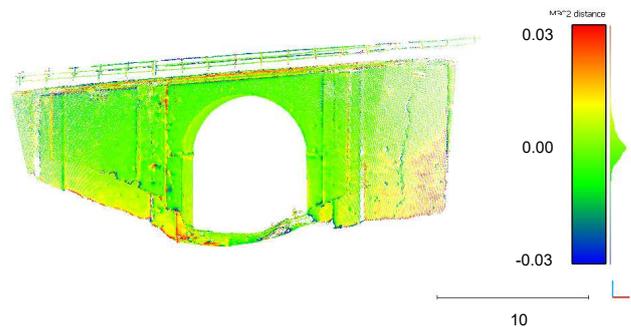
Figure 8. CloudCompare's output

As shown by Figure 8, the distance between the majority of the points of the model is less than 1cm (light green and yellow points). Red and blue points, which represent distances around 3cm, are less than the Lavaiana case and distributed along the upper portion of the structure, characterized by sharp edges.

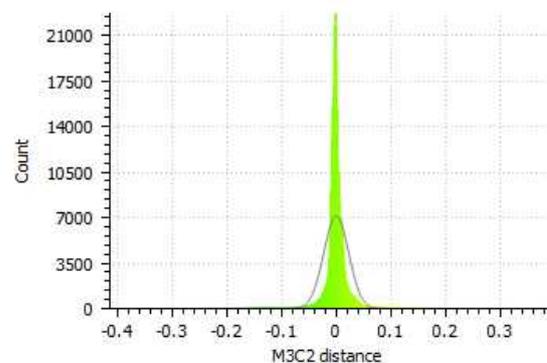
Figure 9. Points' distribution around the average value

Figure 9 represents the statistical distribution of the points, again following a Gaussian curve centered around its average value ($\mu = 0,000\text{m}$) and with a standard deviation $\sigma = 0.023\text{m}$.
