COMBINATION OF THE PHOTOGRAMMETRIC AND MICROWAVE REMOTE SENSING FOR CULTURAL HERITAGE DOCUMENTATION AND PRESERVATION - PRELIMINARY RESULTS

Patryk Kot^{1*}, Jakub Markiewicz², Magomed Muradov¹, Slawomir Lapinski², Andy Shaw¹, Dorota Zawieska², Aleksandra Tobiasz³ and Ahmed Al-Shamma'a⁴

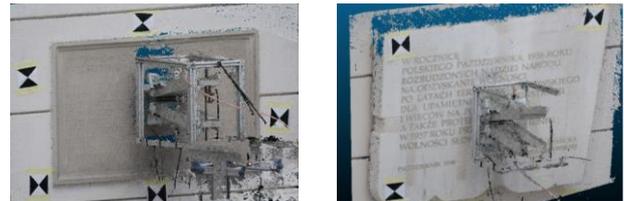
Figure 2. The example of the EM position with dense point cloud used for visualisation.

The point cloud obtained from processed RGB images with oriented EM sensor (based on the classical surveying measurements) is presented in Figure 2. The microwave measurements were repeated three times for each measured object and the response then was averaged and analysed in
