## RPA POSITIONING ERROR INFLUENCE ON CLOSE RANGE PHOTOGRAMMETRY FOR INDUSTRIAL INSPECTION

M. Machado <sup>1</sup>, G. Marcellino <sup>1</sup>, J. D. Salazar <sup>1</sup>, D. J. Regner <sup>1</sup>, P. Buschinelli <sup>1</sup>, J. M. Santos <sup>2</sup>, C. Marinho <sup>2</sup> and T. C. Pinto <sup>1,\*</sup>

<sup>1</sup> Mechanical Engineering Department, Labmetro/UFSC - Florianópolis, SC, Brazil

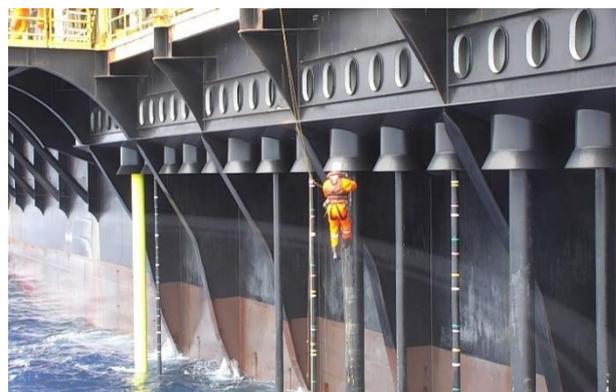
Figure 1. Industrial climbing for riser inspection.

In oil and gas offshore extraction platforms, special pipelines can make the connection between the ocean floor structures and the platform. These especial pipelines, called risers in the portion not touching the ocean floor, are used in extreme environmental and operational conditions. Thus, it is necessary to carry out periodic inspections to assess their integrity as they can suffer damage, such as external abrasion, diameter variations, ripples, deformations, and dents during their operation. These defects can reach meters long and range from a few to hundreds of millimeters depth and are generally detected from external geometry measurements. Traditionally, the external riser inspection between water level and its connection to the platform is performed by an industrial climber, as Figure 1 illustrates. These inspections are done in a hazardous environment. They are expensive, extremely dangerous, and time consuming.

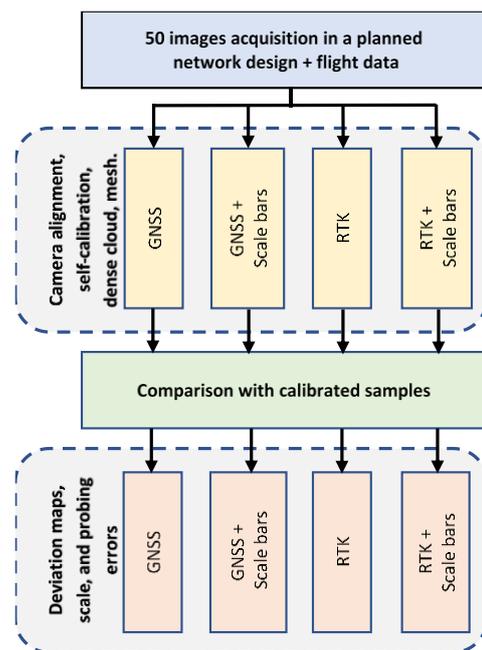
**Figure 2.** Evaluation process flowchart with process and evaluation setup. The acquired images are processed with different strategies and results compared with calibrated artifacts present in the reconstructed scene.

Figure 2 shows the general flow chart of the processes. The measurement scene consists of four scale bars with coded targets, a 300 mm diameter PVC pipe with calibrated synthetic defects similar to a riser, and a pattern with four spheres, as shown in Figure 3. The spheres pattern allows evaluations similar to the VDI/VDE guideline (VDI/VDE 2634, 2002) that presents a methodology for evaluating optical measurement systems, in which it is possible to estimate the systematic Sphere Spacing Error - SSE and the random Probing Error - PE separately. The calibrated pipe allows the direct comparison between reconstructed and reference surfaces.

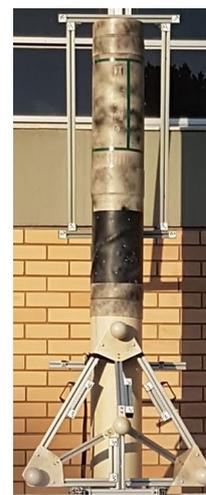
**Figure 3.** Experiment scene setup. PVC pipe, four spheres artifact for scale/random error analysis. Only the four scale bars on the sphere's artifact were used.

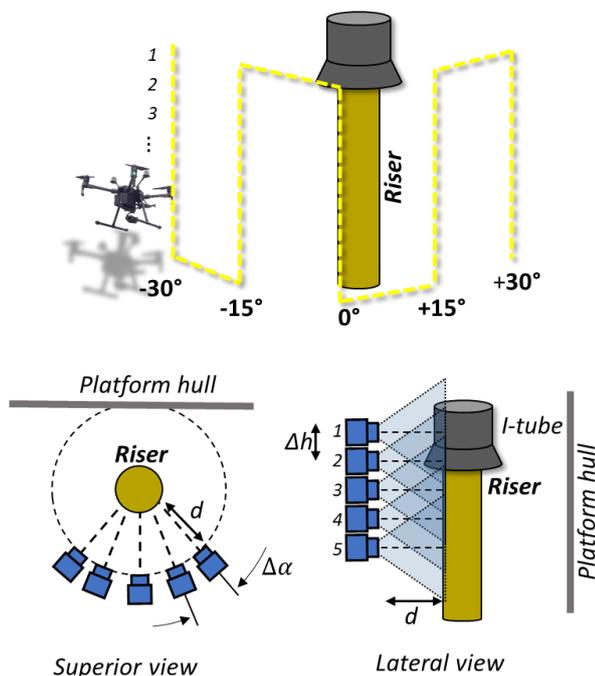
**Figure 4.** Network design for RPA trajectory and image acquisition, called serpentine trajectory.

The developed network design for the RPA trajectory is a fusion of convergent and planar trajectories usually used in close-range industrial photogrammetry (Luhmann, 2010) and in aerial terrestrial mapping (Nex and Remondino, 2014), respectively. Figure 4 shows the network design for the RPA trajectory and image acquisition, called serpentine trajectory.

Using this trajectory, a good convergence is achieved around the riser longitudinal axis in the horizontal direction, but the RPA moves in a straight line in vertical direction, along the riser longitudinal axis. For five vertical lines with a  $\Delta\alpha=15^\circ$  step around the riser axis, an approximately 1:1 base to distance ratio with good convergence is achieved. The vertical displacement between images is used to achieve around 80% overlap between successive images. No camera roll angles are used in the image acquisition as the camera gimbal has a limited roll angle ( $\pm 20^\circ$ ) (DJI, 2019a) and is used only for camera stabilization during RPA flight. In the vertical direction, the image acquisition starts and ends before and after the area of interest in the riser

For the images acquisition, a flight with a serpentine trajectory was performed (Figure 4) with a minimum overlap of 80% between the images, with a vertical step of about 0.3 m. The RPA to pipe distance was approximately 5 m, which is considered a minimum safe distance for offshore acquisitions. 3D processing was done using the Agisoft Metashape 1.7.2 Professional Edition software (Agisoft, 2021), with the following configurations: align photos with accuracy high, camera self-calibration and optimization with 8 parameters ( $f$ ,  $c_x$ ,  $c_y$ ,  $k_1$ ,  $k_2$ ,  $k_3$ ,  $p_1$ ,  $p_2$ ), rolling shutter compensation enabled, build dense cloud with quality high, and build mesh with face count high and disabled interpolation. The images were obtained with the RPA when in hovering mode. At the time of the acquisitions, the average wind speed was of approximately 17 km/h. Figure 7 shows the mesh and the camera stations when images were acquired by the RPAS.

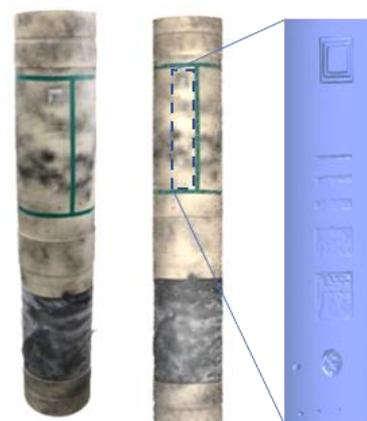
**Figure 5.** PVC pipe: actual photo, 3D textured mesh and reference measurement of the pyramidal artifact and artificial defects region.

**2.1.3 PVC pipe:** A PVC pipe similar to a riser was used. It contains some artifacts and artificial defects on its surface. The PVC tube was calibrated with expanded uncertainty of  $U=\pm 0.075$  mm using a reference fringe projection measurement system ATOS Compact Scan 2M (GOM, 2020). The generated reference CAD files were used as a reference to compare and evaluate the results. These reference files also allowed comparison with artificial defects to assess the resolution capacity of the measurement process. Figure 5 shows the PVC pipe used.

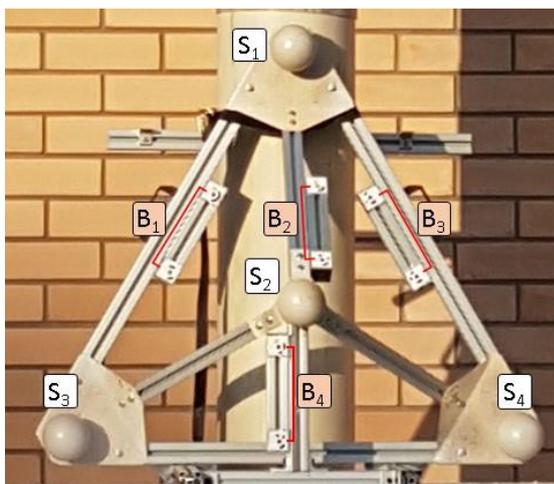
**Figure 6.** Pyramidal artifact with four spheres ( $S_{\#}$ ) and four scales ( $B_{\#}$ ) for metrological evaluation.

**2.1.4 Spheres pyramidal artifact and scale bars:** An artifact composed of a pyramidal structure in structural aluminum profiles and four steel 100 mm diameter spheres with texture application on its surface was used. The component was calibrated using the Faro Platinum measuring arm with a measurement expanded uncertainty of  $U=\pm 0.06$  mm. In the same pattern, four scale bars were set. The scale bars consist of an aluminum structural profile and coded targets in their ends which are automatically recognized by the photogrammetric processing software. Calibration of the distance between the centers of the coded targets in the scale bars was performed with a Renishaw XL-80 interferometric laser and magnifying lens with expanded uncertainty of  $U=\pm 0.09$  mm. The structure obtained can be seen in Figure 6. The distances between the centers of the spheres are listed in Table 2 and the length of the scales in Table 3.

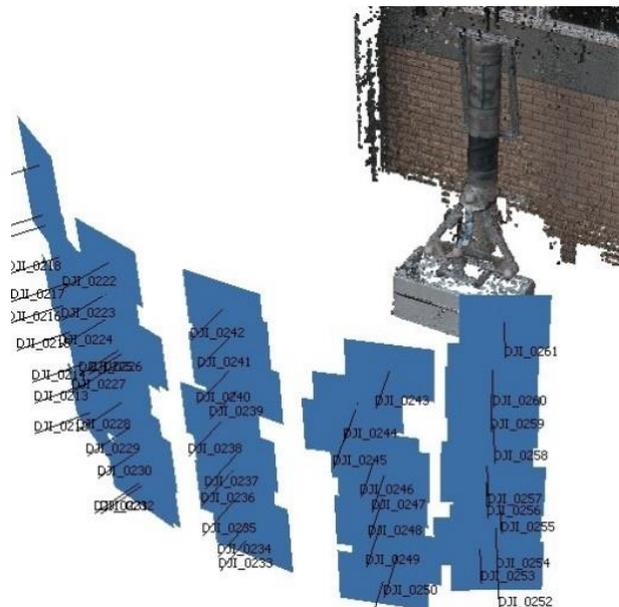
**Figure 7.** Serpentine trajectory performed for image acquisition, resulting 3D mesh and camera stations.

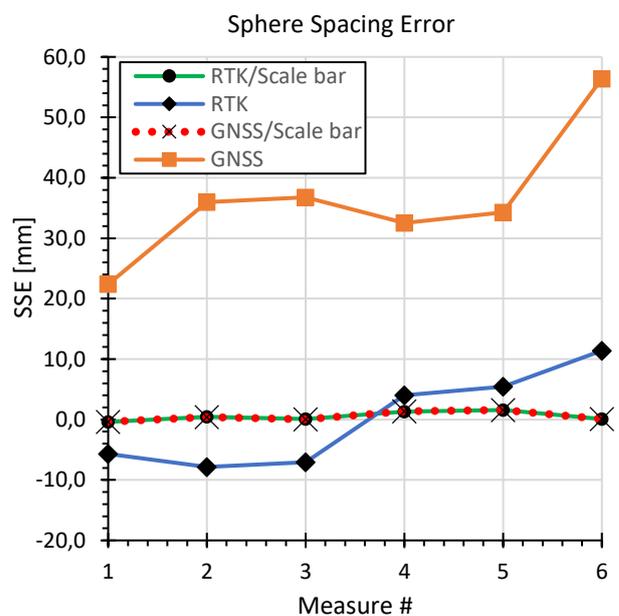
**Figure 8.** Sphere spacing error (SSE) for the sphere's artifact. Measure # is Sphere Spacing Error between spheres as defined in Table 2, in the same order.

Figure 8 presents the SSE for all processing strategies for all pairs of spheres in the sphere's pyramidal artifact. It is possible to identify that the measurements that include the scale bars information have the lowest scale error, as expected. In both cases that use scale bars, the maximum SSE represents 0.26% of the sphere centers distance. When comparing both cases that do not use the scale bars information for scene scale definition, i.e., GNSS and RTK information only, the measurements based on GNSS information has the highest measurement errors. For the GNSS, the maximum SSE represents 5.9% of the sphere centers distance. For the RTK, the maximum SSE represents 1.2% of the sphere centers distance. The same kind of analyses was done with the scale bars in the scene, resulting a maximum relative error of 5.6% for GNSS, 1.6% for RTK and 0.04% for scale bars. Differences from scale bars and SSE errors are due to several factor including the use of a manual selection of point cloud for each sphere and texture-based point cloud calculations. These results are compatible with the contributions from the higher uncertainties in the GNSS data in relation to the uncertainties in the RTK data (Dong-feng et al., 2009). This effect can also be accounted by a relatively poor camera self-calibration, as the desired camera roll angles were not suitable for the camera gimbal used. The advantage of using the SSE to analyze the influence of processing strategies is due to a better separation between the error's components. Thus, in this analysis, it is possible to better remove the random component in the point cloud, as opposite to the surface comparison analyses in the next section.

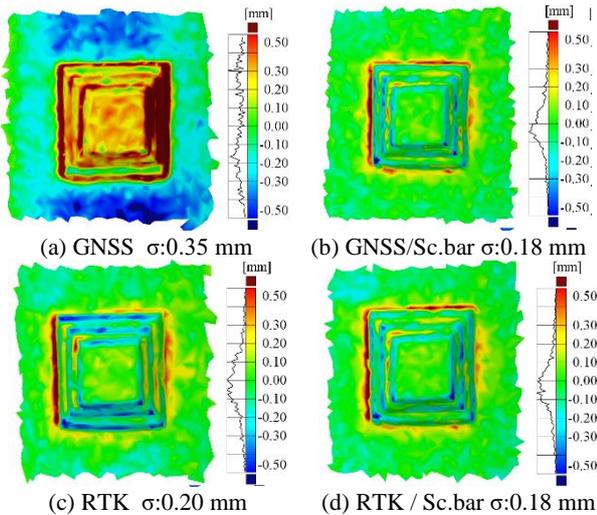
**Figure 9.** Surface comparison of the pyramidal artifact (50mmx45mmx15mm) versus its calibrated reference.

Comparisons were made between the measured surfaces in the PVC pipe and the reference surface (GT), in the region of the pyramidal artifact (50 mm x 45 mm x 15 mm), and artificial defects (100 mm x 300 mm x 3 mm), as can be seen in Figure 4. In this analysis, systematic and random errors act together influencing the quality of the measurement results, as with the analysis of data from actual field inspections. Figure 9 shows the comparisons made between the surfaces.

Through the comparison between surfaces for the pyramidal artifact, there were some significant differences when only GNSS data is used. For the GNSS, the standard deviation is 0.35 mm. For the RTK, the standard deviation is 0.20 mm. In all cases using the scale bars to define the scale, the errors standard deviations are the same, 0.18 mm. For the artificial defects surface comparisons, presented in Figure 10, the use of RTK or scale bars have similar results, and the errors standard deviation is remarkably similar, between 0.13 mm and 0.15 mm, and a higher result for GNSS ( $\sigma$ : 0.29 mm), as expected. It is important to note that scale errors and random errors are presented simultaneously in these analyses, but for the GNSS case the scale errors are evident by the red and blue areas that should be more randomly distributed and predominantly green in the absence of scale errors. In any case, it was possible to identify the artificial defect in the pipe with good quality and with much more detail if compared with a presential inspection using industrial climbing.

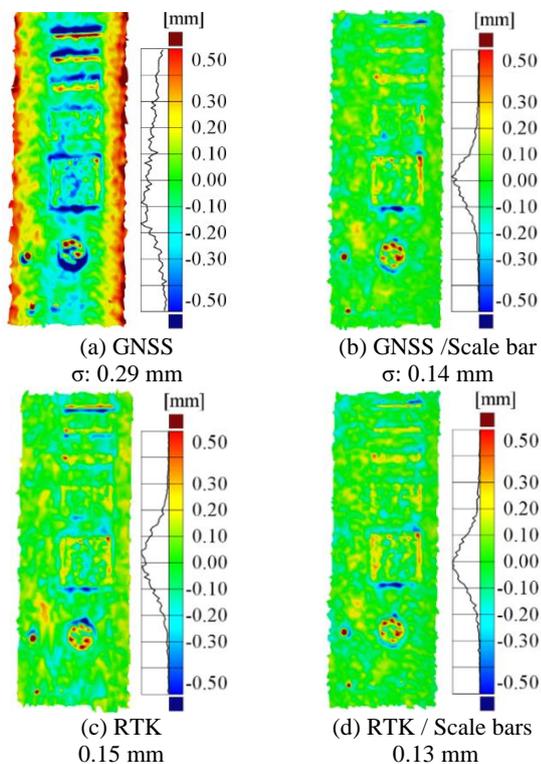
**Figure 10.** Surface comparison and standard deviation of the measured artificial defects region (100mm x 300mm x 3mm) versus its calibrated reference.

The next evaluation carried out consists of comparing surfaces in the region of artificial defects in the PVC pipe. Figure 10 illustrates the deviation maps analyzed.

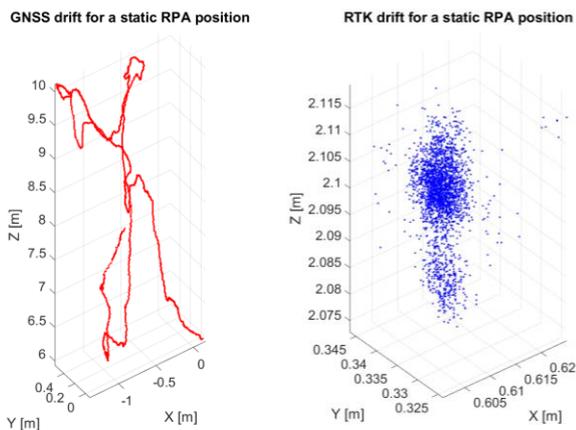
**Figure 12.** RPA positions plotted for a static RPAS. Left for GNSS and right for RTK. Graph scales are different.

To further analyze the error's behavior for the GNSS and RTK data, position information was investigated for the RPA in a static position on the ground. The GNSS presented the position error with a spatial standard deviation of 1428.4 mm while the GNSS+RTK presented a spatial standard deviation of 8.9 mm, as expected. In flight, the positioning uncertainty can increase. Figure 12 shows the 3D points in space recorded over time with static RPAS. For the RTK positions (right image), it is possible to observe a more random distribution of the position errors; and for the GNSS data (left image), it is possible to see a position drift over time. This behavior of the GNSS data can also contribute for the scale errors presented in the measurement results found for the GNSS strategies.
