## 3D AND HYPERSPECTRAL DATA INTEGRATION FOR ASSESSING MATERIAL DEGRADATION IN MEDIEVAL MASONRY HERITAGE BUILDINGS

**KEY WORDS:** Hyperspectral Images, 3D Reconstruction, Material Analysis, Cultural Heritage, Photogrammetry

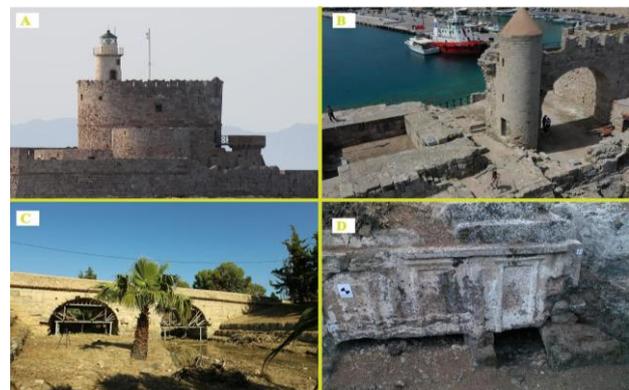
Figure 1. The four pilot areas in Rhodes.

The first pilot area is the Saint Nikolaos lighthouse and fort (Figure 1A) at the entrance of the Mantraki port, which is a part of the medieval fortifications. It includes consecutive reinforcements and expansions after the destructions it suffered from sieges. It was built in 1464-1467 while the walls around the fort were built in 1480. The fort was transformed into a lighthouse in 1863. The second pilot area, the Naillac Pier at Saint Paul's rampart (Figure 1B) was also built around the same period in 1400 on the Hellenistic pier and it was also part of the fortification of the "Great Port", the Commercial Harbour of Rhodes. The third pilot area is the Roman Bridge (Figure 1C)

built across the stream of Rhodini. It is one of the few ancient bridges surviving in Greece dated in the Roman period, but with later repairs at the piers of the arches. The bridge is still in use today, as a two-way motor carriage is running over it, leading to the deterioration of its static competence. Although consolidation works have been carried out on the banks of the stream, the flow of the water is blocked impeded by the dense vegetation and the elevation of the initial riverbed by the modern one, made of reinforced concrete. The fourth pilot area are the Grave enclosures in Rhodini (Figure 1D) dated in the Hellenistic period, in the 3<sup>rd</sup>-2<sup>nd</sup> century BC. The environmental conditions and the microclimate of the area, in which critical role plays the stream of Rhodini, in combination probably with extreme natural disastrous events, such as earthquakes, have caused severe damages to the tombs ranging from the erosion of their stucco-coated facades to fissuring, detachment and collapse of the monuments.

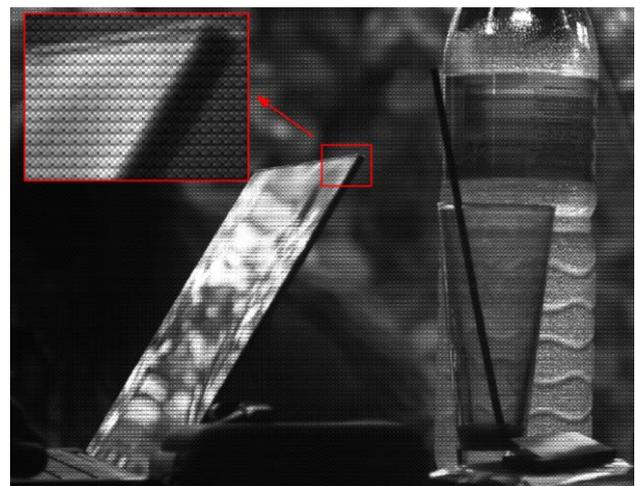
**Figure 3.** A raw HyperView image

The system is designed to be lightweight and can be installed on a UAV after some extra modifications and necessary adjustments. For the time being no appropriate UAV is available and therefore the hyperspectral image acquisitions took place in situ placing the system on a tripod at various Cultural Heritage sites, depicting different materials and corrosion states. These particular cameras are equipped with a mosaic CCD and if someone looks at the raw image of each camera, one would see an image like the one presented in Figure 3.

pixel, while they acquire all the bands in small windows, 4x4 for the VIS head and 5x5 for the NIR head. This is done by appropriate filters that have been added over every pixel of each camera CCD. Thus, the image pixels do not have a uniform spectral response. Rather, they have a complementary spectral response, which if transformed in an appropriate way could produce an image with all image pixels containing a spectral signature from all the camera bands. Special ANSI C programs, which perform the following tasks, have been created for this scope. These programs: (1) decode the raw images, (2) produce band sequential lower resolution hyperspectral images with every pixel containing all image bands, (3) perform appropriate intra band shifts in order to correct the different viewing angles within the 4x4 and 5x5 acquisition windows, (4) correct a systematic NIR sensor pattern, (5) optionally rearrange the image bands in order to be in spectral order, (6) create a full resolution panchromatic image by applying an appropriate Gaussian filter on the initial raw image, (7) perform pansharpening of the lower resolution HS images using the Local Mean Matching pansharpening method (De Bethune et al. 1998), and (8) convert radiance images to reflectance images based on the pixels of a reference surface, if one was used during acquisition.

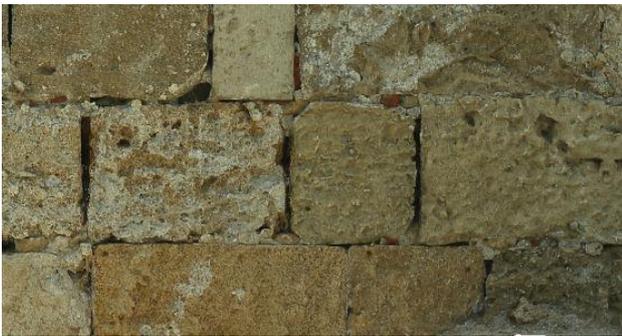
Figure 4. Detailed 3D Textured Model (RGB).

The exploitation of the hyperspectral images required first their transformation and translation in QGIS software. Then the images were aligned with the RGB digital images using the premarked targets as common points, if any of them were visible, or characteristic points at the structure that were easily identified in both the RGB and HS images. More than 6 common points in each HS image were used to properly and accurately align them with the RGB images. Since the HS images were successfully aligned, the 3D Textured models and the orthomosaics were produced enabling the use of the HS images (Figures 5 & 6) along with the 3D data.

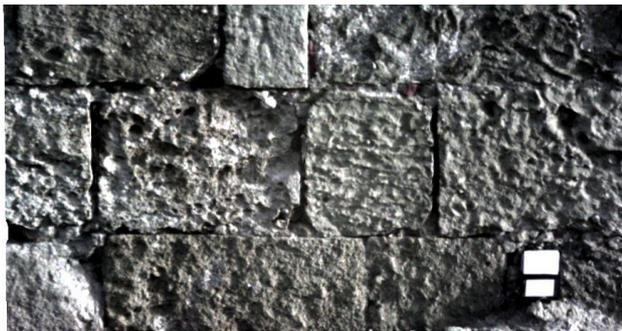
Figure 5. Detailed 3D Textured Model using HS bands 625 nm, 540 nm, 489 nm as RGB.

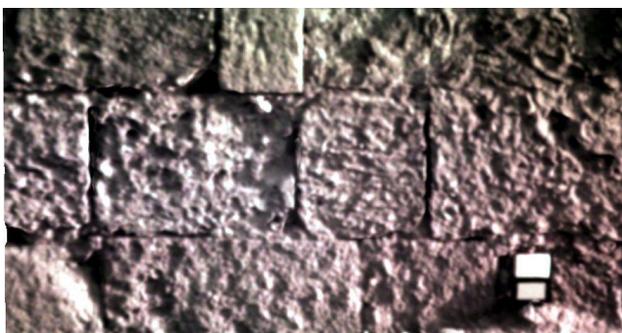
Figure 6. Detailed 3D Textured Model using HS bands 823 nm, 710 nm, 696 nm as RGB.

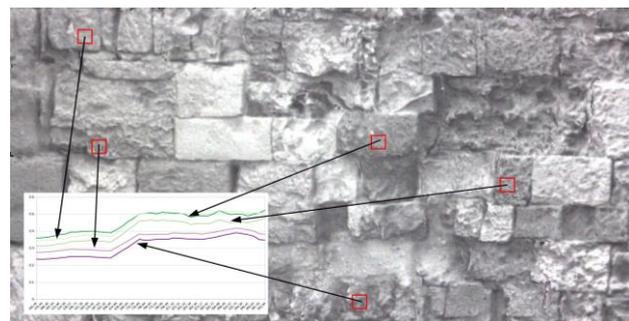
Figure 7. Detailed 3D Textured Model (HS) and spectral signatures of stones with various degradation levels.

As far as material loss is concerned, it was found that the spectral signatures present a general decrease in reflectance when the material loss is more intense (Figure 7). This reflectance decrease is caused by the rougher texture and the occurring shadows and not changes within the stone material. Thus, spectral signatures for material loss cannot be selected and will not be discussed further.

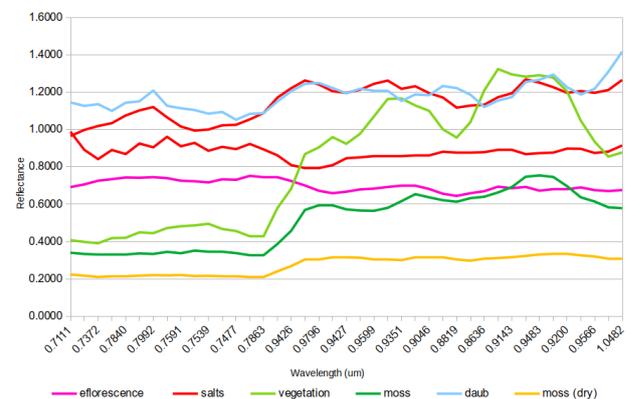
Figure 8. Spectral signatures derived from the HS images of the St. Nikolas Fort

Figures 8 and 9 present spectral signatures from the St. Nikolas Fort and the Roman Bridge respectively. In the case of the

Roman bridge, some parts of the moss were wet, presenting very low reflectance especially in the NIR region. Signatures of the same appearances present similar shapes but different reflectance magnitudes due to irradiance variations, which are still apparent despite the radiance to reflectance conversion. Continuum removed spectra has also been studied in order to detect useful absorption features, but it did not prove to be useful in this case study.

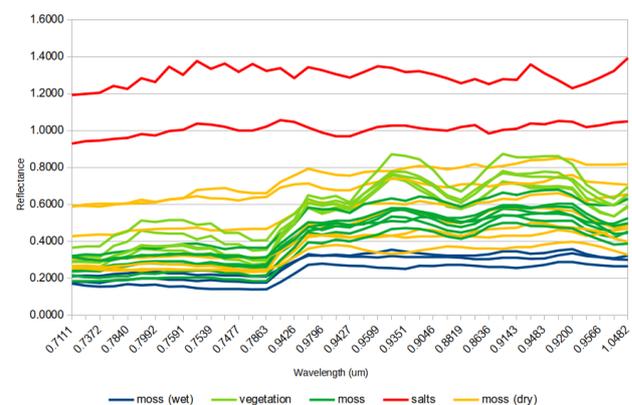
Figure 9. Spectral signatures derived from the HS images of the Roman Bridge

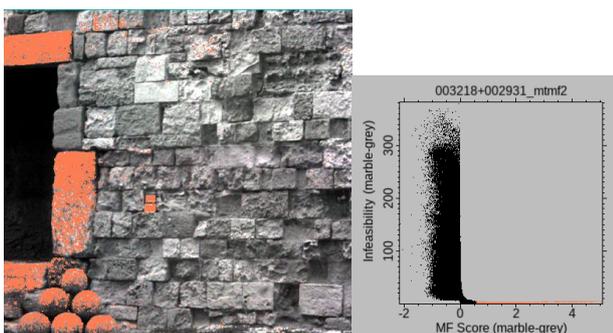
**Figure 10.** Paint in orange are the pixels which are selected for marble MF score > 0.5 and marble infeasibility < 20

In our experiments, pixels with MF score above 0.5 and infeasibility below 20 have been selected as correct for each material type (Figure 10).

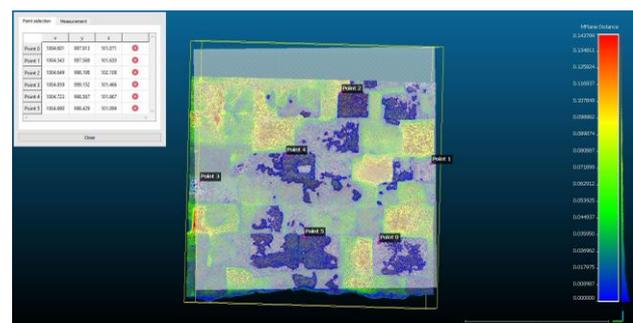
**Figure 11.** qMPlane Plugin: Defining the best fit plane by picking points on the 3D point cloud.

A simple approach was followed in order to assess the material degradation is by trying to adjust a planar surface at the part of the monument that presented no degradation. After defining that plane, the distances between the plane and the 3D Point Cloud or Mesh would indicate the depths of the degradation and the material loss for each stone at the Cultural Heritage buildings. Practically, for each case both the 3D point cloud and the 3D Textured Model were imported in the CloudCompare Software (CloudCompare 2.12 alpha, 2021). Then, the qMPlane Plugin ([http://www.cloudcompare.org/doc/wiki/index.php?title=MPlane\\_\(plugin\)](http://www.cloudcompare.org/doc/wiki/index.php?title=MPlane_(plugin))) was used to define an appropriate plane by picking numerous points at the 3D point cloud where no degradation was obvious according to the 3D Textured model (Figure 11).

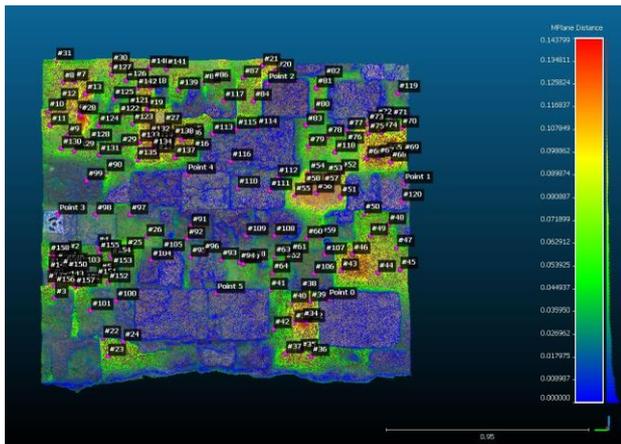
Figure 12. Detailed 3D Textured Model using HS bands 823 nm, 710 nm, 696 nm as RGB.

and the plane leading to a first estimation of the highest and lowest degradation value. Further normal distance measurements against the plane can be performed to acquire accurate and specific results about the depth of the degradation so as to estimate and evaluate the material loss and the level of degradation for each part of the monument in particular (Figure 12).

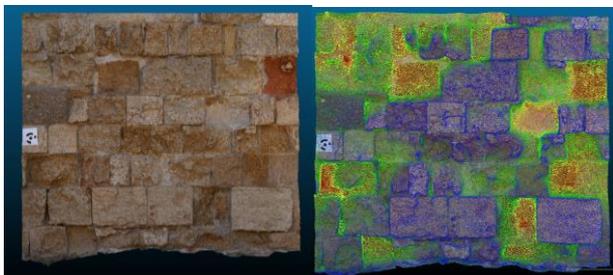
Figure 13. The 3D Textured Model (left) and the visualization of the scalar field on the 3D Textured Model (right).

These measurements can easily be exported in a .csv file and the comparison between the visual degradation and the measured distances is quite easy when observing the 3D Textured model and the scalar field (Figure 13).

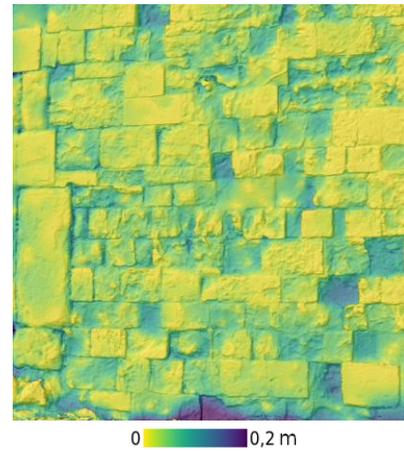
Figure 14. Material loss estimation using the valley depth algorithm (hillshade has been added as background for easier interpretation of the results)

Interestingly, this algorithm gives astonishingly good results for the material loss estimation when being used with a 3D model of a Cultural Heritage building. It only fails at the edges or when other features interfere with the wall plane. The result is derived very fast, without the need for any adjustments (apart maybe from the ridge order to be taken into consideration) and provides very accurate estimations.

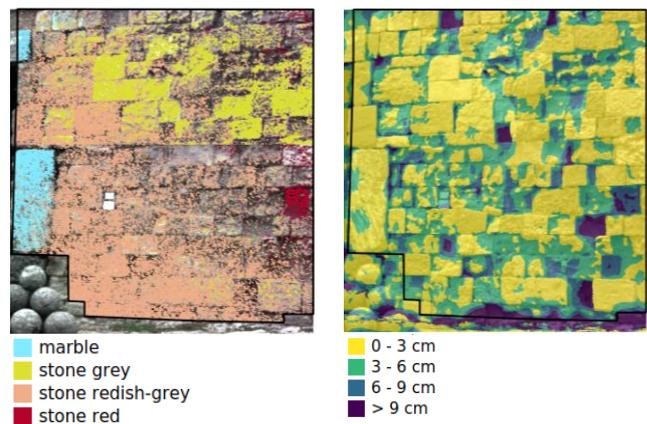
Figure 15. Left image: Building material map derived from MTMF spectral unmixing. Right image: Valley depth classes for the 3D model of the same wall (St. Nikolas Fort).

Spectral unmixing, MTMF in our case study, provides a set of abundance maps for all the endmembers (pure spectra) that have been used. By appropriate selection of thresholds someone can create a classification of the dominant endmember within every pixel. As already mentioned, in this work the MTMF unmixing results have been used for building material maps and biodeterioration maps. Thresholds of MF score > 0.5 and infeasibility < 20 have been applied on each abundance map for classification purposes. Such maps are shown in figures 15 and 16, along with the result of the valley depth algorithm for the same parts (classified in 4 material loss classes).

The integration of the 3D and HS results was achieved by comparing the maps of Figures 16 and 17. The result of the comparison lead to interesting conclusions on the vulnerability of the building materials as well as the role of the biodeterioration factors in material loss. Cross classification matrices have been created (1) between the building material classes and the material loss (ML) classes for the St. Nikolas Fort test area, and (2) between the biodeterioration classes and the material loss classes for the Roman Bridge test area.
